SURVEY REPORT OF IKKATTEQ, BLUIE EAST 2 (BE-2)
SEMERSOOQ MUNICIPALITY, EAST GREENLAND

REPORT PREPARED BY:

HANS HARMSSEN
MIKKEL MYRUP
HANS LANGE

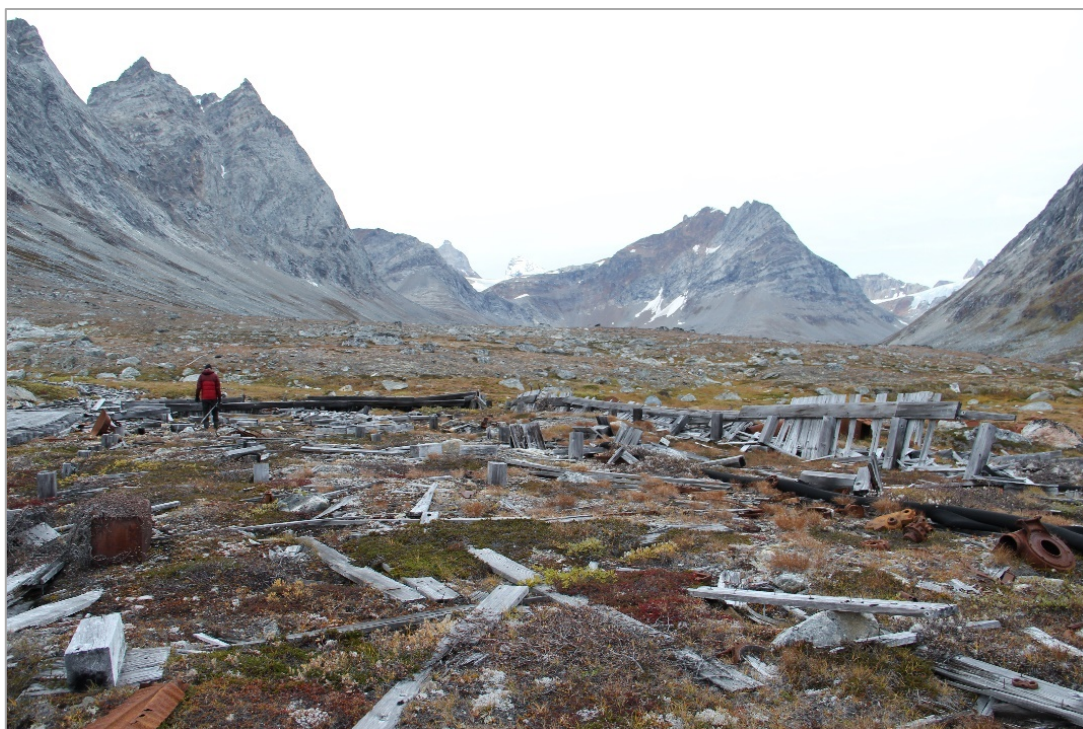
Fig. 7. Scraps of wood, metal and tarpaper were observed throughout the camp area at BE-2 (photo: H. Lange 2018).

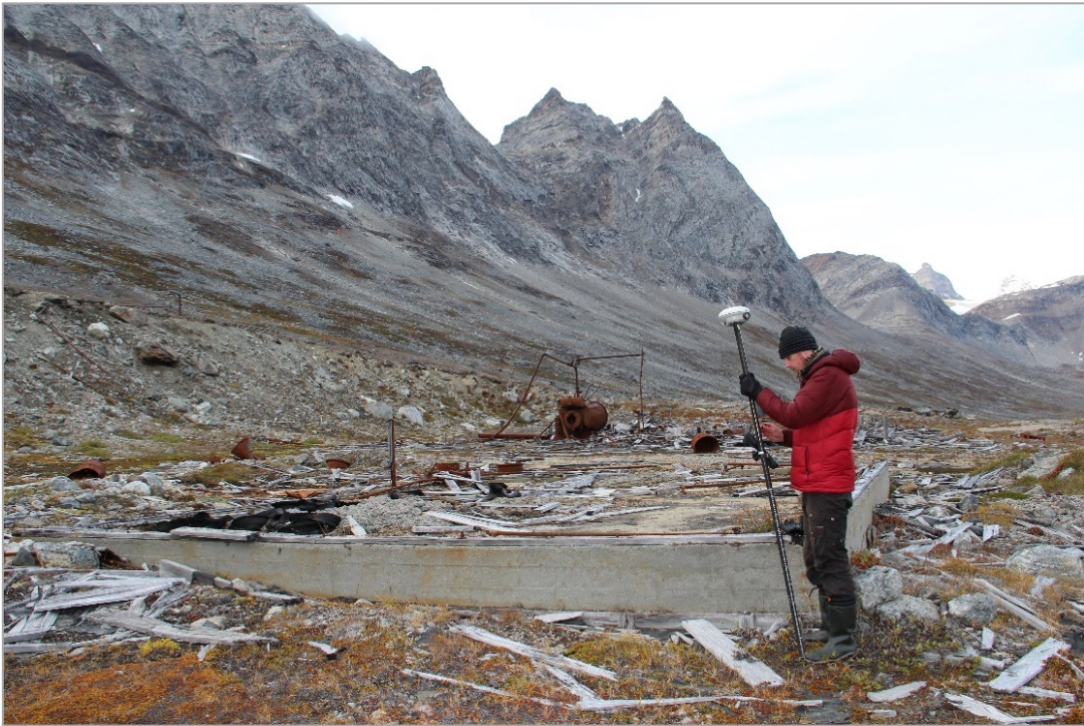
Fig. 8. Several concrete building foundations were observed at BE-2 (photo: H. Lange 2018).

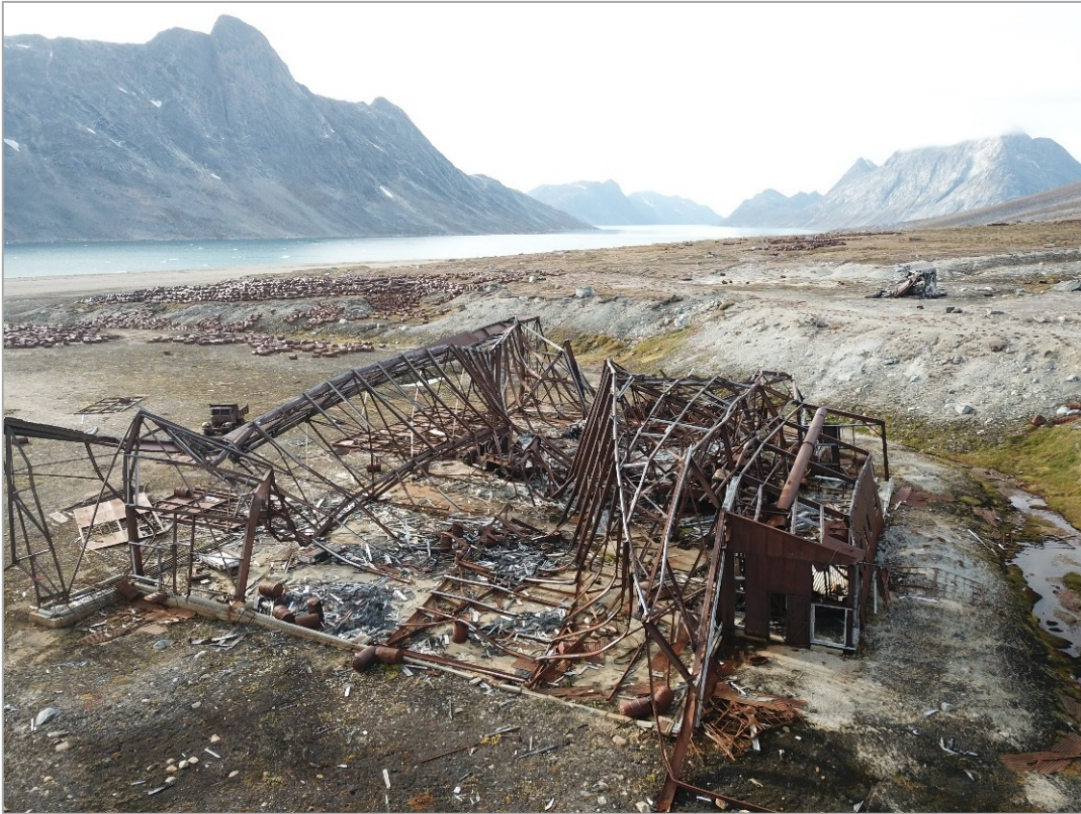
Fig. 10. The collapsed hangar is as the only semi-standing building structure at BE-2 (photo: H. Harmsen 2018).

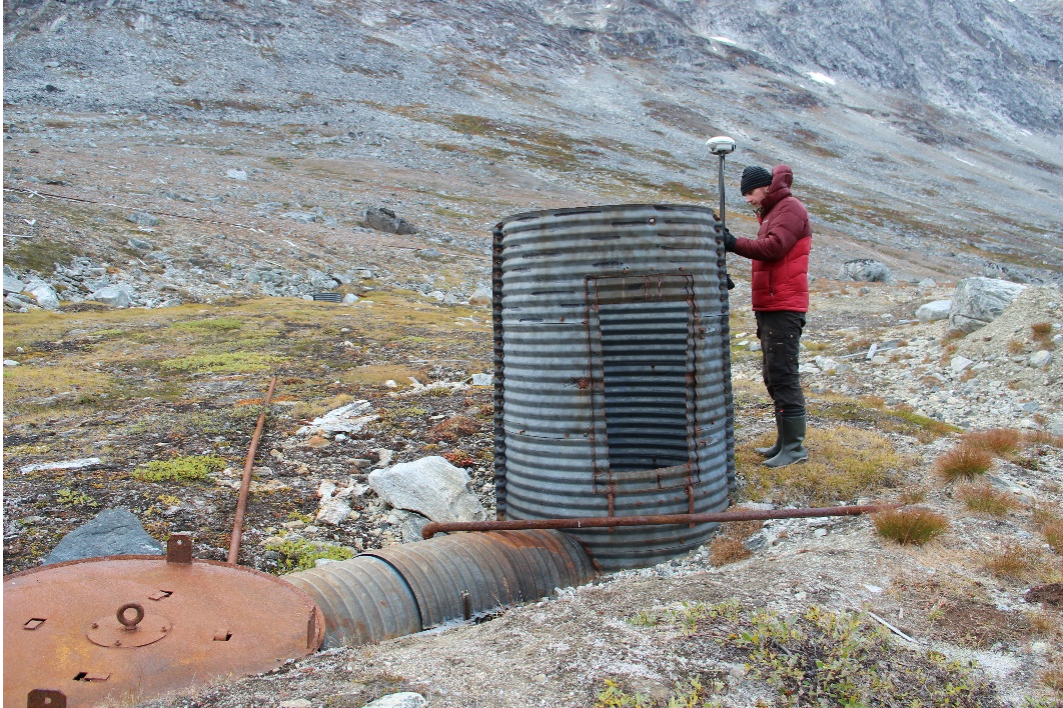
Fig. 16. A corrugated metal housing resting on top of the camp water catchment well at BE-2. At the time of the visit in 2018, water could still be heard to be flowing into and out from the well (photo; H. Lange 2018).

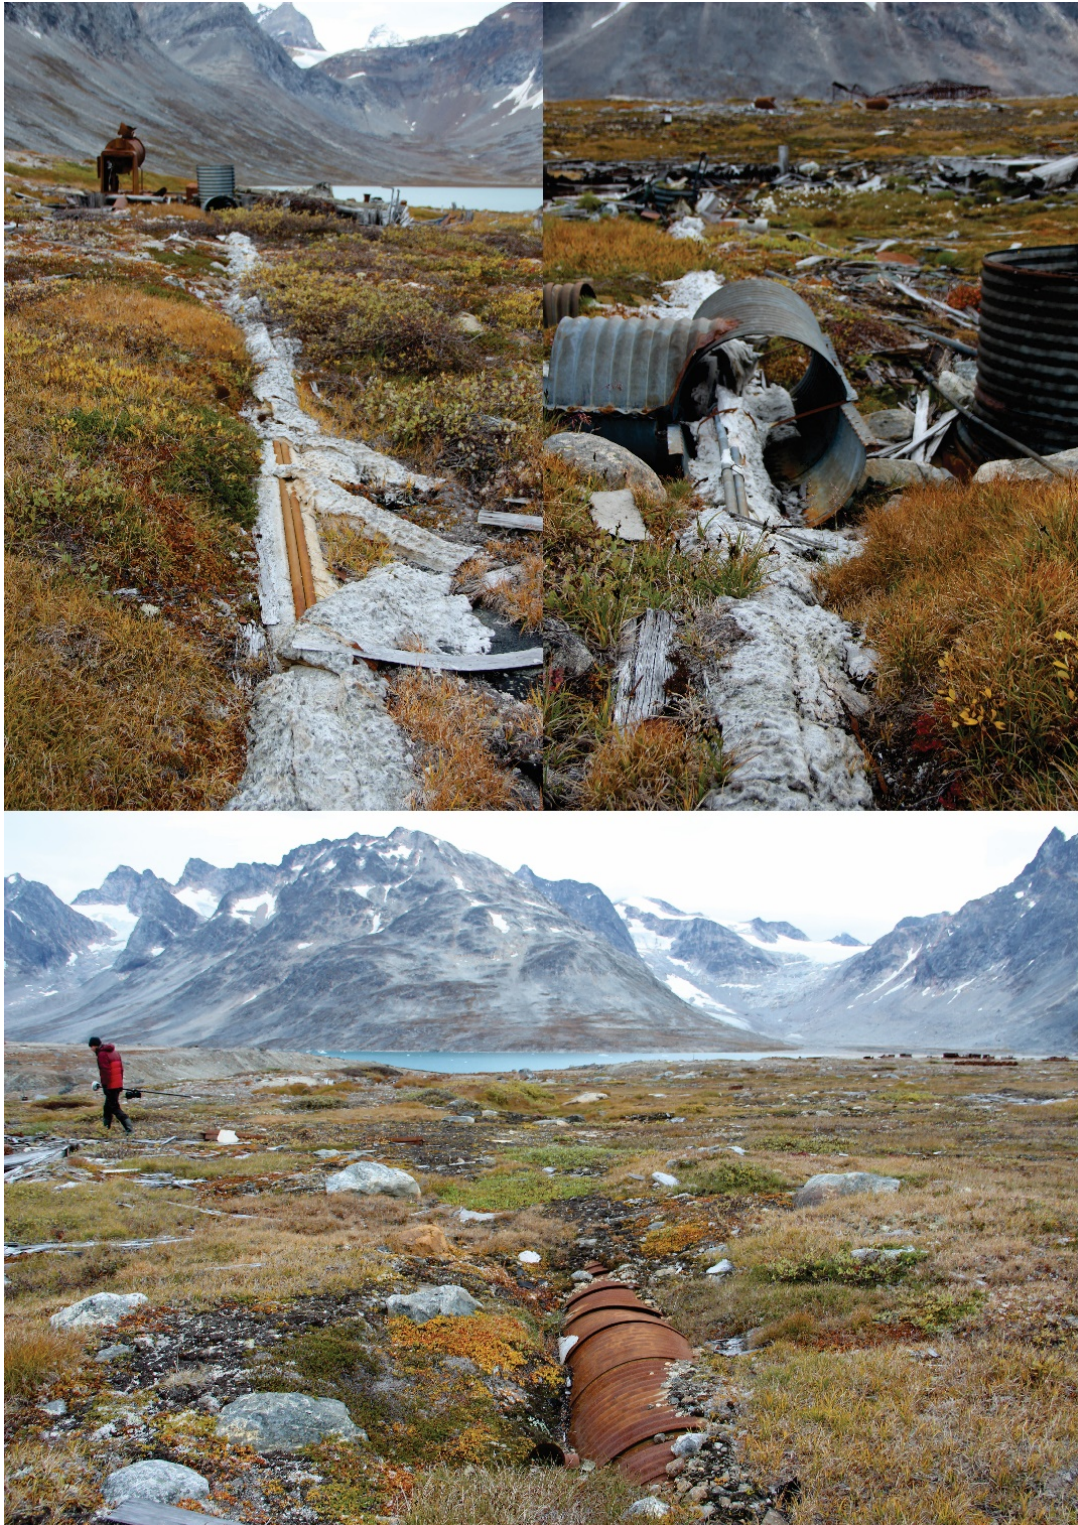
Fig. 18. Broken and rusting water pipes with decomposing insulation crossed the camp area at BE-2. A complex ditch and buried drain pipe system also would have helped to direct snow melt and keep the lower areas of the camp area from becoming inundated during the spring/summer thaw (photos: H. Lange, 2018).

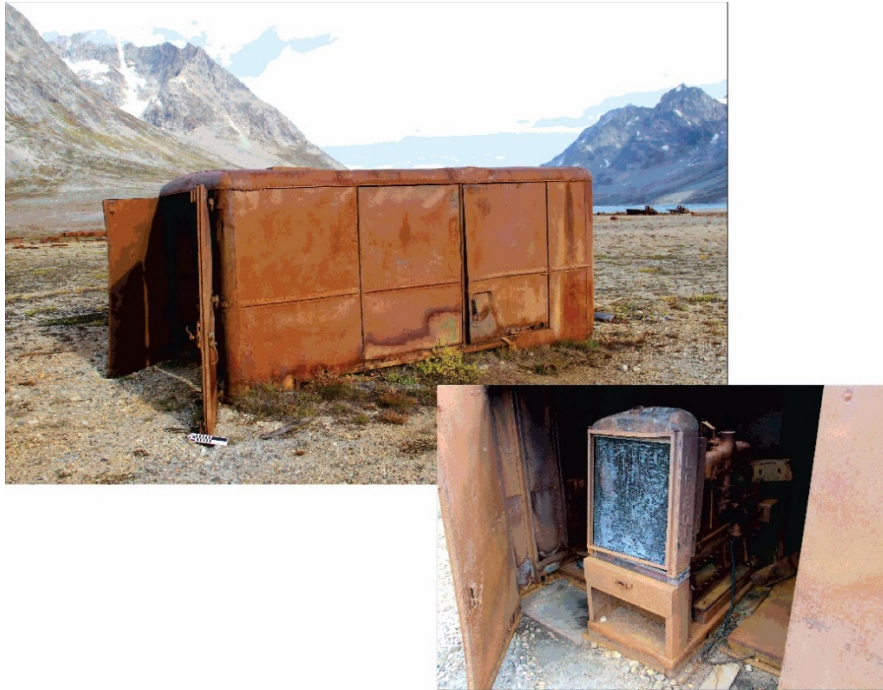
Fig. 19. A LeRoi engine, gas powered generator stationed next to the hangar inside a protective steel Enclosure at BE-2 (photos: H. Lange 2018).

- All heavy and stationary man-made objects (e.g. boilers, furnaces, generators, concrete foundations, etc.) at BE-2 should remain undisturbed. These types of large objects pose no current threat to the environment and possess significant historic value by virtue of their diagnostic character. Present and future generations will benefit from being able to visit and observe these objects in their original setting.

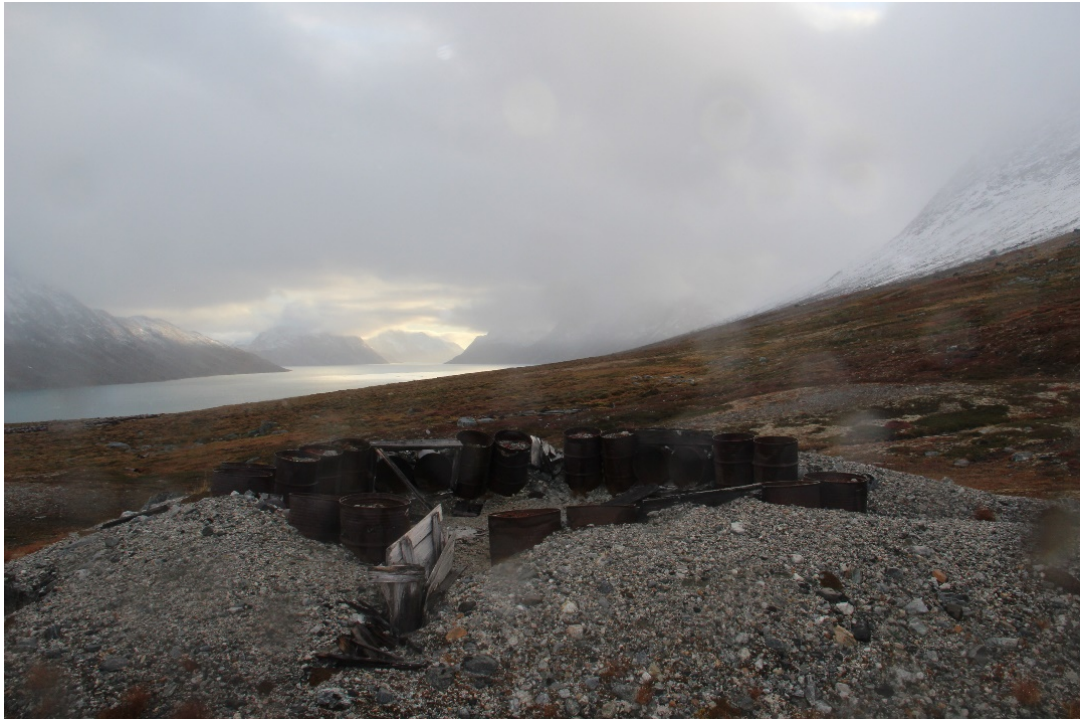
Fig. 25. Defense feature 9, facing south (photo H. Lange 2018)

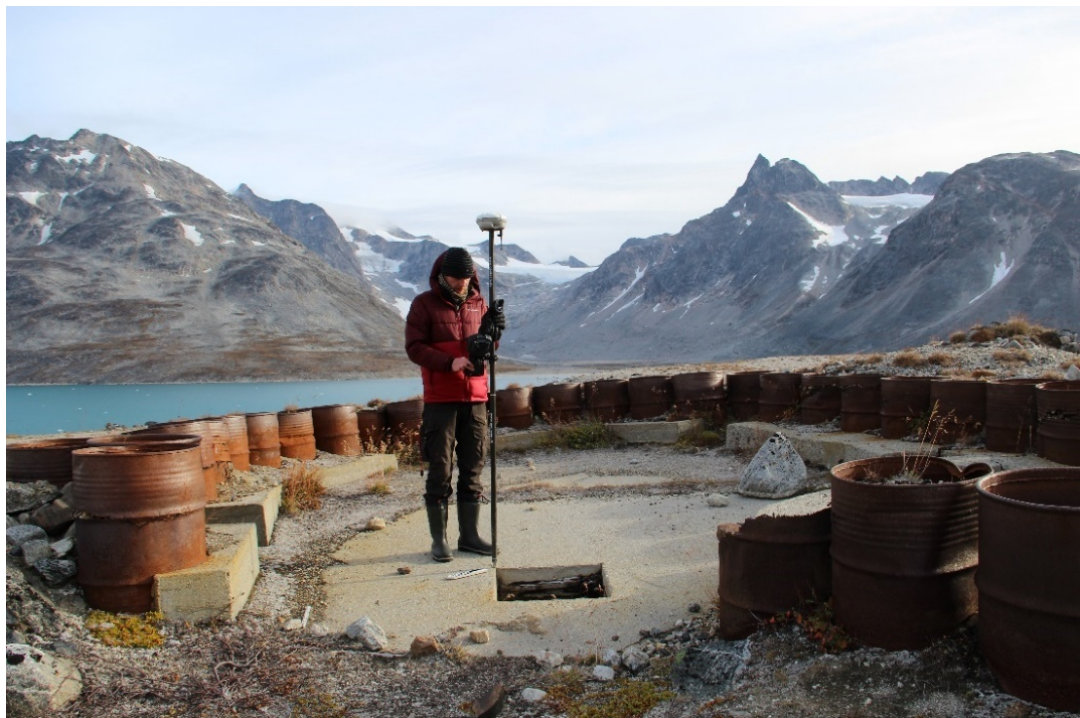
Fig. 26. Defense feature 3, facing east. Harmsen shown collecting a dGPS control point (photo H. Lange 2018).

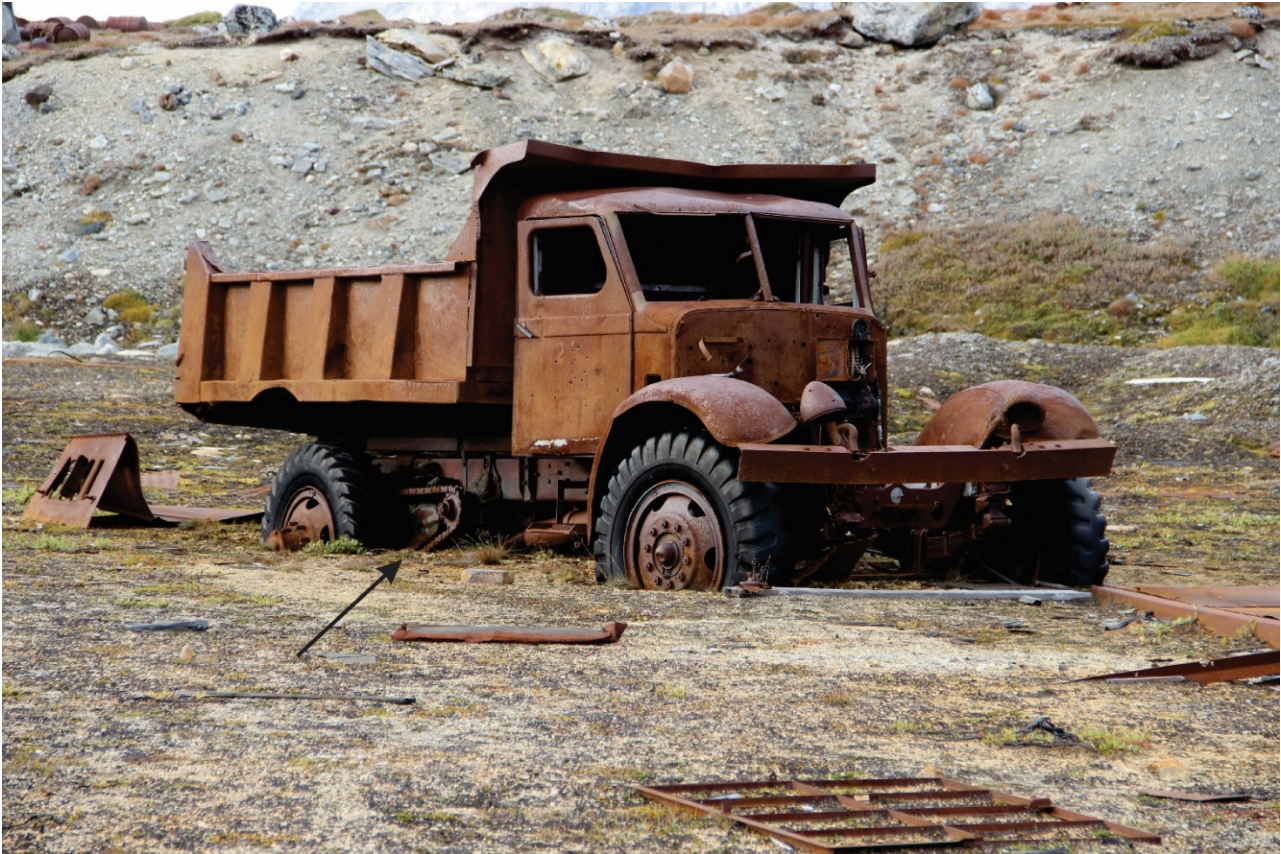
Fig. 29. A lonely Sterling HC 145 truck lying derelict at BE-2. Note arrow pointing to the rear axle chain-drive system. Chain-drives assisted navigating difficult terrain and pulling heavy pay-loads at BE-2 (photo: H. Lange 2018).

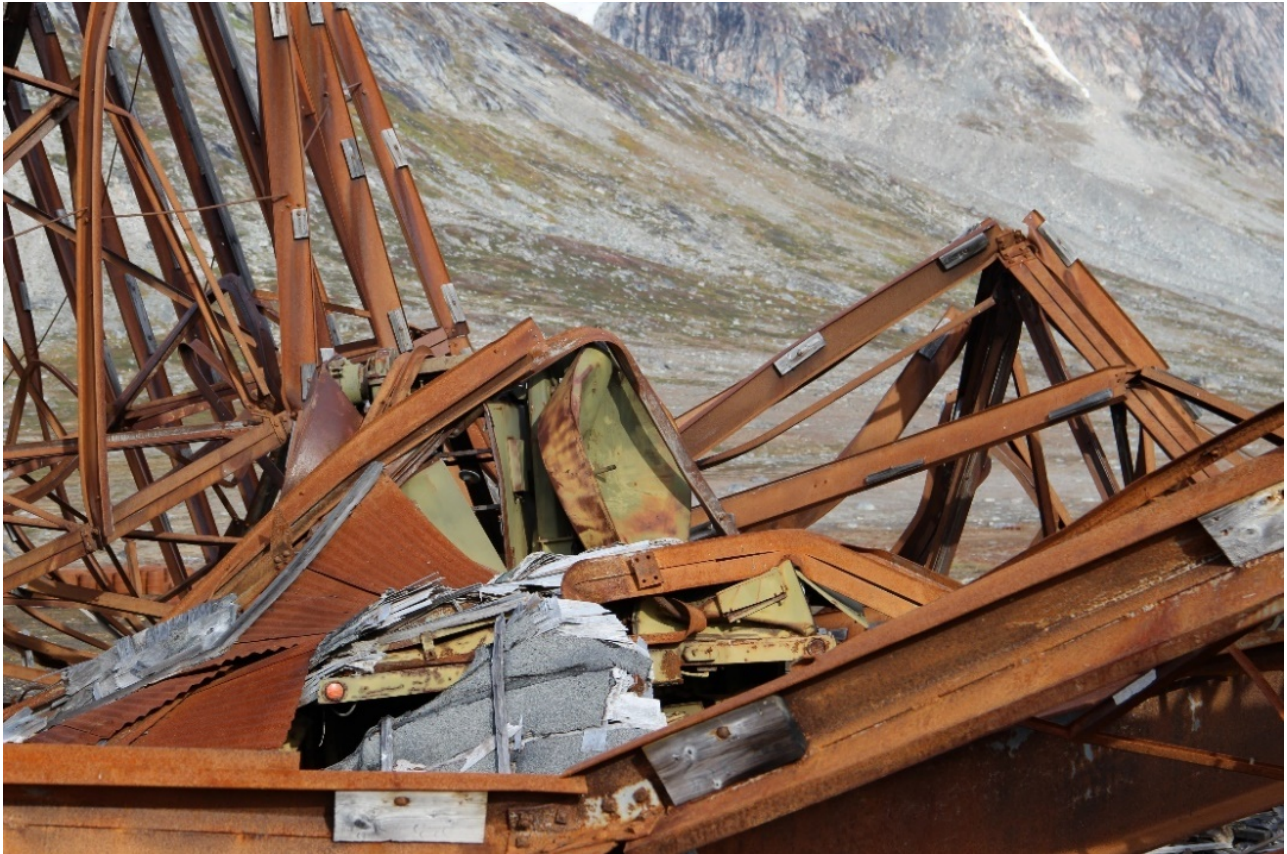
Fig. 30. Mobile radio dish buried in the collapsed remains of the hangar. Close inspection was not possible due to the fragility of the structure (photo: H. Lange 2018).

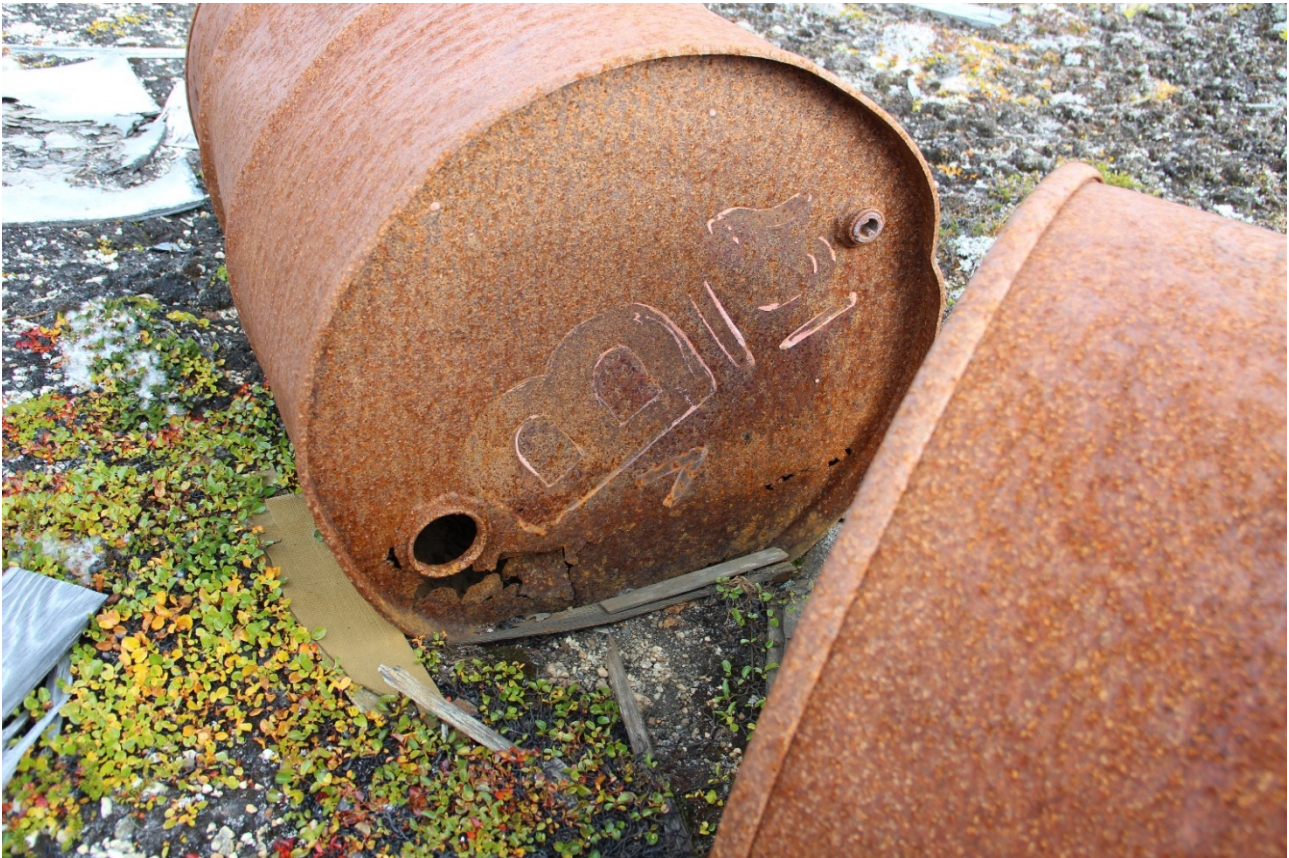
Fig. 43. An enormous quantity of empty and rusting 55-gal. barrels are found at BE-2. As seen in the photo, most barrels have corroded significantly allowing any remnant liquids to transfer into the soil (photo: H. Lange 2018).

For the most part, no fuel was observed to be still present in the barrels—this is attributed to the fact that the barrels are highly corroded, and the liquid has been gradually transported into the topsoil. As a consequence, large portions of BE-2 may be contaminated with a high level of lead and other toxic chemical residues.

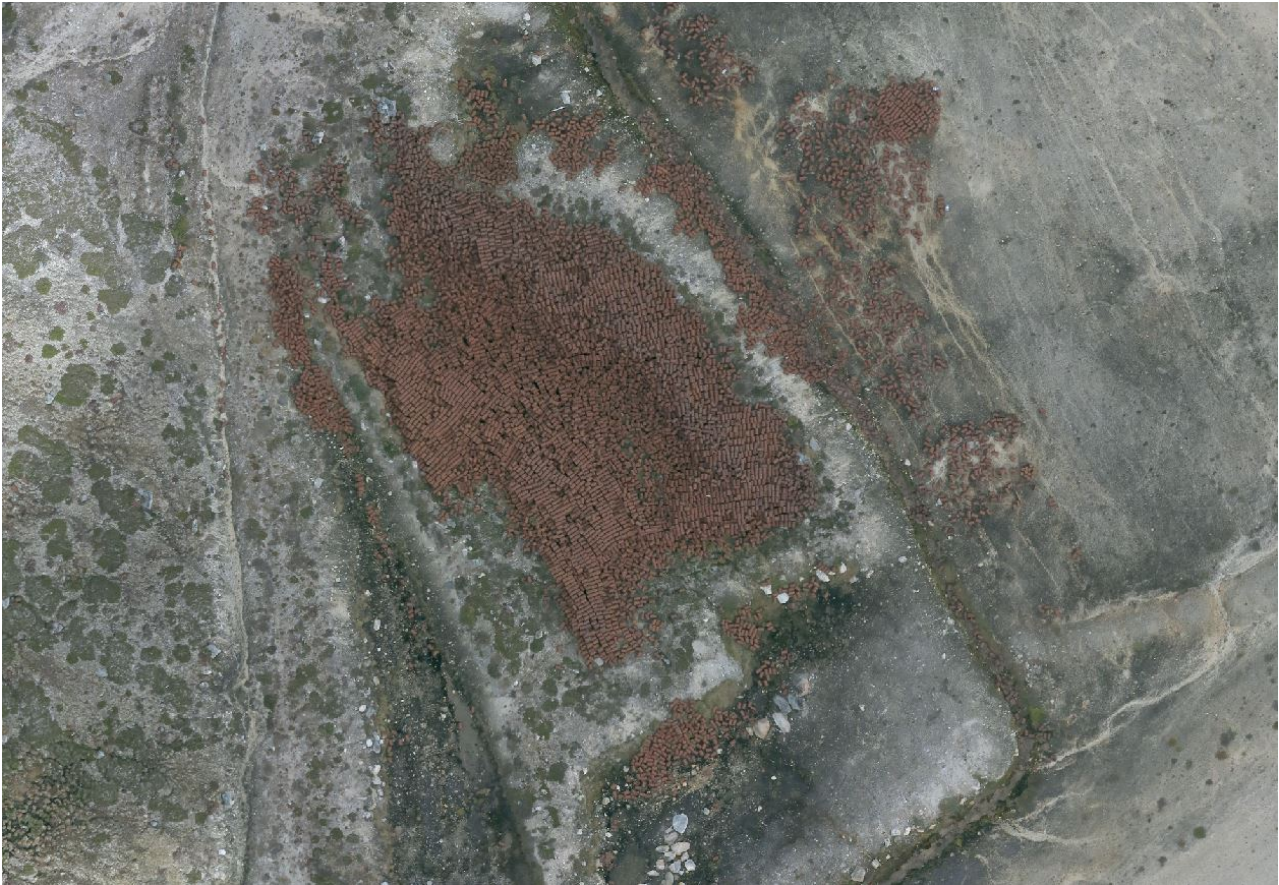
Fig. 44. The largest concentration of barrels seen at Ikkatteq, just 75m to the south of the collapsed hangar. At this location barrels are piled two to three layers deep (photo H. Harmsen 2018).

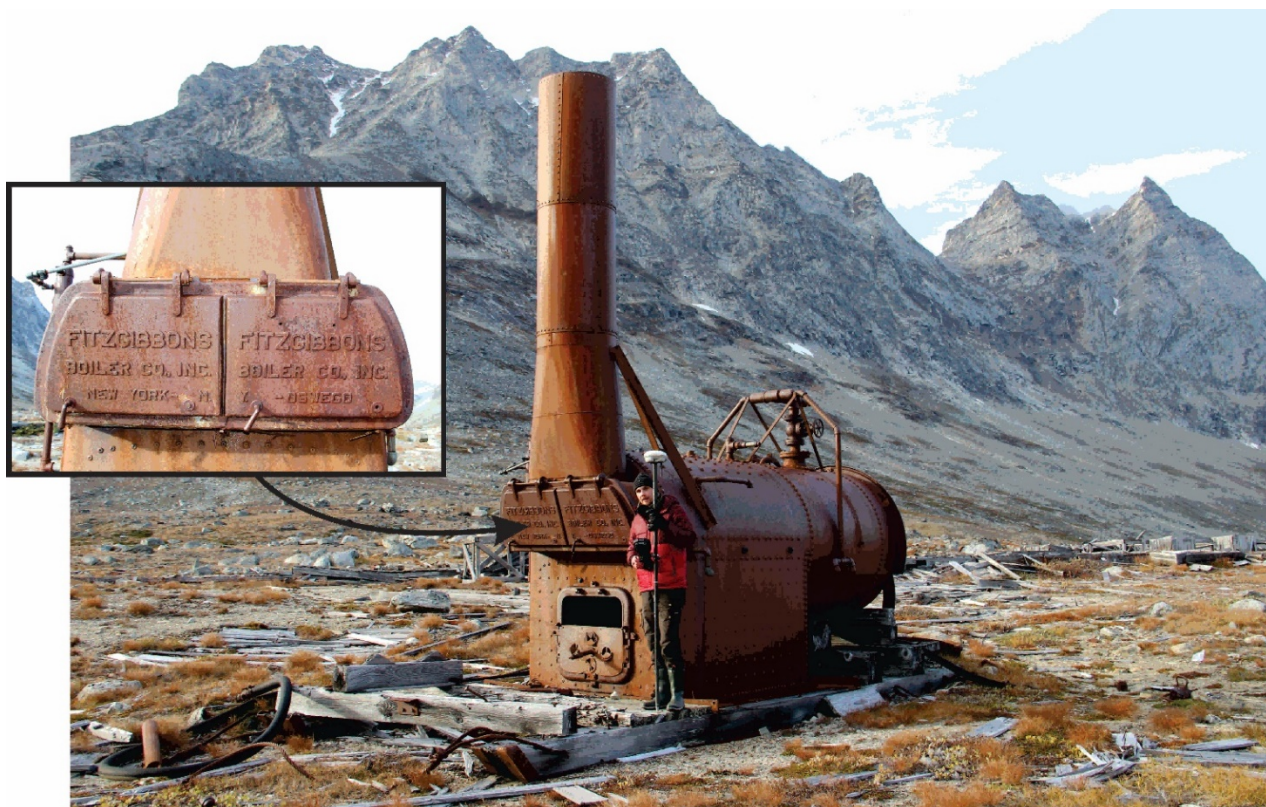
Fig. 55. A lonely boiler far from home. This industrial boiler was manufactured by the FitzGibbons Boiler Company, Inc., Oswego, New York. Harmsen shown collecting dGPS point (photo: H. Lange 2018).
