Archaeological Surveys in the West Greenland Inland, summer 2009, in Advance of Proposed Development of Hydroelectric Power.

- Report prepared for ALCOA
- November 2009

Report on archaeological surveys undertaken for ALCOA/Greenland Self-Government in Advance of Proposed Development of Hydroelectric Power in summer of 2009

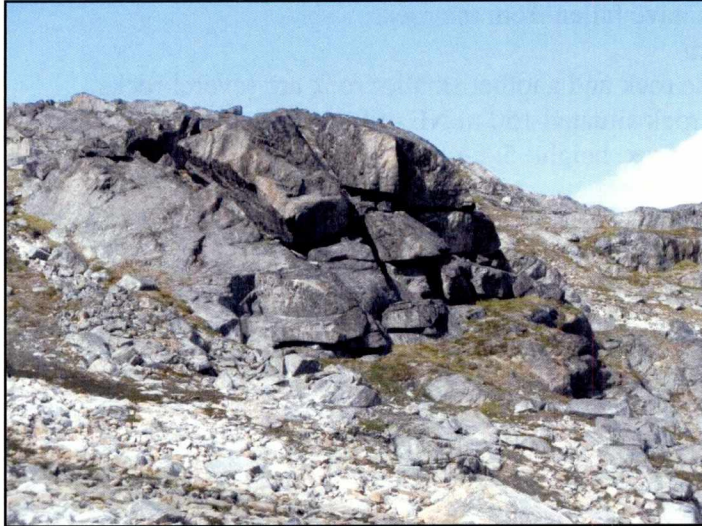
65VI-00I-023: Two or more rock shelters under and between clefts in an outcrop. The shelters are situated on the S side of the outcrop protruding from the north slope of a valley.

Fig. 5: Outcrop containing at least two shelters. Site no. 65VI-00I-023

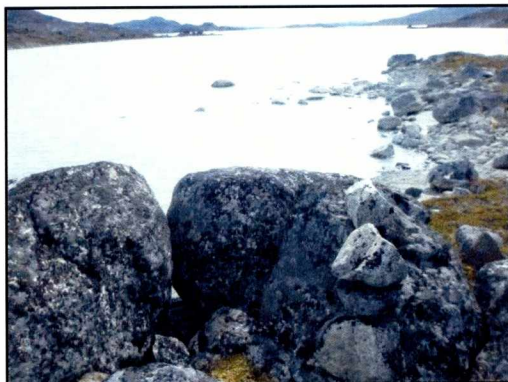
64V2-0IV-045: A shooting blind (D3), a tent ring (E) and a cairn (F) were added to the structures recorded last summer. The tent ring, approx. 10 m. NW of the shooting blinds, is built by smaller than head-sized stones placed with approx. 30 cm between them. Dim. of ring: 4 x 4 m.

Fig. 6: Natural rocks used as shooting blind by adding stones. Site no. 64V2-0IV-045.

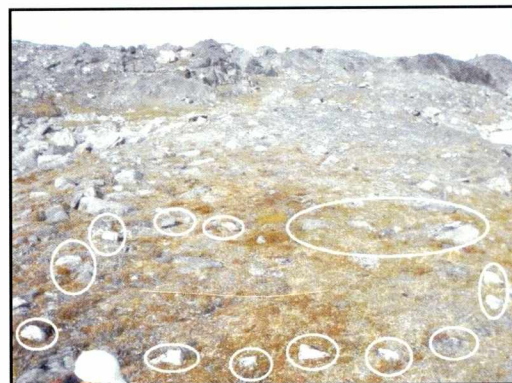
Inside the vegetated ring two lead bullets and a corroded tin cap with the imprint *Nescafe* and “*EFTER BRUGEN*” were found. On the beach near the tent ring a white plimsoll was found. The cairn is 30–50 m N of the site.

Fig 7: Square tent ring on site no. 64V2-0IV-045

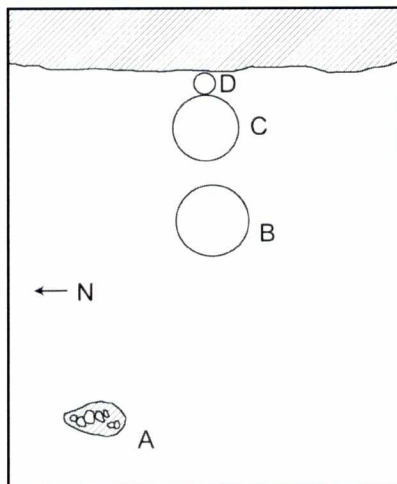
Fig. 9: Small hunting camp site no. 66V2-III-186.

This site will not be inundated if Tasersiaq is dammed.
