# PEOPLE OF ALL TIMES

## FIELD REPORT

## **Field report for the pilot project “People of All Times”**

*Submitted January, 2014*

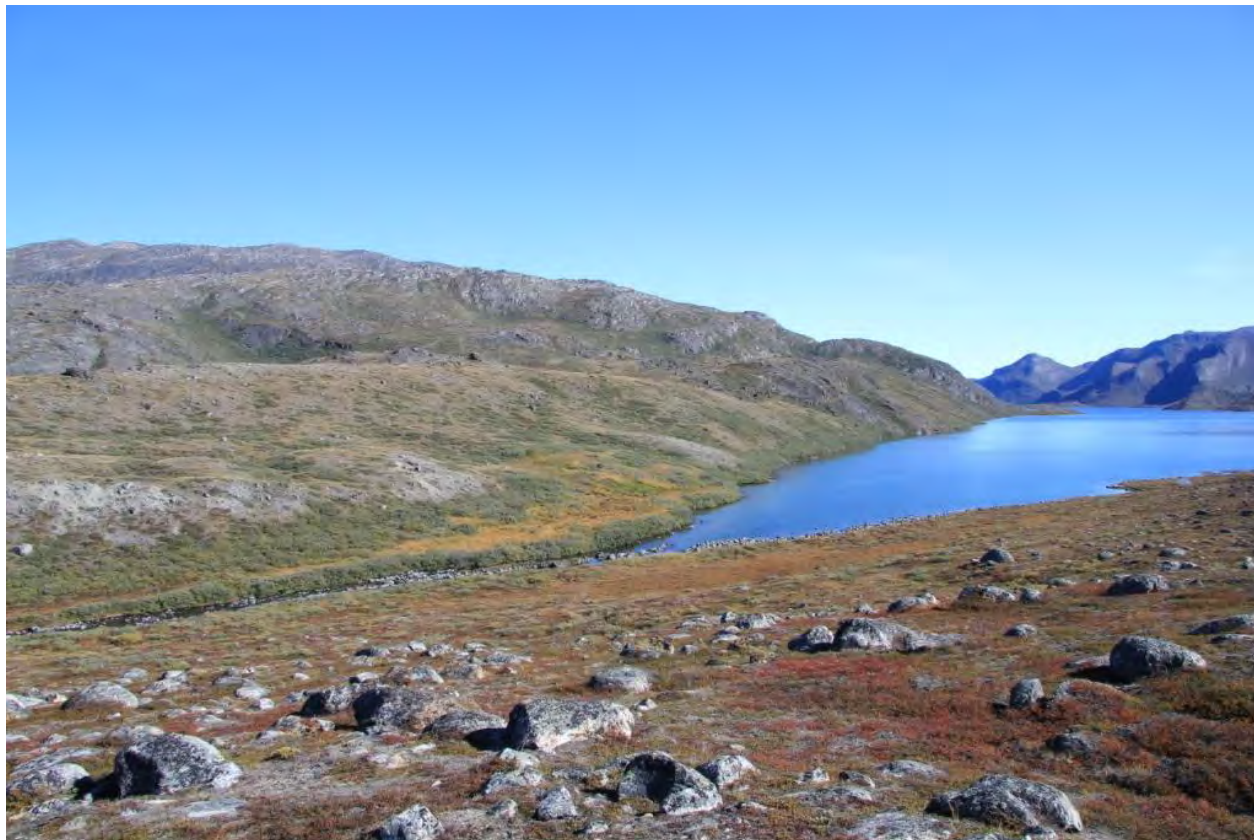
**Fig.3.2** Ruin group V35 at the western end of lake Tummerallip Tasersua seen towards the NE. Ruins 1-3 are located just above the patch of grassland on the far side of the river and lake, ruins 4-5 on the top of the lower ridge running parallel with the lake (*photo: C.K. Madsen 2012*).

Ruin group V35 lies at the extreme western end of the large lake Tummerallip Tasersua (fig. 3.2) c.5km NNE of Kilaarsarfik/Sandnes. It lies at an altitude of approximately 230 m (according to map). Along a short stretch on the northern banks of the lake as it narrows in its western end is a small stretch of former lakebed or mire now vegetated by lush grass that stands to a height of about a meter or so. This is the relict homefield of the Norse site; the ruins lie just above the patch of grassland on the lower, more drained, part of the slope, also surrounded by grassland. The river flowing past the site eventually turns north and continues northwards into the wide valley between Kilaarsarfik/ Sandnes and Kapisillit.

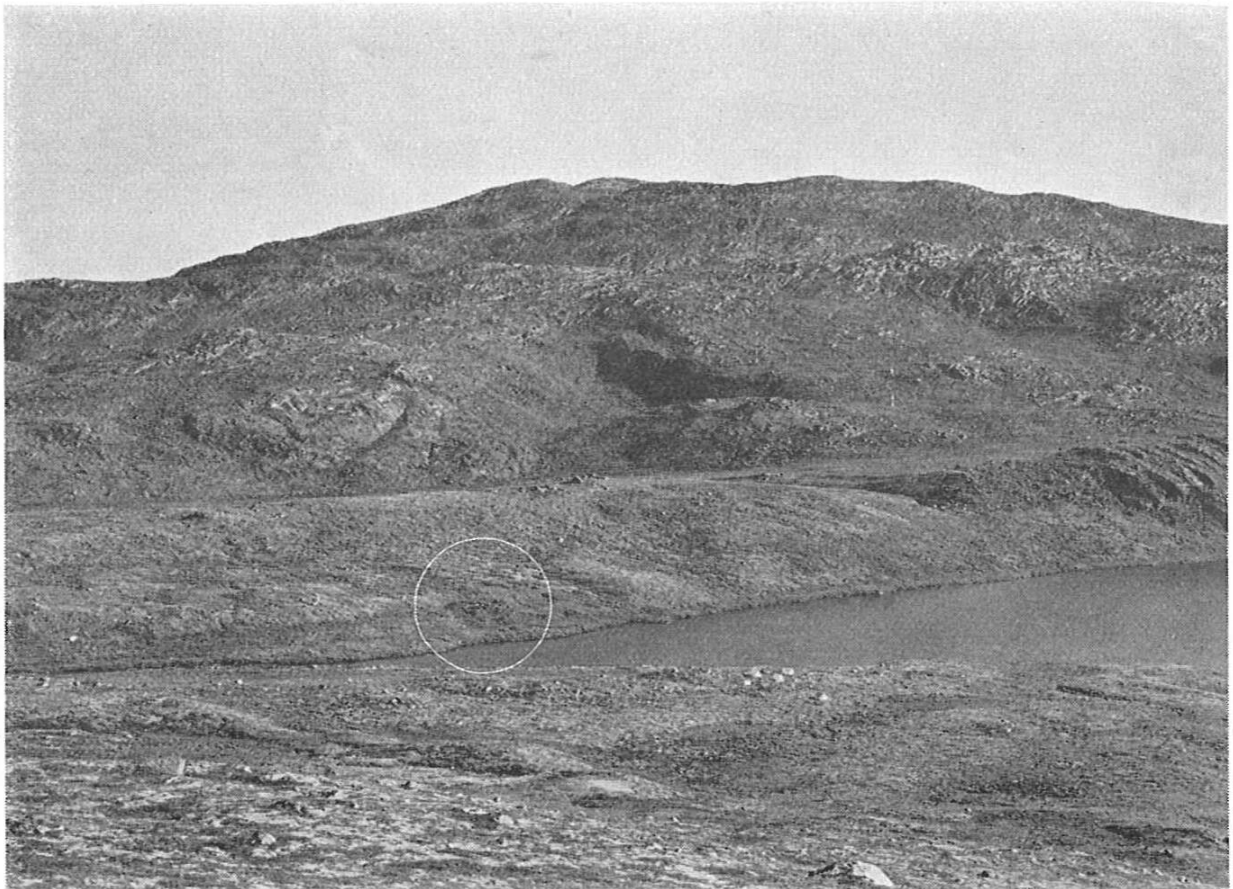
the slope below the dwelling – a trench that was not backfilled and is clearly visible (fig.3.4) – recording frozen deposits and excellent preservation (Ibid.;167).

Fig.3.4. Photograph of V35 from 1937; only slight vegetation changes are visible when compared with a present photo, cf. fig.3.2 (after Roussell 1941;fig.50).

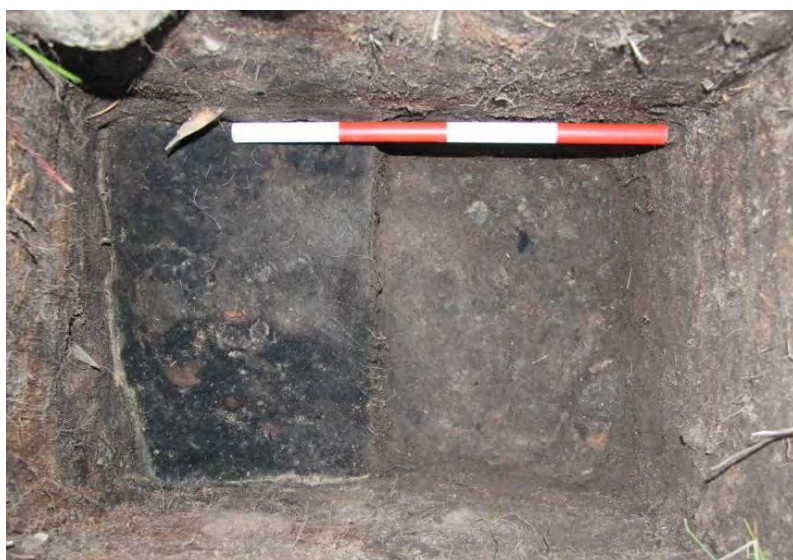
**Fig.3.6** The top of [05], a burned layer that produced a quite large quantity of burned or scorched wood, sheep/goat pellets, and a few bones. It is the first definite and undisturbed cultural deposit, possibly a landnám layer. To the right, the backfill of the 1981 trench has been emptied out (*photo: C.K. Madsen 2012*).

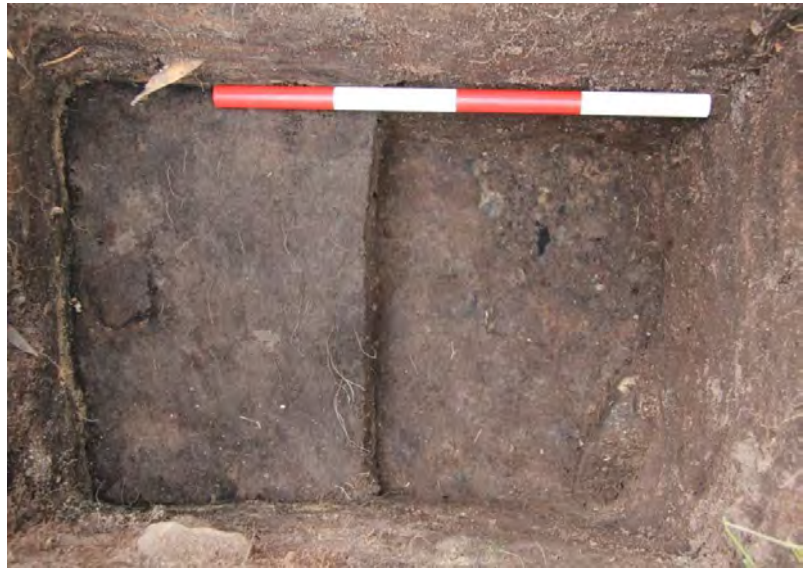
**Fig.3.8** Burned or scorched sheep/goat pellets found in layer [05] (*photo: C.K. Madsen 2012*).

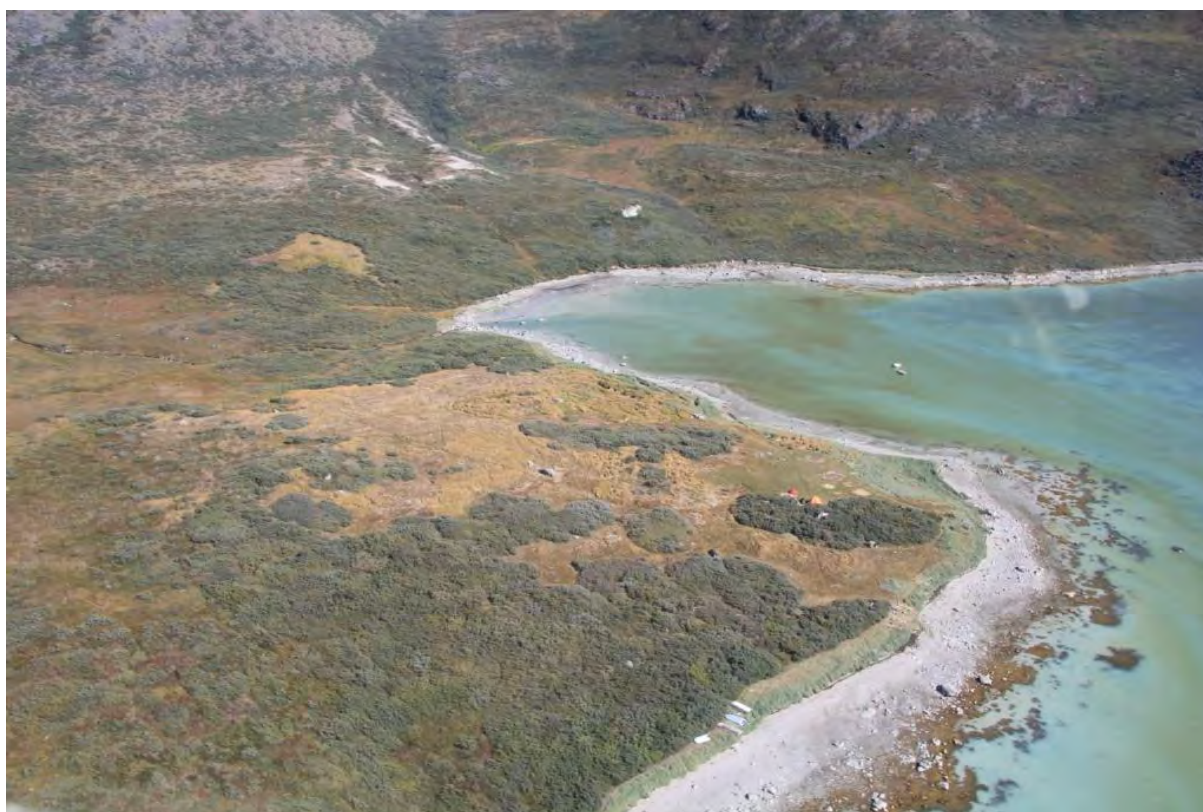
**Fig. 3.10** Aerial photograph, looking east, of the bay at the head of the Ameralla and the alluvial fan with ruin group V51/Kilaarsarfik. Clearly visible is the lush grass vegetation on the relict Norse homestead surrounding the ruins and an equal lush patch of grassland on the far side of the river (*Photo: C.K. Madsen 2012*).

The front of the alluvial fan, where the ruins are located, rise only few meters above sea level; here lie the ruins of V51 and, surrounding them, a lush vegetation dominated by grass often standing more than a meter high (the relict Norse homefield) and dense willow scrub of up to two meters (fig.3.10). Undoubtedly, the willow scrub now spreading on the alluvial is a more recent vegetation feature; in fact, comparing with a 1903 photographs by Bruun (1917;53) and Roussell (1936) fig.1, 6, the willow scrub has spread significantly during the last c.100 years (cf. fig 3.10); Accordingly, it is reasonable to suspect that the grassland vegetation was much more prevalent during the Norse occupation (as is also demonstrated from new pollen evidence), and that the willow scrub will continue to encroach on the grassland and ruins with some negative impact on the latter.

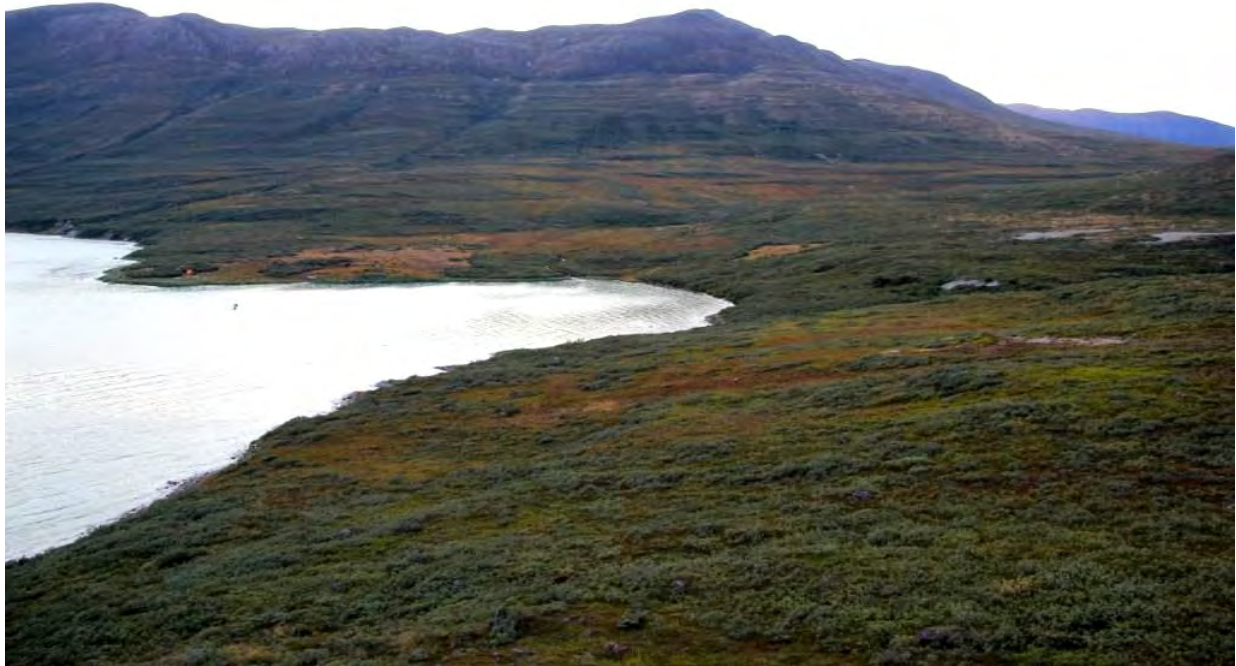
**Fig. 3.11** The slope E of the river and the alluvial fan with ruin group V51 seen towards the NW; behind the slopes of the mountain covered by willow scrub. Cf. fig.3.10 for the extent of grassland also visible in the photograph (*Photo: C.K. Madsen 2012*).

On the gentle slope rising E of the river and along the shore of the bay, the lower part vegetation is completely dominated by very rich willow scrub with the inclusion of a few birch trees and small wet mires (fig.3.11). Ascending the slope, the scrub vegetation quickly gives way to dwarf heath vegetation. However, there is a patch – roughly 60x60 meters – of grassland, equally luxuriant as that of the relict homefield, on the slope just above the river.

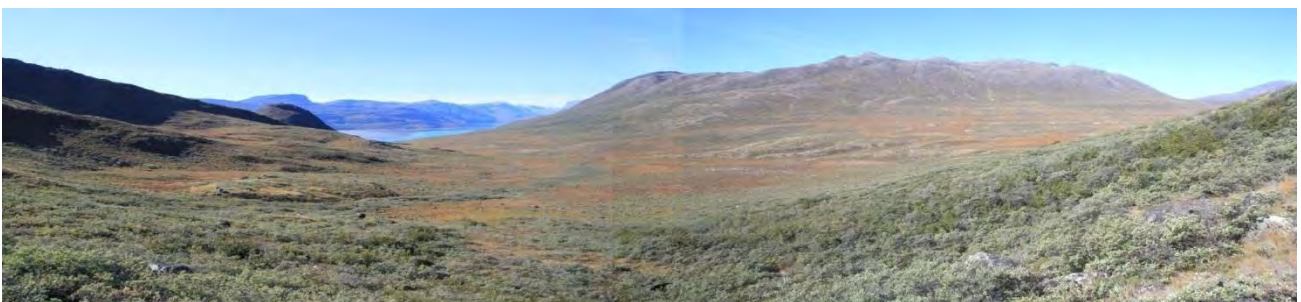
**Fig. 3.12** View looking SSE of the valley above Kilaarsarfik/Sandnæs with the Ameralla just visible in the background. Except for a few small side valleys, the vegetation is rather poor and consists almost entirely of mire on the valley floor and scrub a little up the valley sides (Photo: C.K. Madsen 2012).

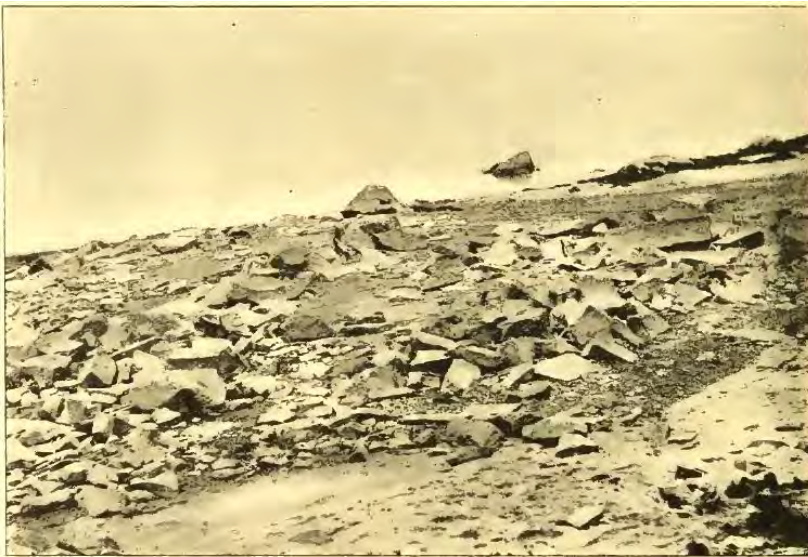
Bruun was also the first to provide a detail survey plan and photograph of the church, ruin 1 (fig.3.14 and 3.15). Bruun describes the church building accordingly: *'To the north, east, and south one clearly sees the remains of walls, while the western end of the house (k-g) is indistinct'* (au. trans. after Bruun 1918;98). The accompanying photograph (fig.3.15) largely supports Bruun's observations; a rough outline of the ruin was visible at least in 1903. The lack of a clear western wall likely owes to the typical condition of the Norse churches mostly having a wood built western gable.

**Fig.3.15** 1903 photograph of the church building (after Bruun 1918; fig.27).

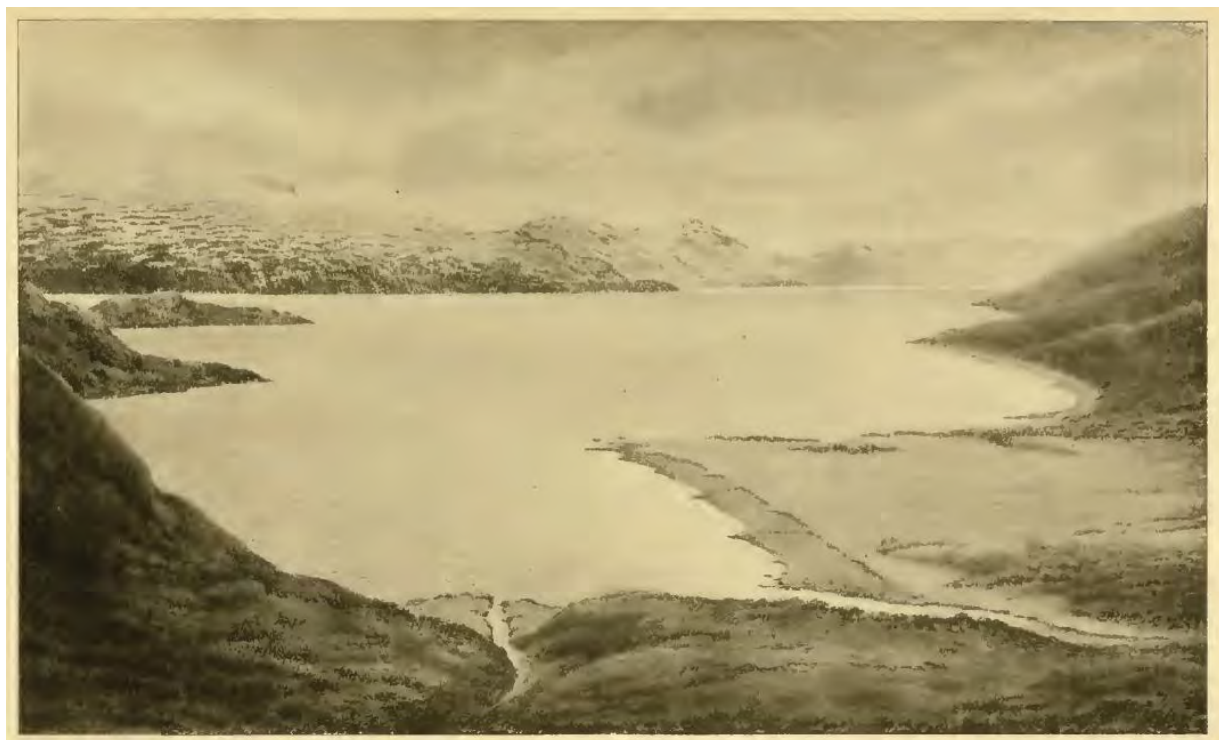
**Fig.3.16.** 1903 prospect of the Ameralla fjord branch and the bay in front of the alluvial fan with ruin group V51, Kilaarsarfik/Sandnes. Note the extensive grass vegetation on the alluvial fan, cf. fig.3.11, and the small alluvial fan centrally in the drawing (which was based on photograph). After Bruun 1918b;53.

A drawing, based on photograph, of the landscape surrounding Kilaarsarfik/Sandnes produced by Bruun during his 1903 visits has some other interesting implications; first of all, one clearly notices a marked vegetation change on the alluvial fan from today, grass vegetation apparently being much more prevalent in 1903 – and surely during Norse occupation – than today (cf. fig.3.16, 3.10 and 3.11). Clearly, the willow scrub is increasingly reclaiming the area, which it undoubtedly dominated prior to Norse settlement. As mentioned elsewhere (see section 3.3.3.), this re-vegetation has some negative impacts on the ruins and their visual qualities.

In the lower central part of Bruun's depiction, one also notices the small alluvial fan by a smaller river or stream. This must be the river or stream referred to by both Thorhallesen and Breiðfjord (see above) as the stream that was flooded at high tide and where seals would swim up; they also mention a flooded ruin here (not investigated in 2012). This small alluvial fan in front at the mouth of the stream does not exist today (cf. fig.3.10).

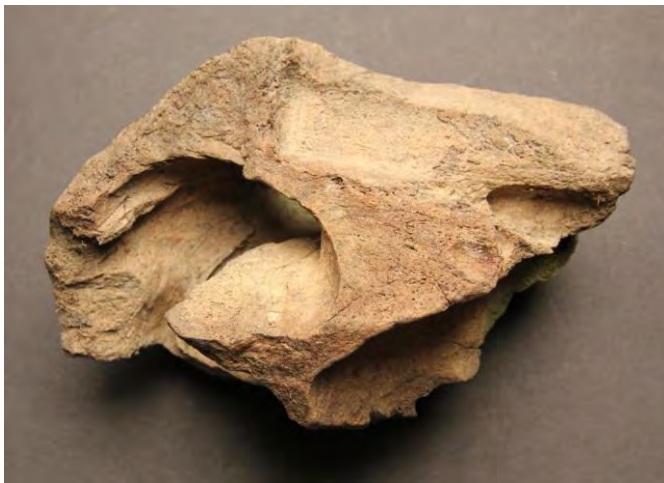
Trench FVII was a newer four-sided structure, which proved to be some kind of hunters' shelter or hut, likely from the 20<sup>th</sup> c. (J. Arneborg 1984, unpubl. excavation report, NKA archives). In the erosion front just in front of the hut, a few bones (x17) were found in 2012; they are likely from a slight midden associated with the structure, which is now being eroded by the waters of the fjord; one of them is part of a walrus skull, split in a similar way as walrus skulls found in several Norse sites (fig.3.19).

**Fig. 3.19. Part of a walrus skull (x17) split for the extraction of tusk found in front of a more recent structure across the bay from V51 (photo: A.L. Lennert 2012).**

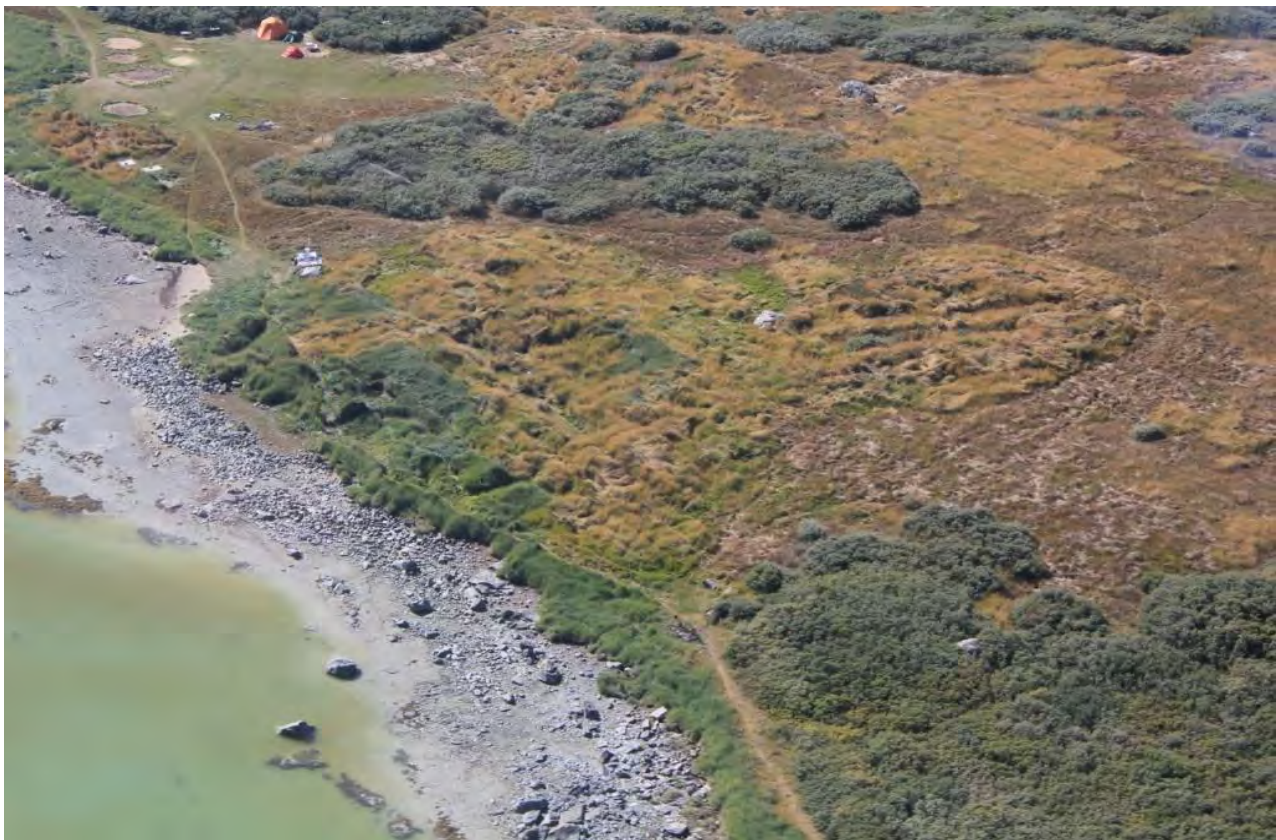
**Fig.3.20** The main cluster of Norse ruins, V51, of Kilaarsarfik/Sandnes as they appear today: ruins 3-5 and the midden area is located centrally in the photograph, ruin 6 in the top and, just left thereof, the present camping area, which was used as base camp for the Norse Team (*photo: C.K. Madsen 2012*).

Today, the Norse church farm of Kilaarsarfik/Sandnes appears rather confusing and indistinct: Roussell's unfilled and unmapped trenches enclose the ruins and crosscut the midden, while the backfill in the 1984 excavations have sunken so that they today appear half filled (fig.3.20). Everything is covered by meter high vegetation – grass, sedges, and willow – through which one constantly stumbles and falls into the old pits, trenches, and rooms while moving about the site. Upon closer examination, however, the ruins and rooms are mostly quite distinct and stable.

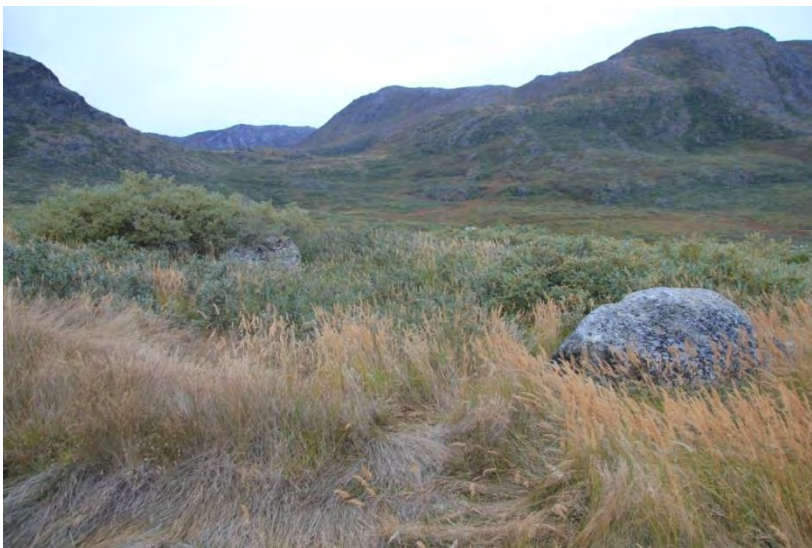
**Fig.3.21** Ruin 09 (photo: C.K. Madsen 2012).

**Ruin 09 (fig.3.21):** Some meters W of ruin 6, stands two boulders between which is a distinct depression or lowering in the terrain. To the one side, the depression is delimited by a bank/wall c.60 high and 100-120cm wide, while to the other side the banks is much less visible, the feature here instead dug beneath the surface level to create a room/enclosure. The width of the ruin, and its location outside the homefield suggests that it is an animal enclosure of some square meters with

turf or turf/stone built walls. The location and size of the ruin suggests that it corresponds to Bruun's ruin F, which he did not for some reason describe in his 1918 publication. Ruin 09 is today vegetated by low willow scrub and grass.

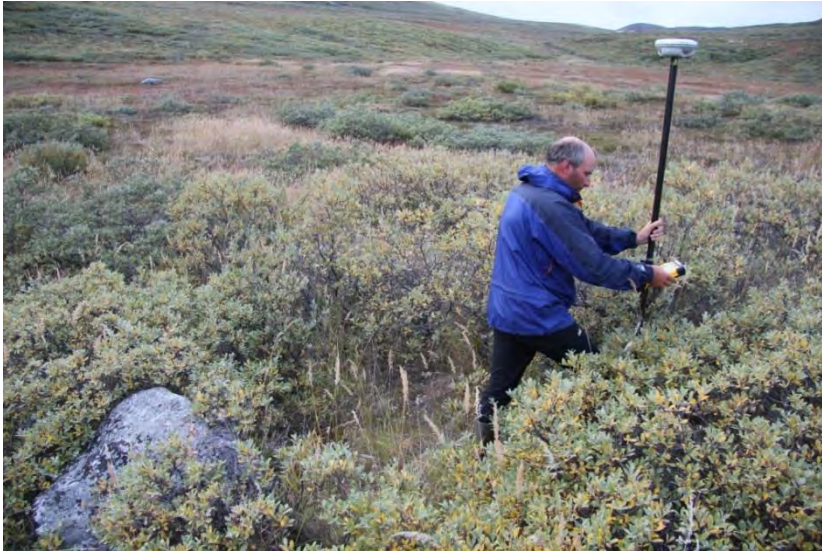
Fig.3.22 Ruin 10 (photo: C.K. Madsen 2012).

**Ruin 10 (fig.3.22):** A few meters from ruin 09 lies another unregistered ruin, a rectangular structure, completely overgrown by willow scrub. It has been created by exploiting a natural low (c.40-50cm) vertical cliff face for one wall and huge boulders as a foundation for a turf built (now disappeared) wall. It is likely a sheep/goats shed used in connection with ruin 09. The ruin is today vegetated by willow scrub and grass.

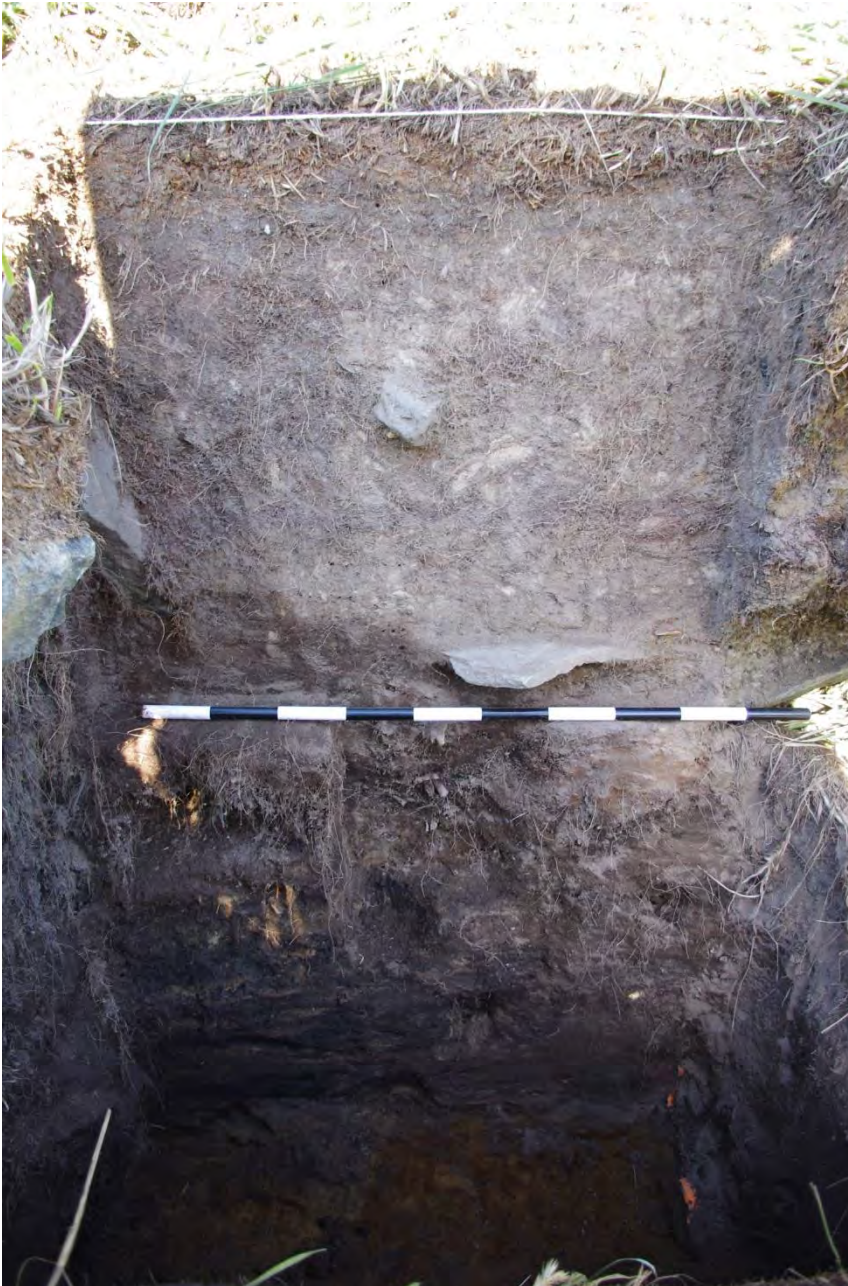
Section P I was located in the SW corner of the 1984 excavation (fig.3.23); after cleaning the present vegetation and emptying out the backfill, a meter of the 1984 section was cut back by up to 30cm with trowel and without sieving in order to install experimental and monitoring equipment. Section P I produced 18 X-numbers; apart from one piece of baleen, as well as a few poorly-preserved wood chips not numbered, all the finds were bones, in total 81 mostly smaller fragments. All the bones retrieved from section P I was sent to the Conservation Department, Danish National Museum, for analysis and degradation studies.

**Fig. 3.23: Section P I after cleaning and before installation of monitoring equipment. Photo: H. Matthiesen**

Field measurements of the soil water content, conductivity, pH and soil temperature were made in the excavated profile P I (fig 3.23) and the results are given in figure 3.31. All depths are given relative to the soil surface. The different soil strata may be briefly described as: 0-20 cm: topsoil with root felt; 20-55 cm: dry silt, possibly from soil flow; 55-60 cm: peat layer; 60-70 cm: dried midden layer; 70-80 cm: midden layer with some charcoal and bones; 80-120 cm: very heterogeneous midden layers with many bones, wood and other organic remains; 120-150 cm: dense silt layers with varying colors black, grey and brown and fewer finds compared to the layers above; 150-155 cm: light colored silt; 155-?cm: gravel.

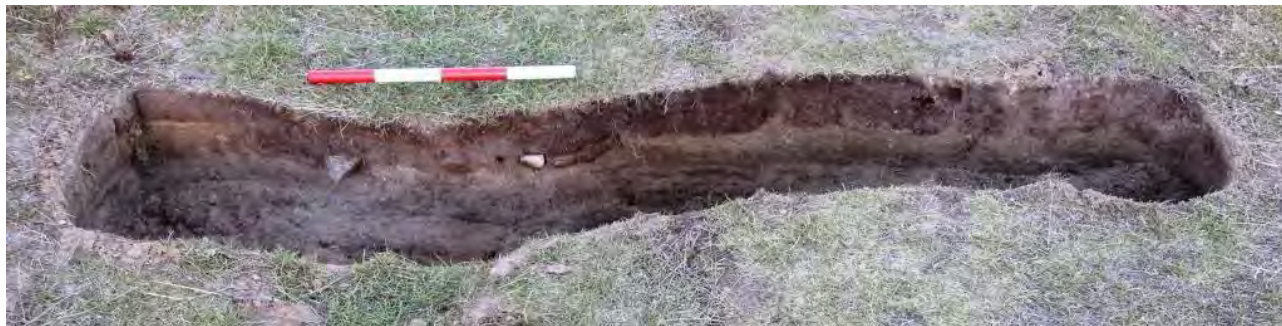
Fig.3.24 Section P II seen towards the N (photo: C.K. Madsen 2012).

In the 1984 survey plan (fig.3.18), a number of irrigation channels are mapped S of the main cluster of ruins. Being ahead of schedule we decided to investigate one of them: focusing on the easternmost and N-S oriented channel, it on the surface appears as marked depression running across the present camping ground. We excavated with spade a cut, 125x30cm, across the channel, as shown in fig. 3.24 – 3.25; in the section P II, the suggested irrigation channel was very shallow

and showed no evidence of any constructional features, e.g. turf or stone lining. We instead interpret this feature as a caribou trail, still a human trail.

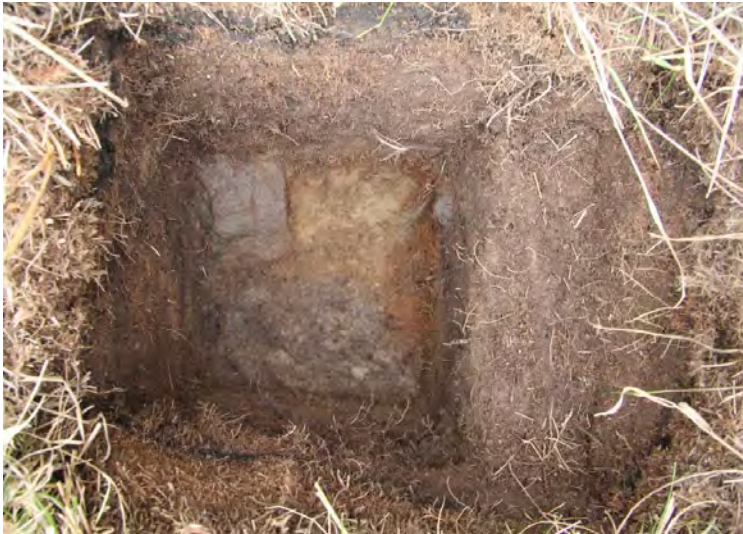
**Fig.3.26** Trench P III after finished excavation; a balk have been left for possible DNA-sampling (*photo: C.K. Madsen 2012*).

To have a DNA-sample comparative to that from the stable of ruin group V53d room 17, and to check for preservation, we made a very small trench, 40x30cm (fig.3.26), in the N end of the excavated ruin 5 room III; under the present vegetation surface came a thick layer (c.25cm) of densely rooted earlier vegetation layers – grass re-growing the soil spilling into the rooms after Roussell's excavation. At the bottom was the very slight traces of a floor layer, < 0,5cm in thickness, before coming on to natural deposits of yellow gravel.

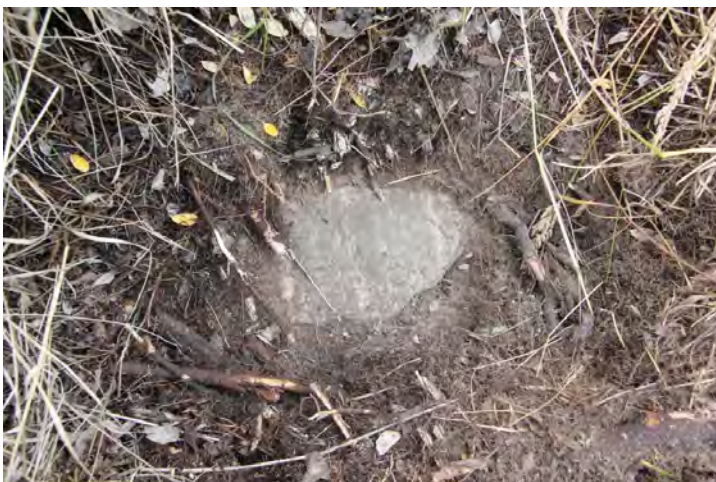
**Fig. 3.27** Trench P IV after finished excavation; nothing but a likely flagging stone is discernable after the willow roots have penetrated and disturbed all the layers (*photo: C.K. Madsen 2012*).

With trench P IV resulting only disturbed deposits unusable for DNA-sampling, we decided to excavate a like small trench in the SE corner of ruin 6's room III (fig.3.27): here Roussell noted thousands of pre-served sheep/goat pellets between two layers of flagging. Room III, and most of the rest of the inside of the rooms of ruin 6, are today heavy vegetated by willow scrub. As we tried to excavate a small trench some 50x50cm we encountered an extremely dense root layer, which had completely disturbed all layers down to what was a probable flagging stone resting on top of the yellow sand of the natural deposits. There was no trace of preserved organic material. This small trench gave a clear indication of what damage willow scrub can cause to the ruins and possible excavation.

- damage from roots on the archaeological remains was observed at several sites (e.g. fig 3.27) and furthermore increased vegetation cover made it difficult and sometimes impossible to locate sites (fig. 5.38 and 5.39). This shows that changes in vegetation need to be studied and monitored in more detail

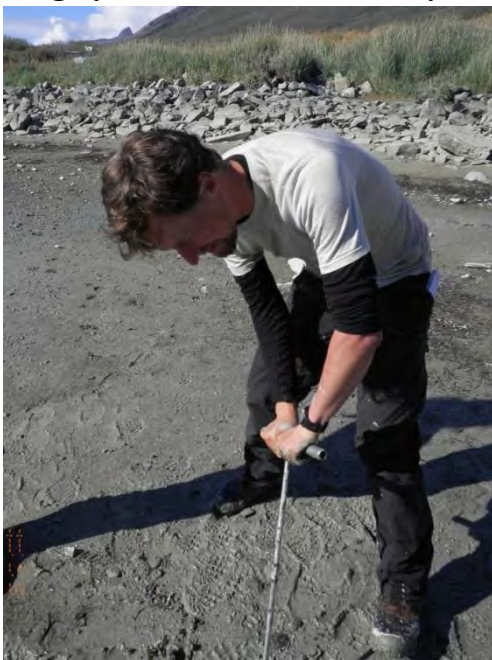
Fig. 3.28 Coring in front of the church and churchyard (photo: H. Matthiesen 2012).

To learn more about the erosion and isostatic/eustatic processes and preservation of cultural layers in the now completely flooded and eroded church and churchyard, we did some coring in the small, stony, and slightly elevated 'headland', where the church once stood, and the seabed some meters east thereof (fig.3.28). Coring in the saturated silt of the seabed exposed at low tide, naturally, proved highly problematic, as the core hole would quickly fill up with silt and water and the sediment in the core would slide and mix. Nonetheless, we could establish with some certainty that:

- There are no preserved cultural or organic layers beyond the small elevated stony headland, only silt sediments resting upon sand/gravel deposits.
- There is slight traces of a vegetation layer on the small headland, once outside the church, while in the area where the church once stood, there is too many stones to get through the sediments with the corer. Between the erosion noted in the earlier accounts and excavations

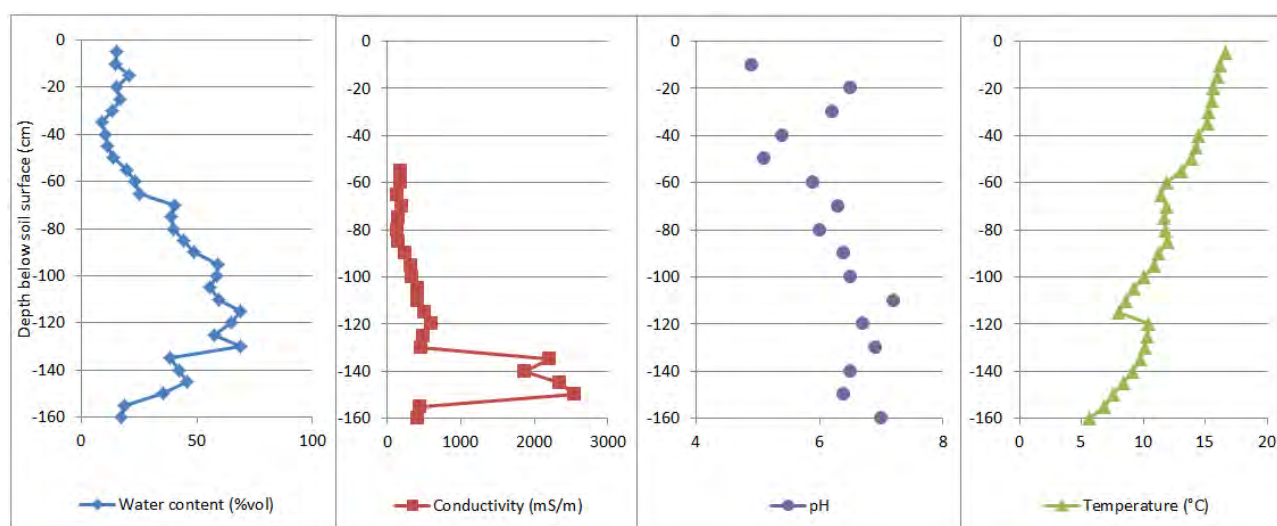
Figure 3.31: Environmental measurements in trench P I at V51, 28-30 August 2012. Water content and conductivity was measured in the outer 5 cm of the profile with a WET probe from Delta-T instruments, pH and temperature was measured with a SS37 probe from IQ instruments. Note that measurements in open soil profiles are not necessarily representative for measurements in the undisturbed parts of the midden, and for instance the measured soil temperature may be strongly influenced by direct sun on the excavated profile.

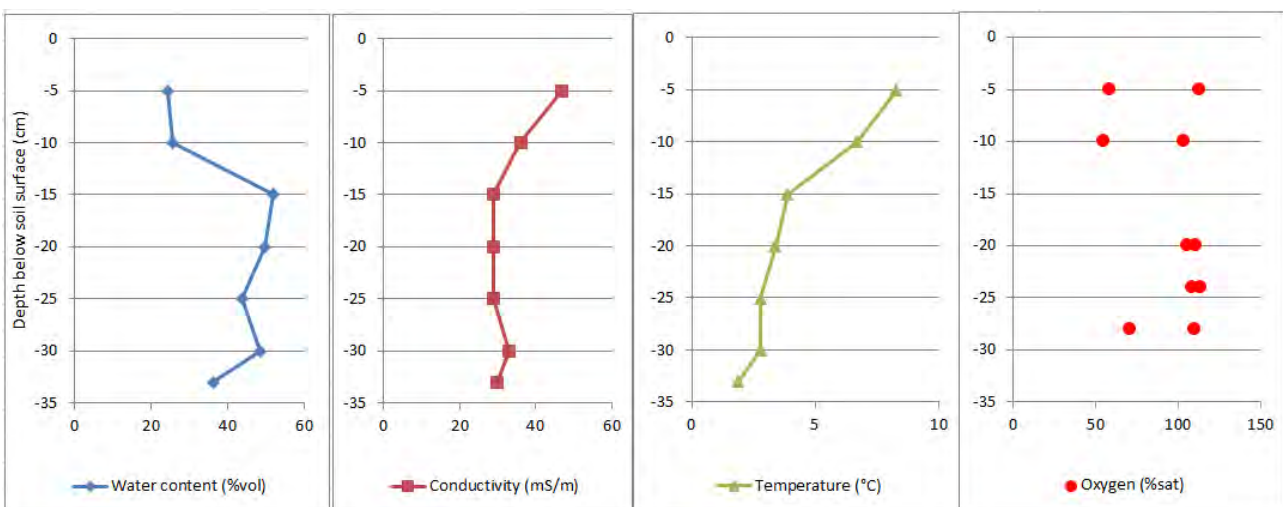
Figure 3.33: Environmental measurements in the upper soil layers at the permafrost drilling PF1 next to trench P I. Water content, conductivity and temperature was measured with a WET probe from Delta-T instruments, oxygen was

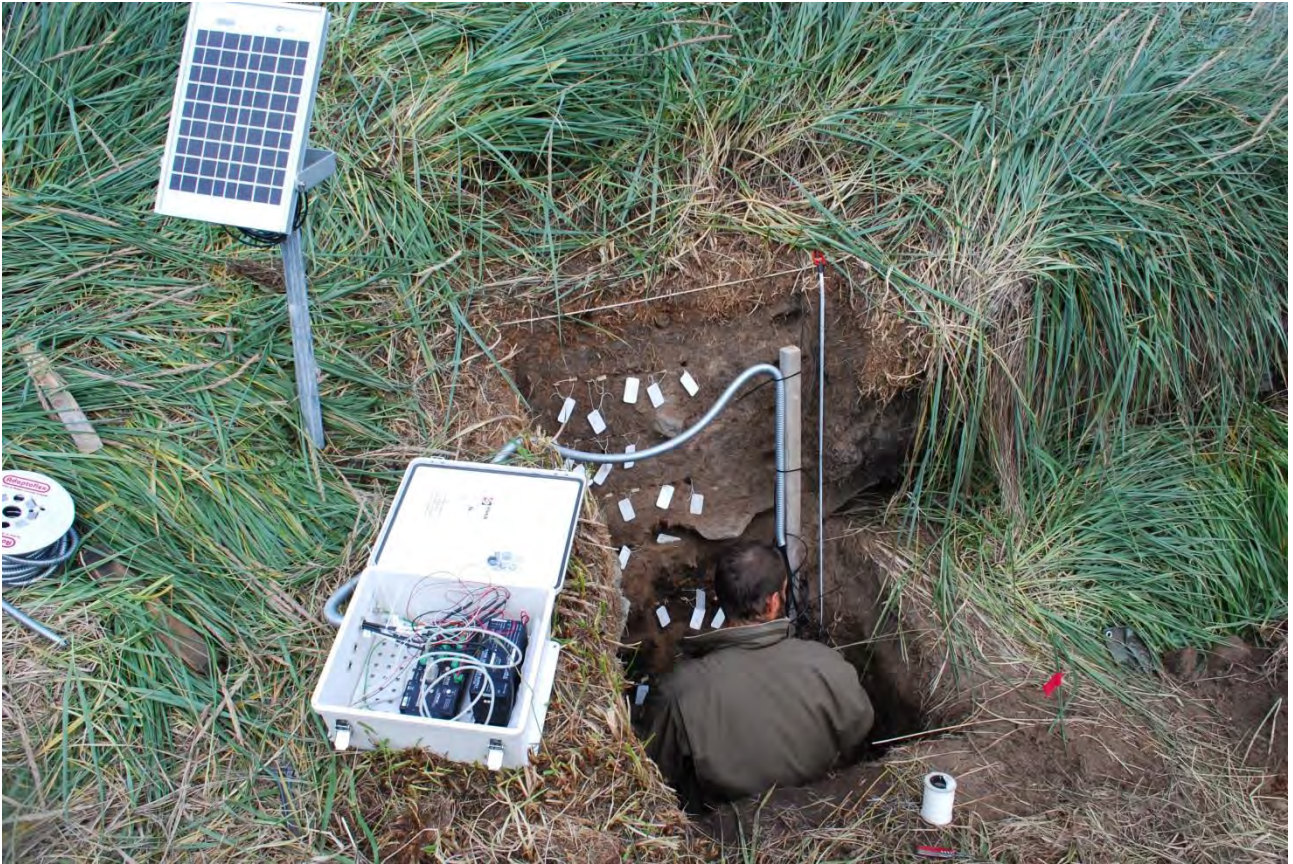
**Figure 3.34: Installation of the logger station at Trench P1.**

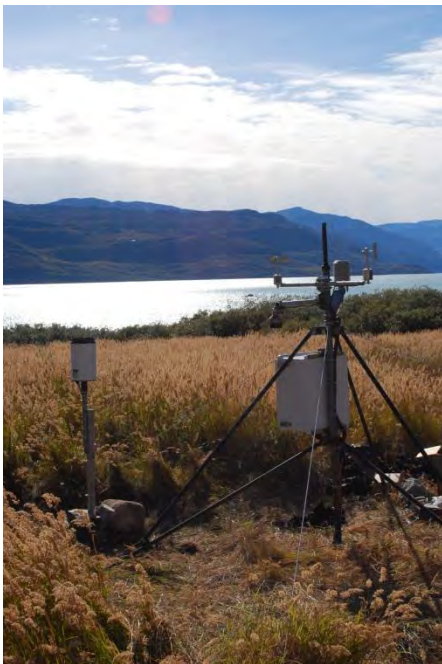
**Figure 3.35: Weather station at Sandnes**

A weather station was installed 100 m west of the Kitchen midden (fig 3.35 and fig 5.11). Every hour the station measures air temperature and relative humidity (MP100A Temperature & Relative Humidity probe), wind speed and direction (A100R Anemometer & W200P Windvane), snow depths (SR50A Sonic Ranging Sensor) and precipitation rates (52202 Tipping Bucket Raingauge) using a Campbell Scientific CR1000 datalogger. All sensors are mounted 2 m above the soil surface. Next to the weather station subsurface temperatures are measured every hour in 0, 25, 50 and 75 cm depth using Campbell Scientific 107 that are connected to the datalogger in the weather station. The Campbell datalogger is powered using a Yuasa NP24-12I lead acid battery (12V, 24Ah) and a solarpanel as charging source. Data is stored on a 2 GB Compactflash card that easily can be changed.

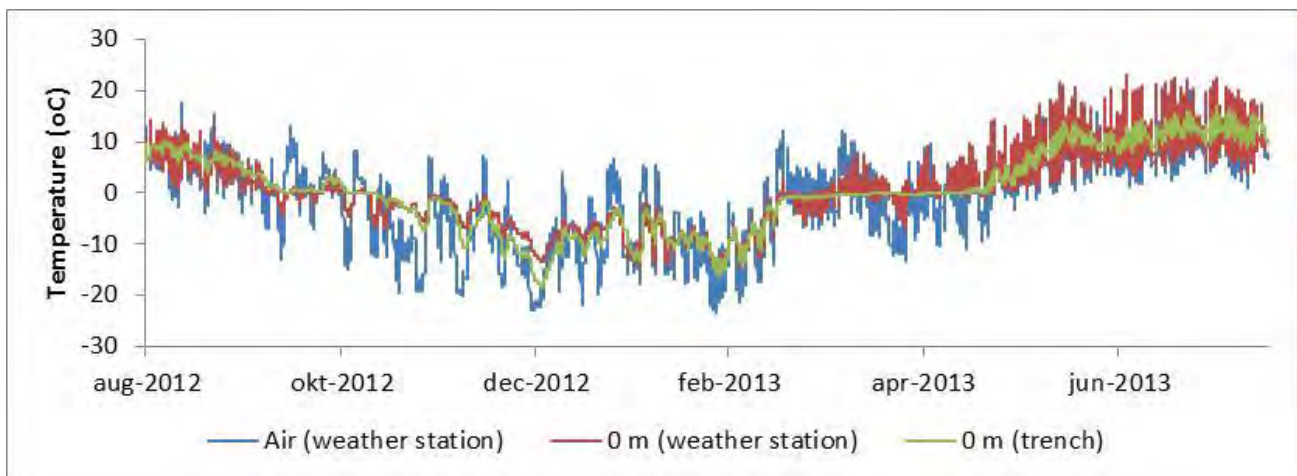
Figure 3.36: Air temperature and surface temperatures measured ant the weather station and at trench P I.

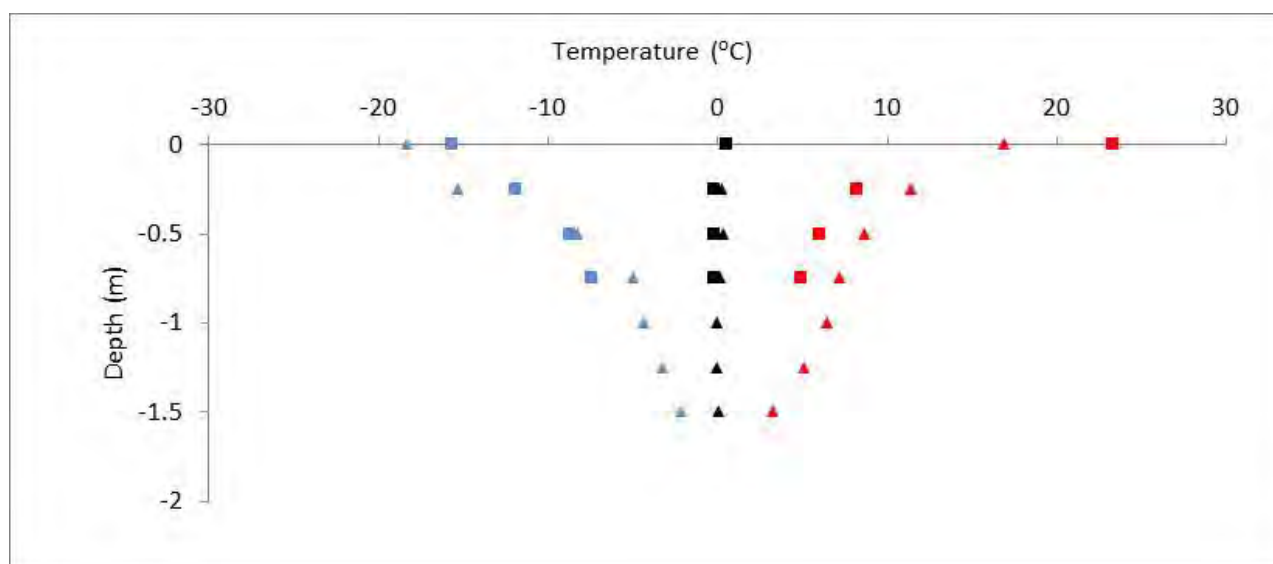
Figure 3.38: Mean (black), minimum (blue) and maximum (red) temperatures measured in the natural soil at the weather station (squares) and in the cultural layer (triangles).

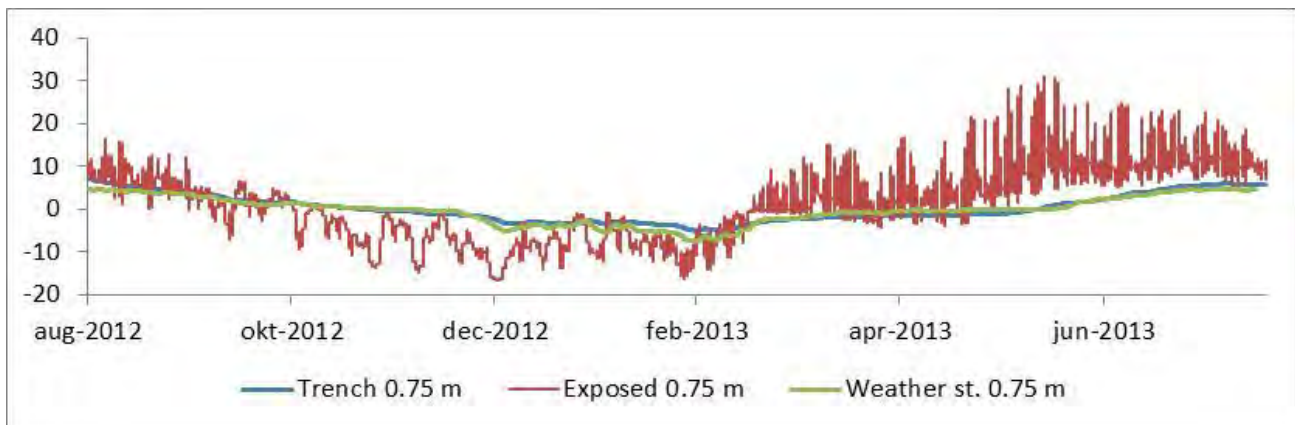
Figure 3.39: Measured temperatures at the weather station, in trench P I and in the exposed profile.

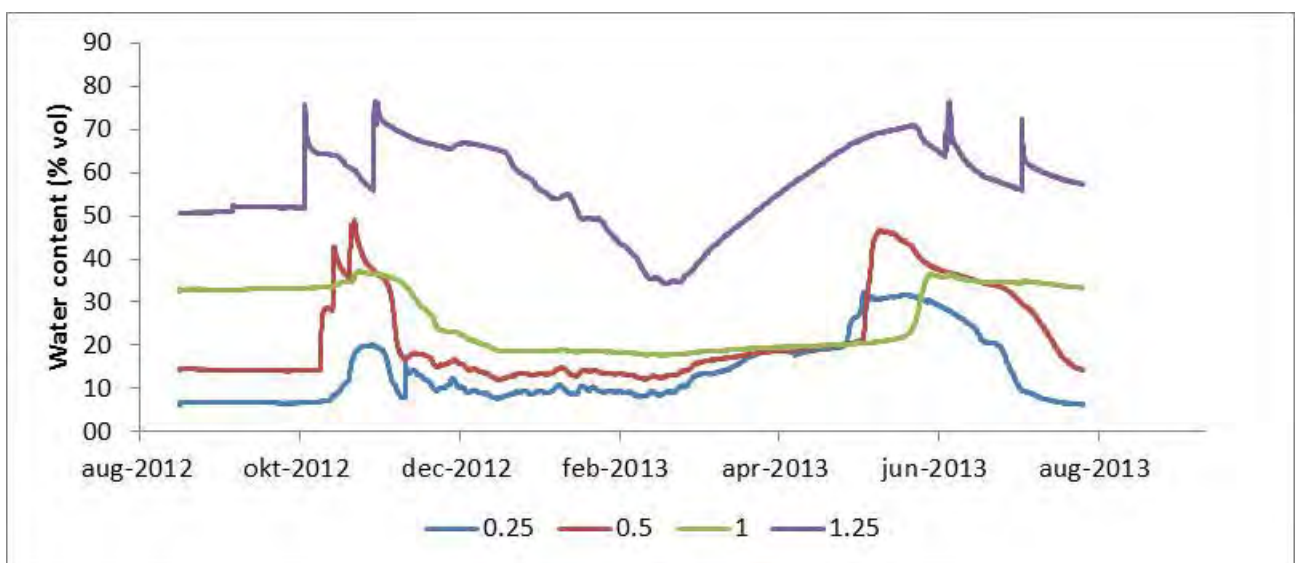
Figure 3.40: Soil water contents measured in trench P I. NB. The drop in water contents during the autumn/winter period is due to freezing.

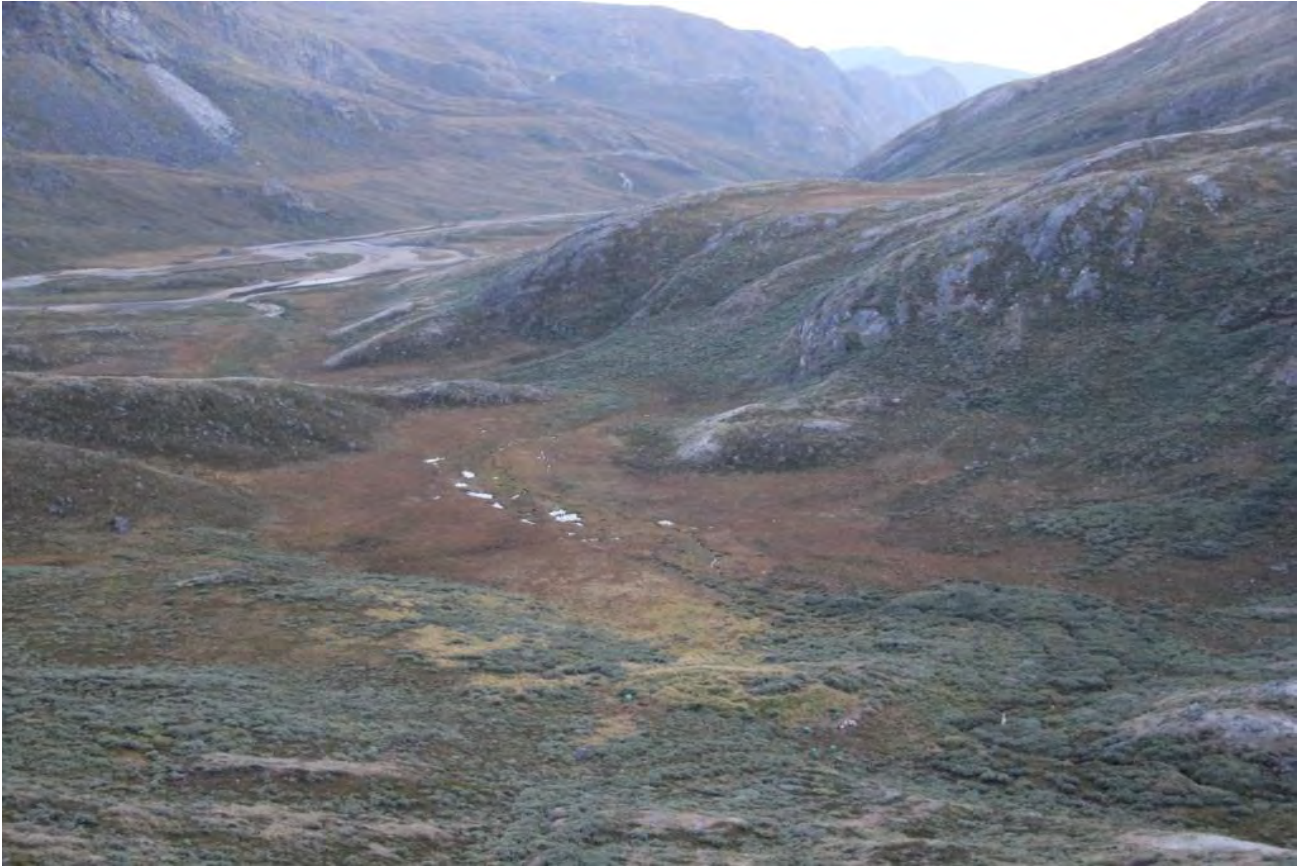
Fig.3.41 View, looking, SW of ruin group V53d, the second last Norse farmstead in the Austmannadal. The main cluster of ruins are located in and around the green patch in the lower central part of the photograph, in front a great mire (*photo: C.K. Madsen 2012*).

About 10km into the Austmannadal, a small side valley branches off to the north; on the valley floor is a rather large mire and on a drained knoll just above and NE of this mire lies the ruins of V53d (fig.3.41). The site stands out from afar because of its lush vegetation of high grass that has settled on the walls and spoil heaps left by Roussell's 1938 excavation. Below and down slope of the dwelling lies the midden, another type of grass that has been grazed to a neat even surface by sheep and caribou (see below). The slopes surrounding the valley are dominated by rather rich will scrub, which in comparison with Roussell's 1938 photograph is a more recent landscape feature, heather and grass clearly dominating the landscape in the first half of the 20<sup>th</sup> century (cf. fig.3.43).
