# PEOPLE OF ALL TIMES

## FIELD REPORT

## **Field report for the pilot project “People of All Times”**

*Submitted January, 2014*

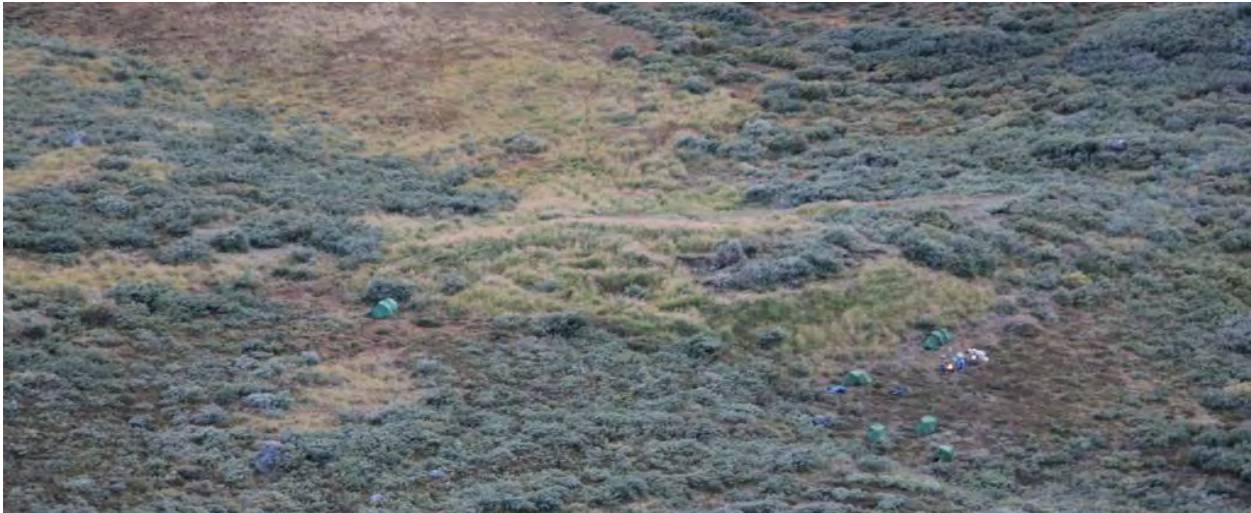
The ruins of V53d today appear stable; however, except for ruin 6, the ruins have been completely covered with vegetation, ruins 1 and 4 with grass, the others with willow scrub. In spite of intensive and prolonged search for ruin 5, we never managed to find it; if still visible on the surface, it must hide in dense willow scrub along the stream.

**Fig. 3.44** The dwelling (ruin 1) of V53d as it appears today; note the expanded willow scrub (*photo: C.K. Madsen 2012*).

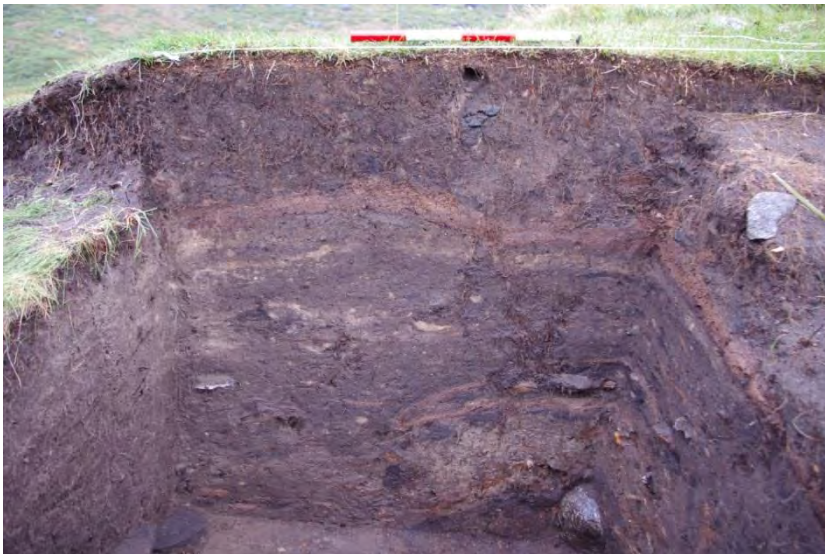
It is clear from the section drawing and layer description that it was hard to establish a clear stratigraphy in the middle layers, which also accounts for the erroneously removal of unit [6a] along with [05]. Unit [06] did, however, show up very nicely; first believed to be turf lumps/lenses also recorded in the above layers, it actually proved to consist of a dense and thick series of turfs, likely wall collapse or a wall proper as could be suggested also by the large stone in the corner of the trench. In the S part of the trench, the turfs did not lie as nicely and horizontal as in the N part, and included more cultural material.

On the third day of excavation rain set in making it extremely hard to sieve the removed soil; we began water sieving in the nearby stream, but as we would need the soil to backfill the trench, we decided to conclude the excavation. This we did just at the top of layer [07] and [08], the boundaries of which were very clear. Based on the coring down the midden these layers must be very close to the natural aeolian deposits. We then marked the extent of the trench with plastic tape and put down two small perforated mats to mark the level of excavation for future investigations; finally we backfilled and re-turfed.

**Fig.3.46: North section of trench V53d P I (photo: H.Matthiesen 2012).**

Field measurements of the soil water content, conductivity, pH and soil temperature were made in an excavated profile P V just next to P I (fig 3.46) and the results are given in figure 3.51. All depths are given relative to the soil surface. The different soil strata may be briefly described as: -10 til 0 cm: vegetation layer with roots; 0-14 cm: midden with bones, possibly from soil flow; 14-31 cm: Compact peat which is naturally grown on top of midden; 31-84: midden layer with several bones in a matrix of windblown silt; 84-90 cm: dark silt layer with bones, possibly pressed down in the soil; 90- ?? cm: light colored windblown silt.

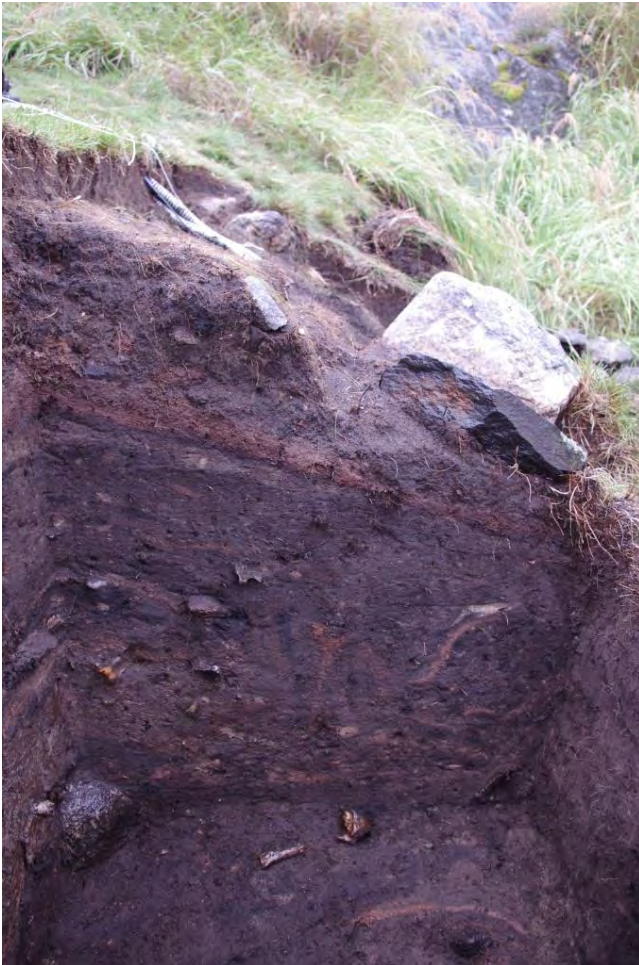
**Fig.3.47: East section of trench V53d P I (photo: H. Matthiesen 2012).**

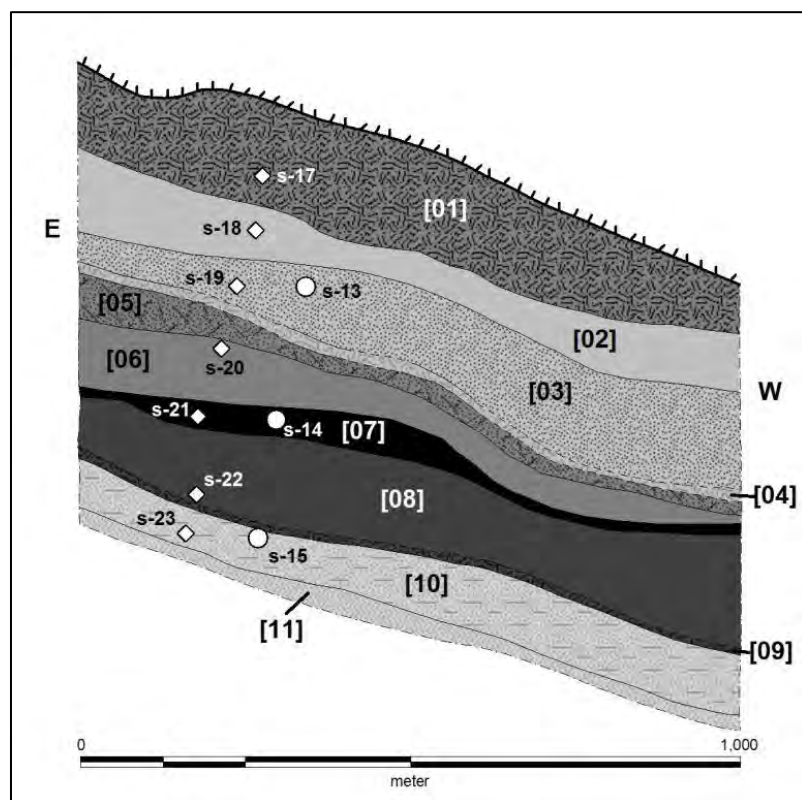
Fig. 3.48: Section drawing of the north profile of trench V53d P II.

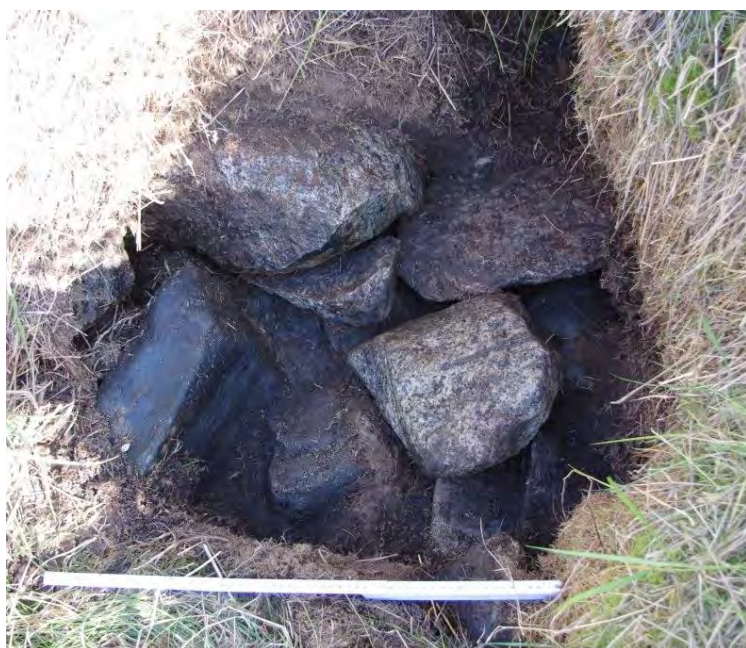
**Fig.3.49: V53d trench PIV after cleaning of the upper layers (photo: A.B. Møller 2012)**

Removing the present vegetation layer, we quickly came upon collapse stones (fig.3.49) some having fallen from the walls only after Roussell's excavation. Wanting to keep the investigation to a minimum we simply cleared a space just large enough to take samples and left most of the lower collapse stones in place. Roussell's floor layer came up nicely on top of some stones (fig.3.50), still including lots of organic material and sheep/goat pellets. The layer was then DNA-sampled; in the holes left from the sampling, a further 1, likely 2, underlying floor layers were visible, each

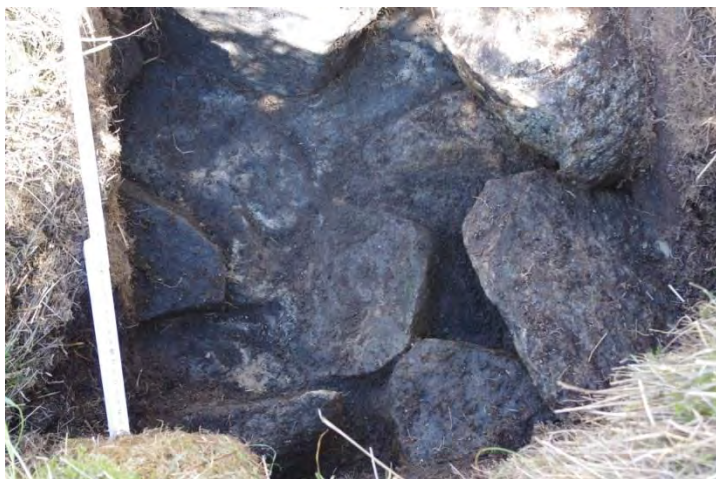
separated by floor leveling with sterile clay. After installing monitoring equipment, the trench was backfilled and closed.

**Fig.3.50: V53d trench PIV on top of Roussell's 1937 floor layer (photo: A.B. Møller 2012).**

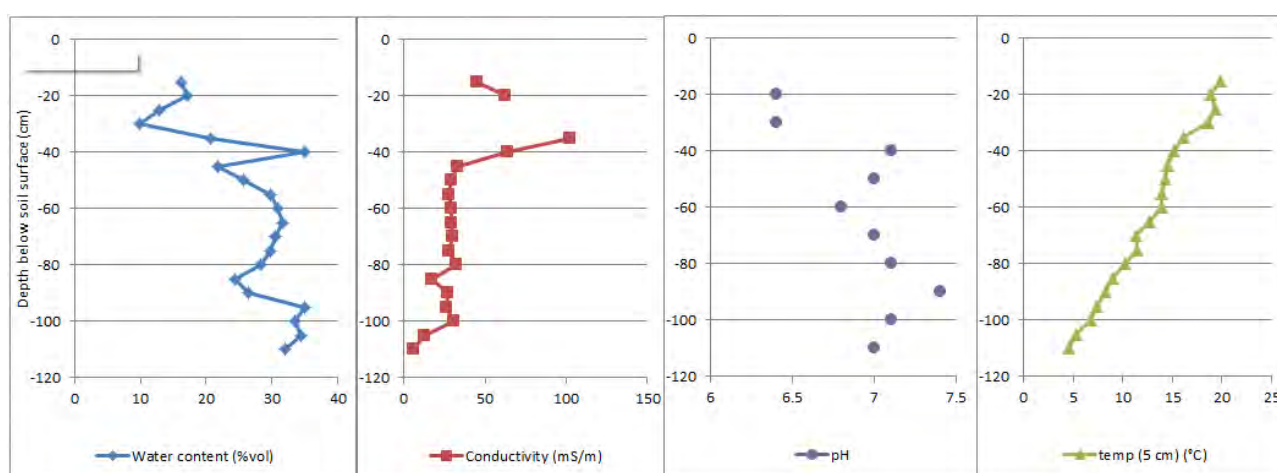
Figure 3.51: Environmental measurements in trench P V at V53D. Water content and conductivity was measured in the outer 5 cm of the profile with a WET probe from Delta-T instruments, pH and temperature was measured with a SS37 probe from IQ instruments. Note that measurements in open soil profiles are not necessarily representative for measurements in the undisturbed parts of the midden, and for instance the measured soil temperature may be strongly influenced by direct sun on the excavated profile.

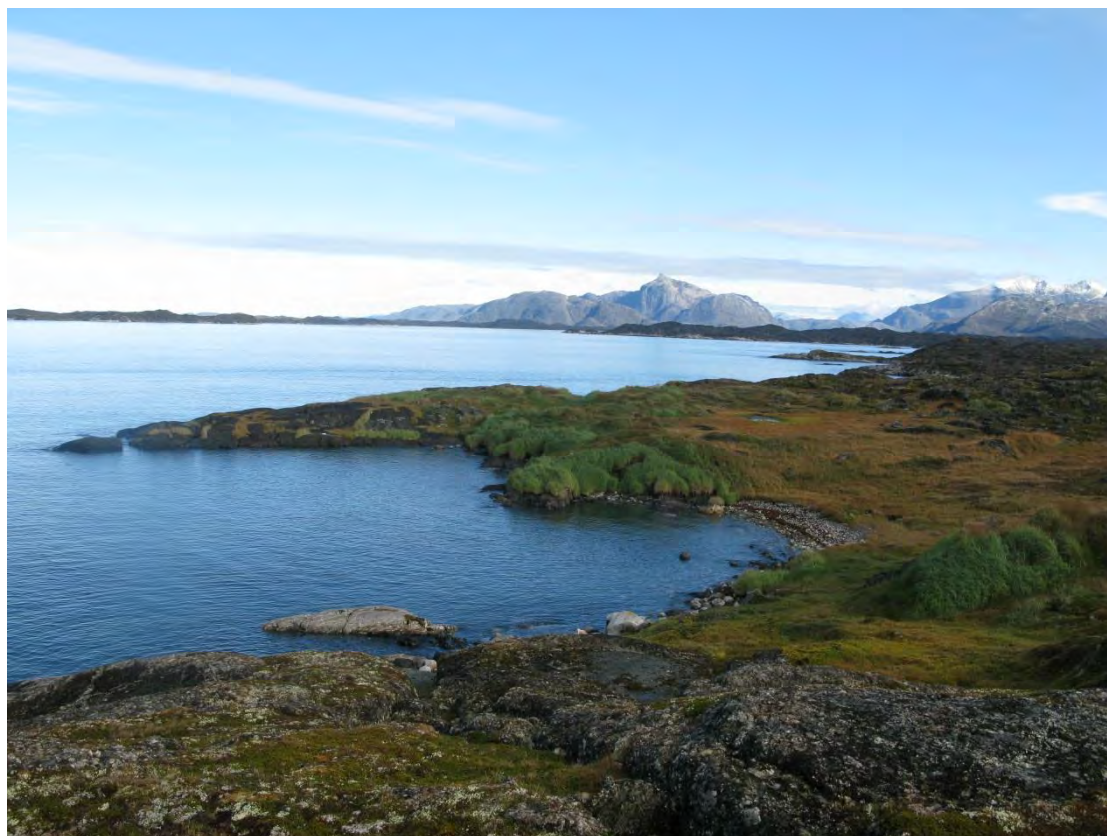
**Fig. 4.7 The Kangerluarsussuaq site seen from the south. The grass covered midden is visible in the pictures central part.**

The Kangerluarsussuaq/Grædefjord settlement (63V1-II-13) is situated 4 km S of the Kangerluarsussuaq Fjord at the coast. The site was abandoned in 1959 (Gulløv 1983:34).

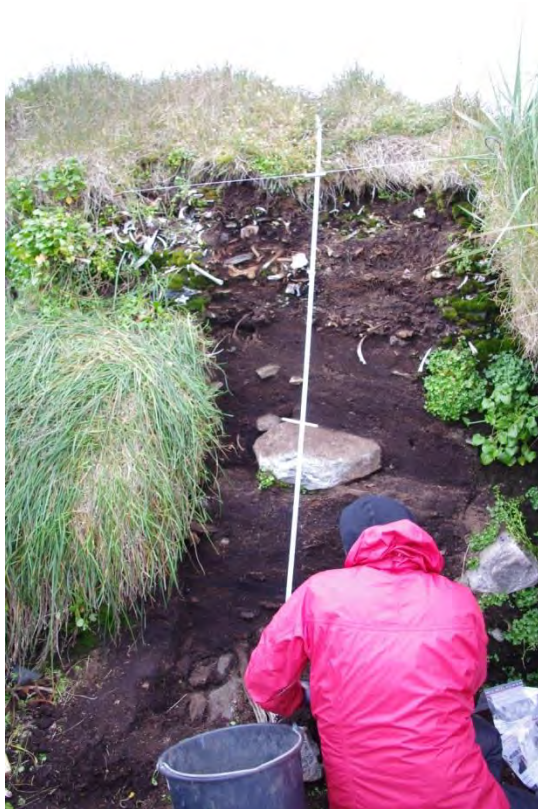
Fig 4.8: Profile A under excavation.

During the 2012 field campaign a 1 m. broad profile (profile A) was cleaned and documented in midden A in order to observe and measure present preservation conditions (fig. 4.8 & 4.9). Further the ruins and coastline was measured by precision GPS and a photographic documentation was conducted of the erosion front of midden A and B. The investigation also included coring for soil samples and permafrost, retrieving pollen samples from the settlement area and the bog behind the

midden, inserting modern bone and wood samples for testing the variability of preservation conditions and setting up a monitoring station measuring the water content and temperature of the midden layers. During the 2013 field campaign the photo documentation of midden A and B was repeated and data was collected from the monitoring station set up in 2012. Further the site was surveyed to recognize any changes in the structures and surface scatters.

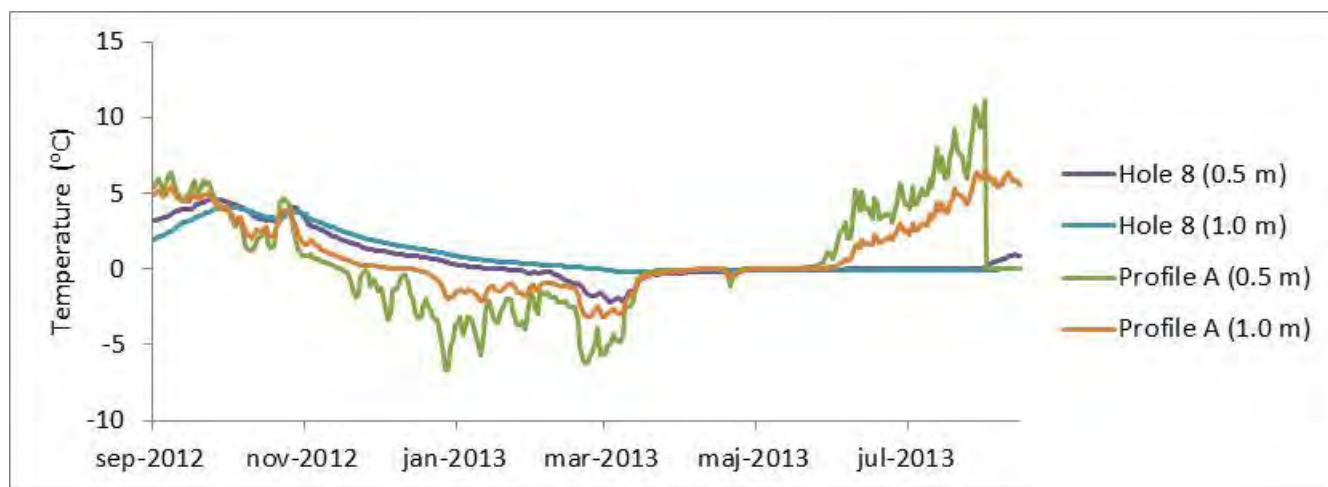
Fig. 4.13: Comparison between soil temperatures measured in hole 8 and the exposed profile A.

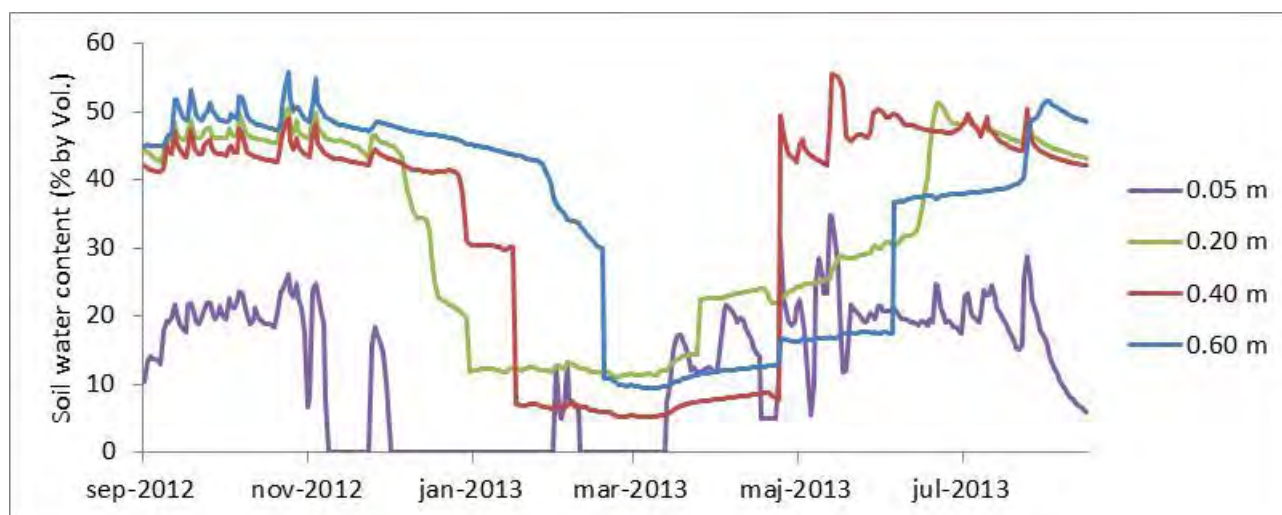
Fig. 4.14: Soil water contents measured in hole 8. The data was calibrated using the wet probe measurements and values of porosity seen in figure 4.11. NB. The drop in water contents during the autumn/winter period is due to freezing.

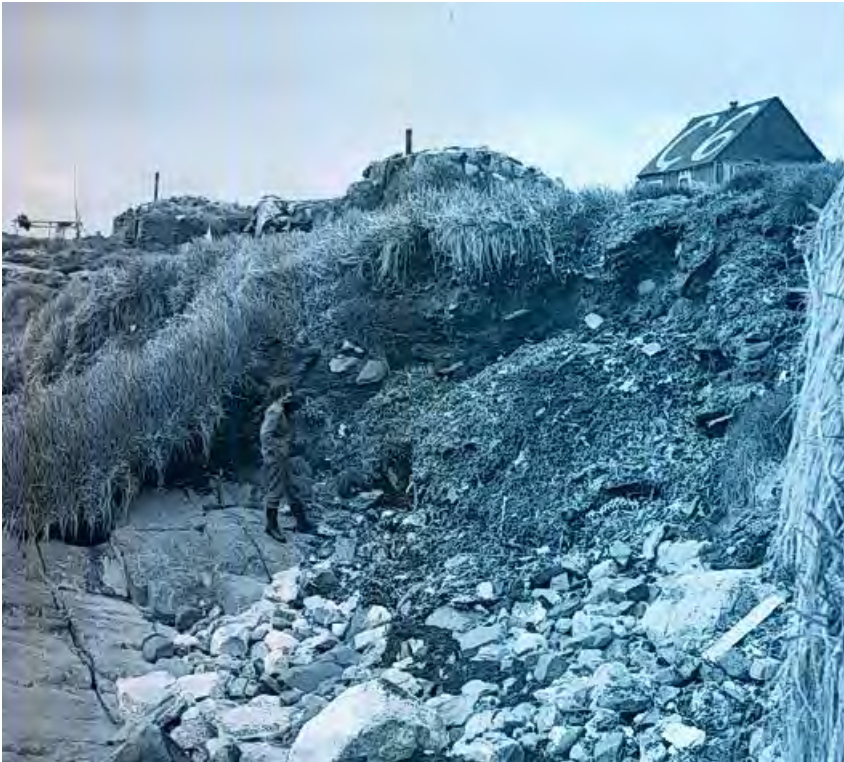
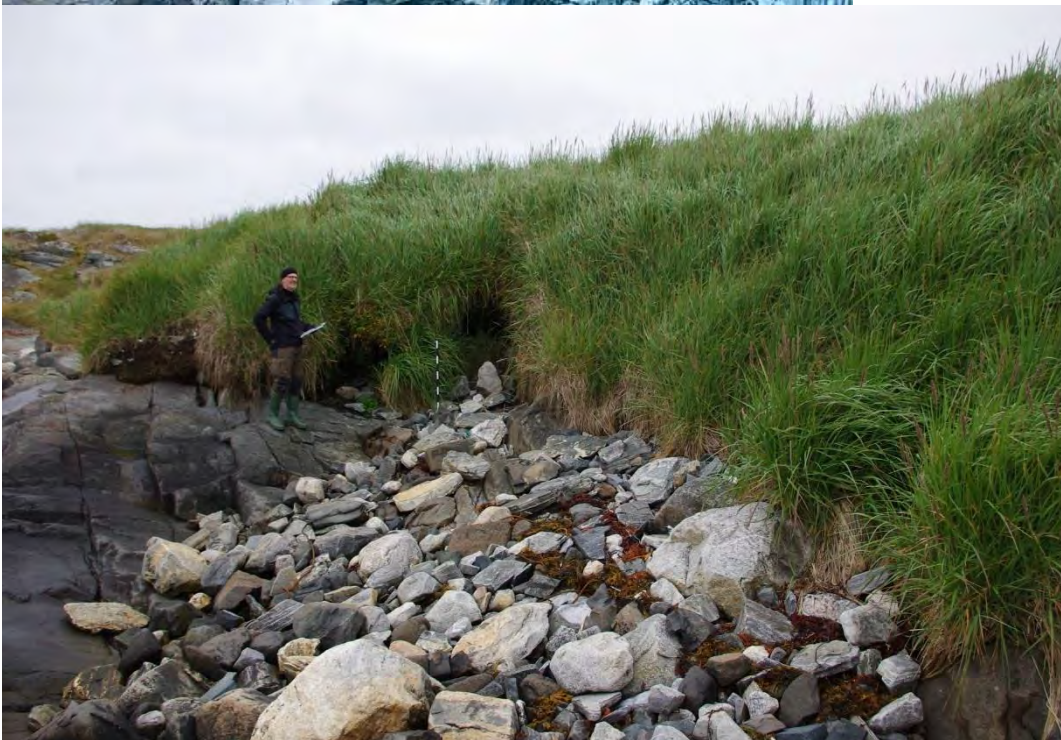
**Fig. 4.15 Comparison between photo taken by Jørgen Meldgaard in 1952 (upper) and during the field work in 2012 (lower)**

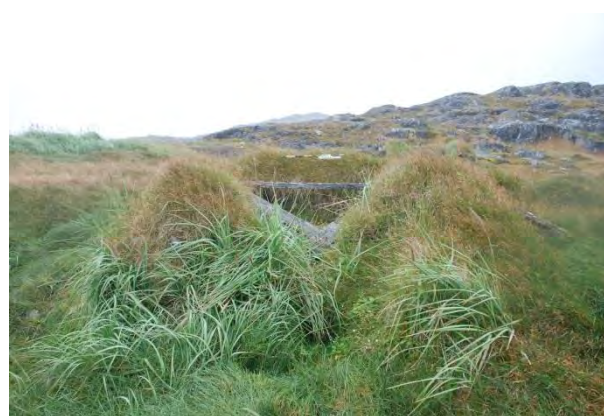
Fig. 4.16 Kangerluarsussuaq, structure 1.

**Structure 1:** Square well with sides of wooden planks; 0.7 x 0.7 m. Half of the planks are still in situ. The well is located 1.5 m. from the stream.

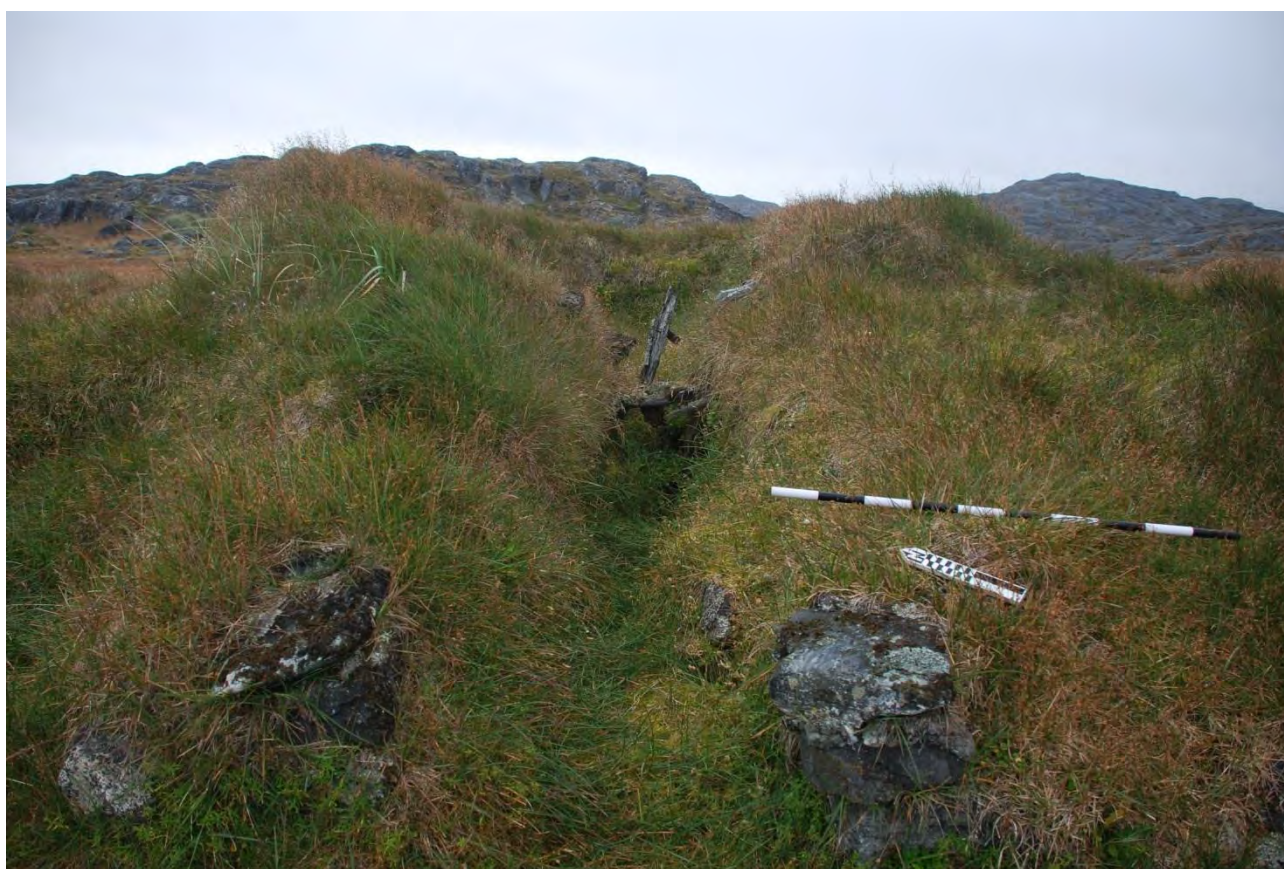
Fig. 4.18 Kangerluarsussuaq, structure 12.

**Structure 12:** Rectangular house with entrance in the W. Remnants of the wooden door is preserved in situ in the passage. Is sharing wall with structure 13.

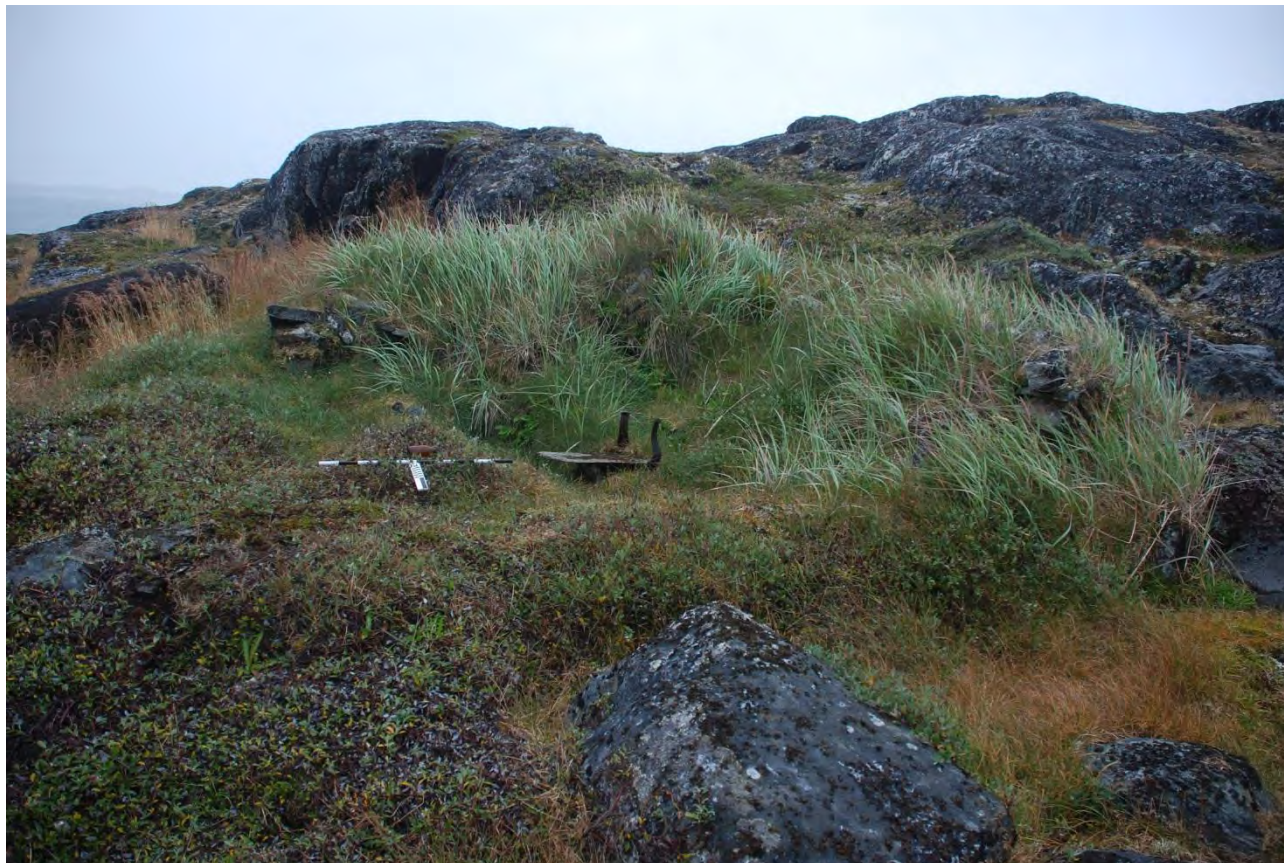
Fig. 4.19 Kangerluarsussuaq, structure 18.

**Structure 18:** Rectangular house. The walls are higher towards the east. Entrance between two rock projections. Fragments of an iron stove inside.

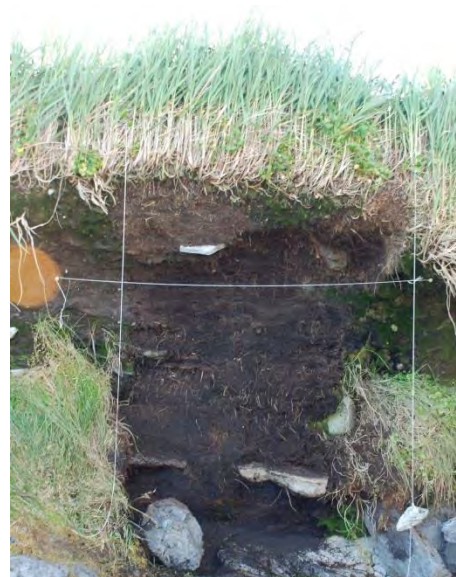
Description of layers in the profile:

- 1: Dry layer with roots
- 2: Humus rich layer
- 3: Sandy layer
- 4: Compact very dark and moist layer.
- 5: Very compact black sticky layer
- 6: Compact dark partly sandy layer with roots
- 7: As layer 5.
- 8: Dark, wet partly sandy layer  
with a lot of wood preserved.
- 9: Black, wet and sandy layer.
- 10: Bed rock.
- 11: Profile partly covered by vegetation.
- A: Wood

**Fig. 4.24 Kangeq profile A, section 3-2 m. 2012 documentation (left and bottom right). 1968 documentation (top right).**

The investigation of midden section A & C in 2012 showed, that wood is present in very large amounts in lower layers, medium to good state of preservation. In the old excavation profiles the bones are very decayed, but in parts with "fresh" erosion the material is better preserved. Further turf is degraded in exposed profiles, but it still has some structure and cohesion. A bird very well preserved bird wing found in layer 9 in the lower part of the midden section A (fig. 4.25) indicates that good preservation conditions are still found in parts of the midden although conditions vary from poor to good.

After the 2012 field work the cleaned midden section was covered with a plywood board for protection and to make on site dissemination of the layers possible in the future.

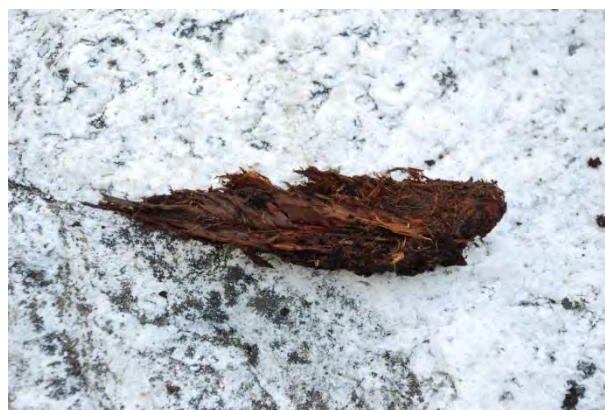
**Fig. 4.25 Well preserved bird wing found in the lower part of the Kangeq midden, section A.**

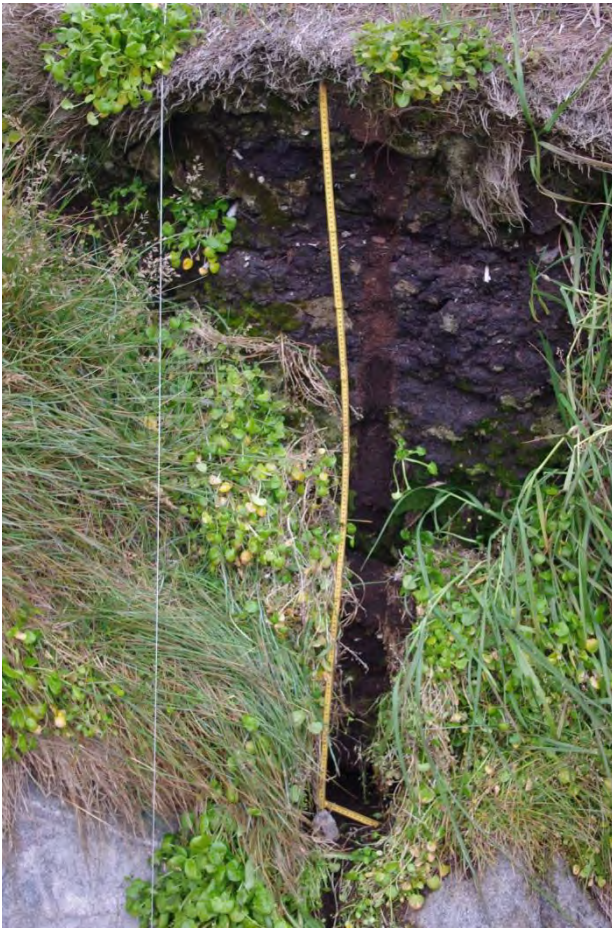
**Fig. 4.26 A small band on profile C from 1982 was superficially cleaned to make measurements of environmental parameters. The vertical string corresponds to Gulløvs 4 m line in profile C.**

Field measurements of the soil water content, conductivity, pH and soil temperature were made in part of Gulløvs profile C from 1982 (fig 4.26), in hole no 6 (1½ m behind profile C) and at selected sites around the midden to check for variability. Soil samples of 100 cm<sup>3</sup> volume were taken at a few depths in profile C and in hole no 6 for measurement of porosity and organic content. Several samples of wood and bone were taken at different depths from hole no 6 for further studies in the laboratory.

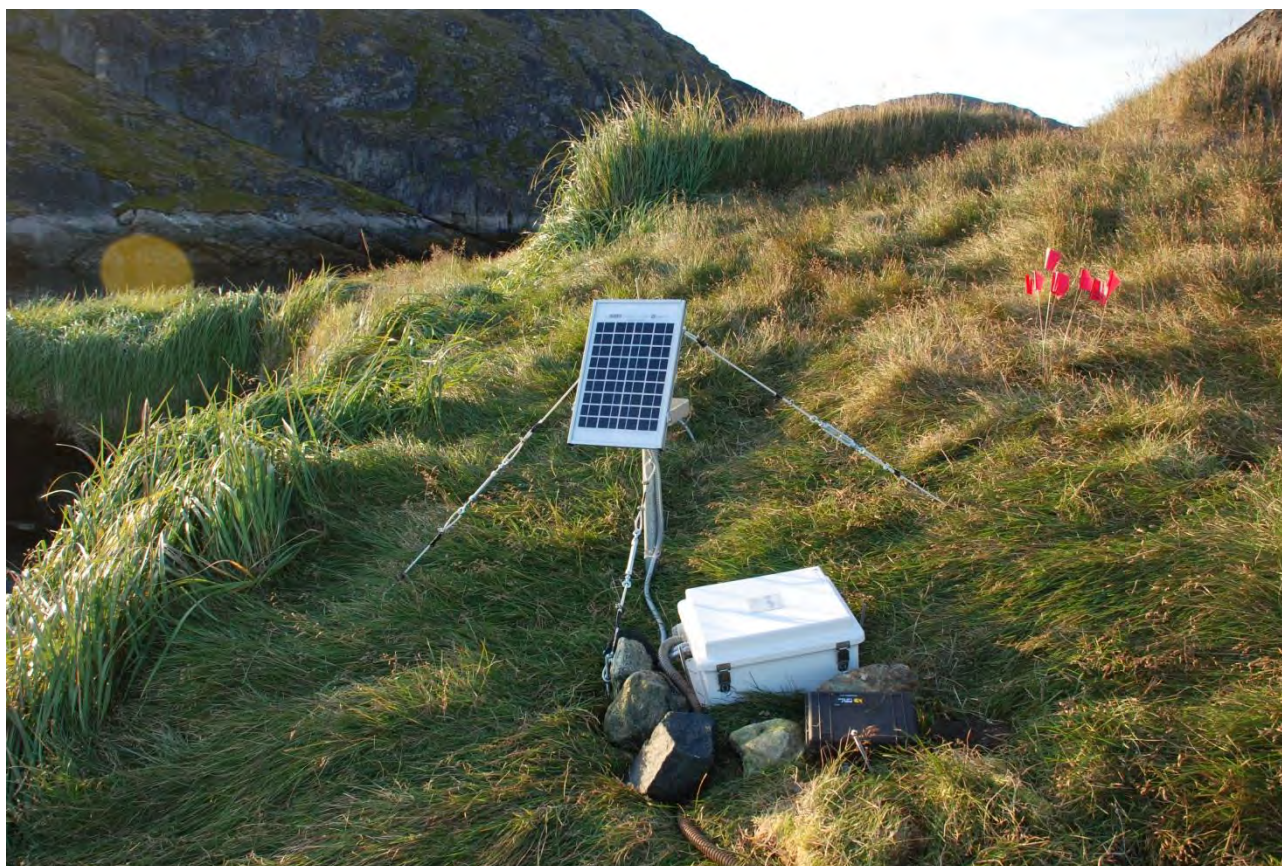
**Fig. 4.29** Monitoring equipment on top of Kangeq midden section C (to the left). In the back one of the house ruins overlaying the midden is visible.

In profile C temperatures are measured in 45 and 90 cm and on the south side of the small bay temperatures are measured in hole no 5 at 30 cm and 60 cm depth. The measurements are made using Gemini PB-5001 temperature probes connected to Gemini Tinytag (Tgp-4520) dataloggers. The loggers are powered by single lithium 1/2AA batteries; they measure every 3 hours and will be full by July 2014. Data can only be retrieved using a special cable.

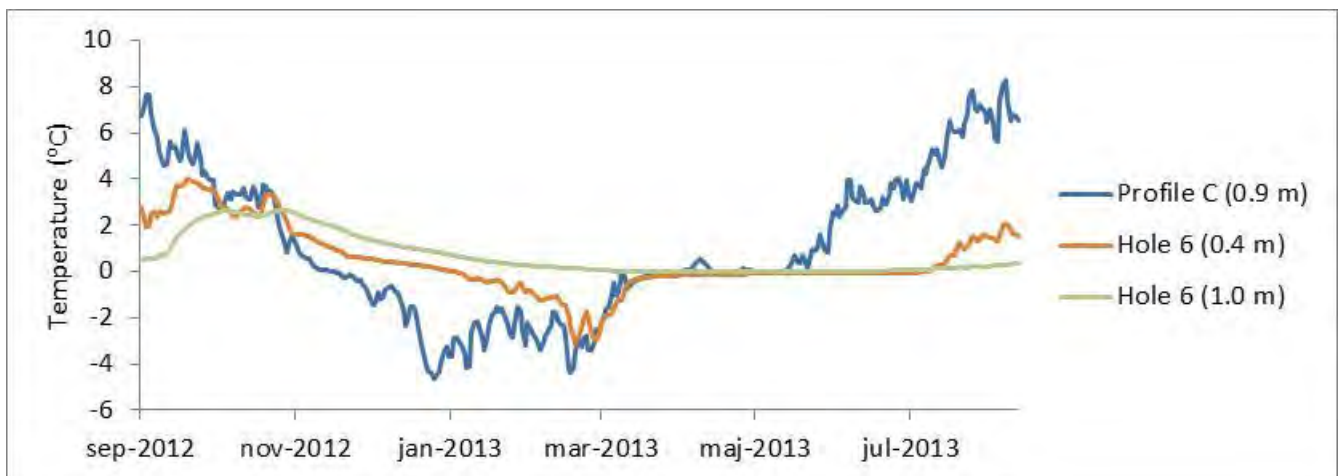
Fig. 4.31 Comparison between soil temperatures measured in hole 6 and the exposed profile C.

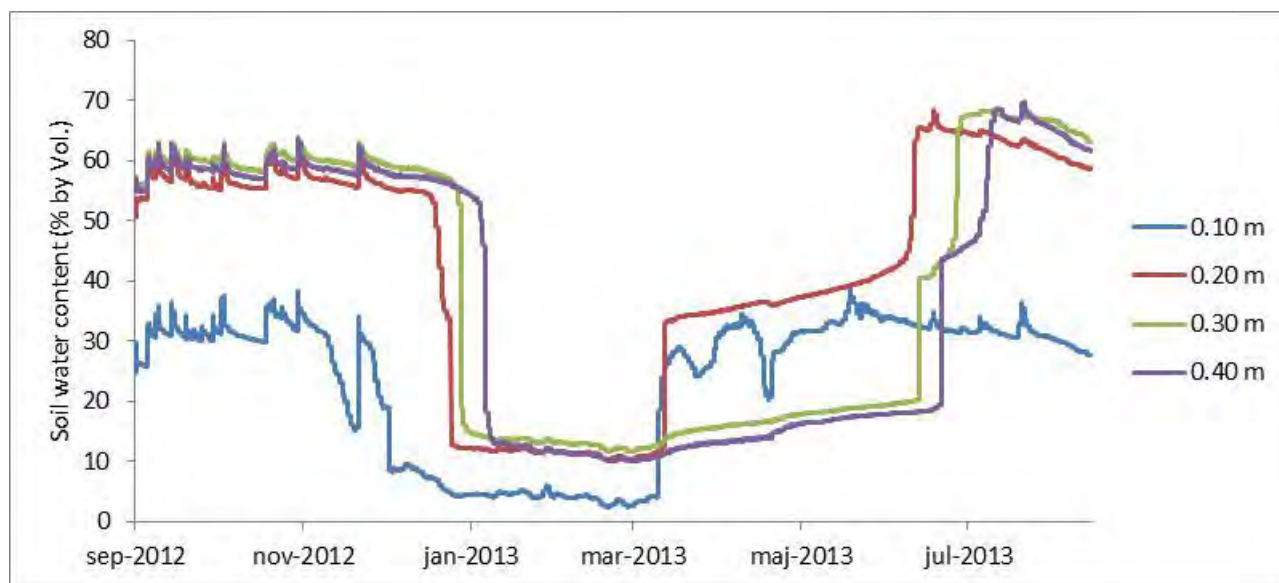
**Fig. 4.32** Soil water contents measured in hole 8. The data was calibrated using the wet probe measurements and values of porosity seen in figure 4.29. NB. The drop in water contents during the autumn/winter period is due to freezing.

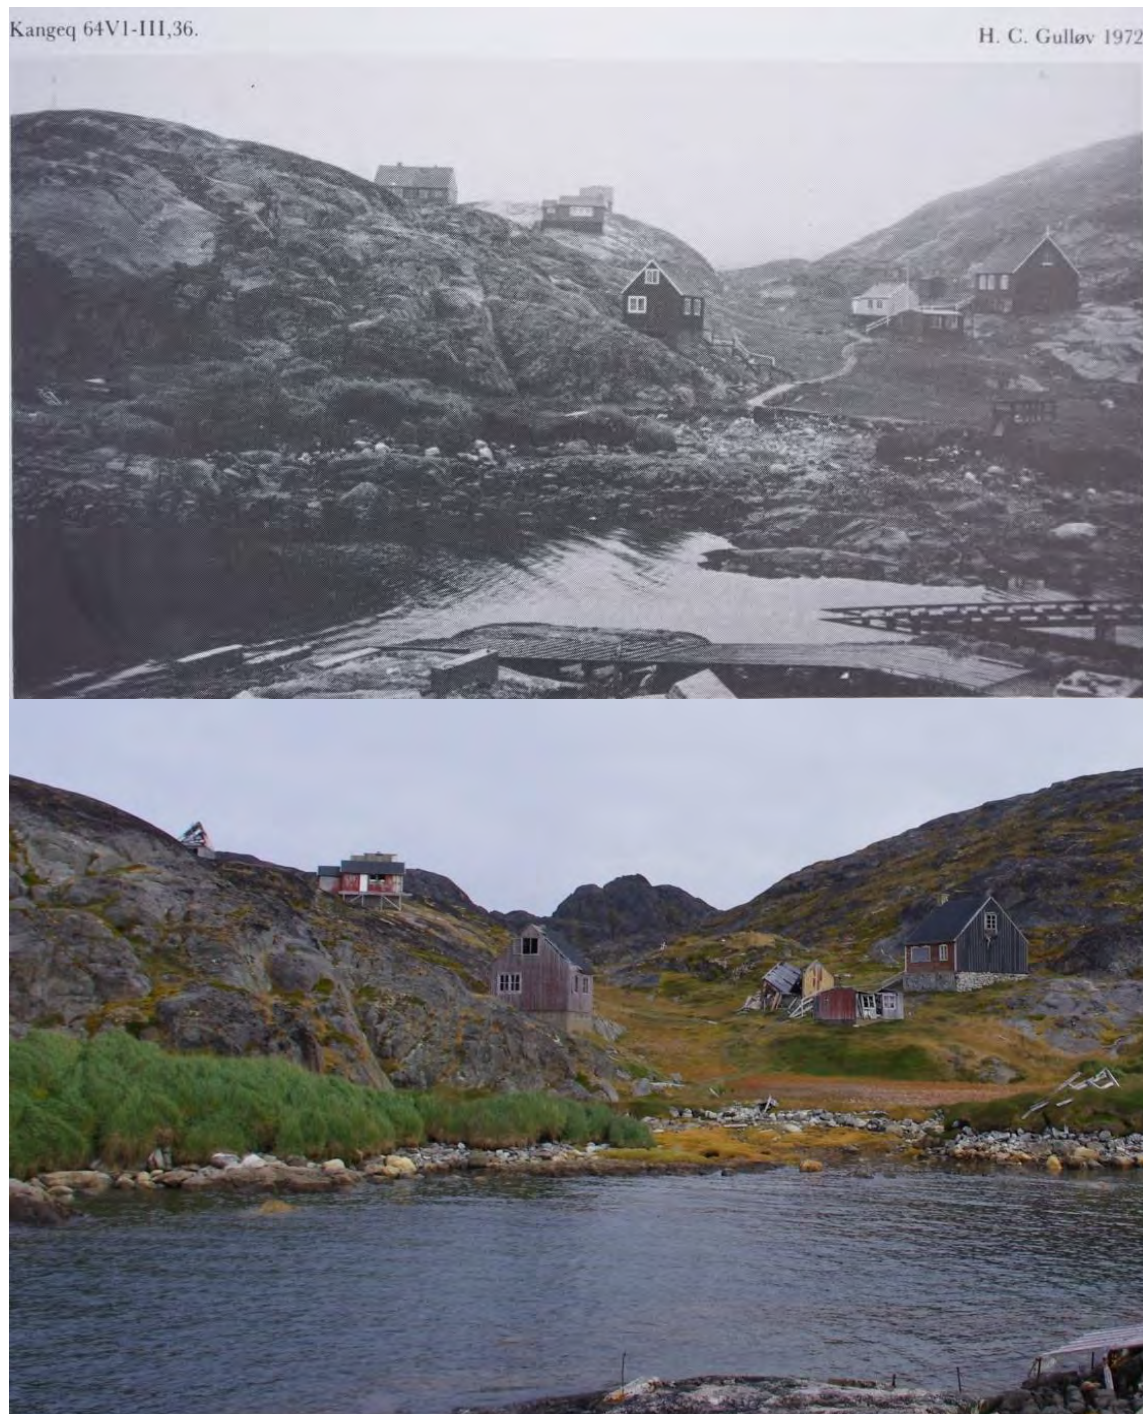
**Figure 4.33 Comparison between photo taken by Krabbe in 1894 (upper), Hans Gulløv in 1972 (middle) and during the field work in 2012 (lower).**

The three photos in fig. 4.33 doesn't indicate a severe erosion during the last 120 years in this area of the midden – rather the midden seems to have become stabilized by grass growing on top of it.

Comparison was made to old photographs taken at the site (figure 4.33).

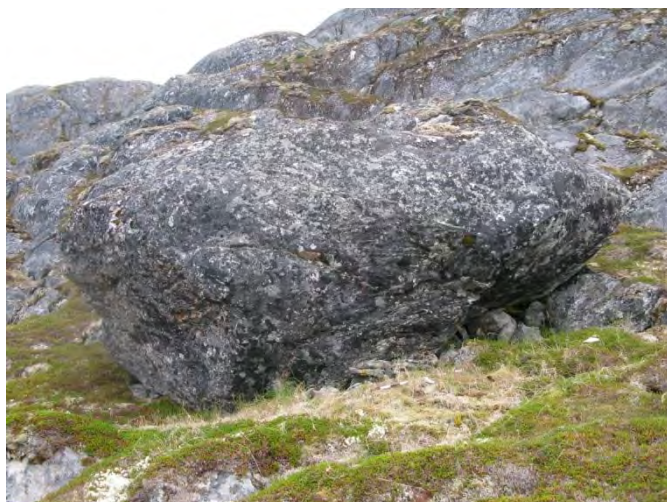
**Structure 9:** Stone built grave under a big boulder. 2.5 x 1.3 m., height 0.4 m. Partly disturbed. Two limb bones are visible. Vegetation: moss and lichens. Well preserved.

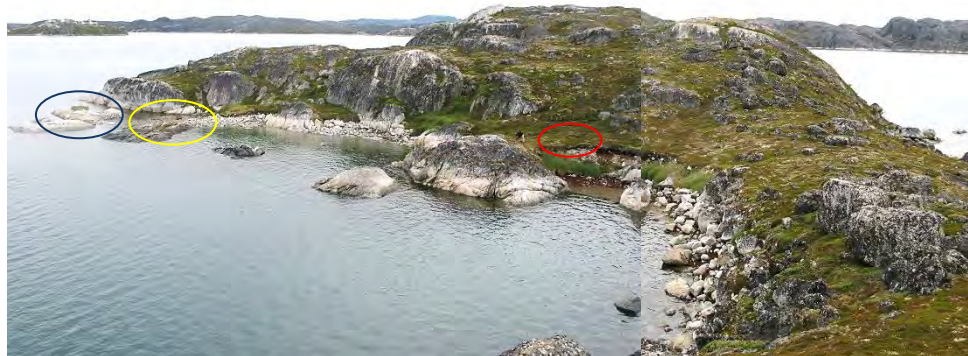
Fig. 4.39

The east tip of Upernivik at high tide. Three very eroded structures 13 (blue), 14 (yellow) and 16 (red) are located on the beach ridge and in breakwater zone.

**Structure 14:** Remnants of a sidewall and platform of a tent house stones located in a west-facing bay NW of structure 13 on a point which is now washed away by the sea. The walls are built of turf with head sized stones in its outer foundation and with head- to hand-sized stones in the platform foundation. The wall measures 3.6 x 1.4 m. and are 0.5 m. high and 0.8 m. wide. The platform measures 1.5 x 1.2 m. and is 0.25 m. high. A line of stone is also observed along the back wall on top of the platform. From the position of the platform the entrance of the house must have faced south towards the bay. In front of the platform an oval stone structure, 1.1 x 0.75 m. made of 0.5 x 0.5 m. large stones, has been added in recent times. West the stone structure lays two flat stone tiles and four head-sized stones; none of which are in situ. Vegetation: Moss and grass. Most of the house has been eroded away by the breakwater at high tide.

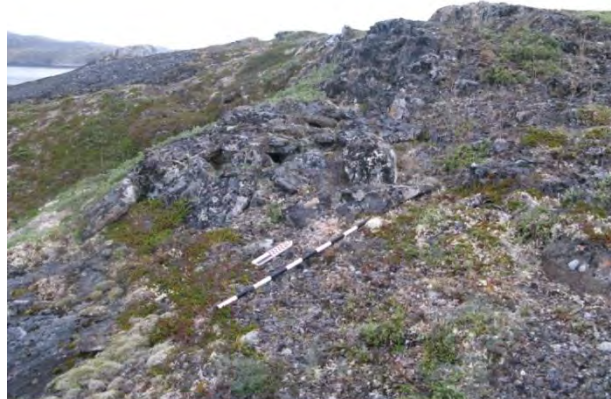
Fig. 4.40 Upernivik, structure 2.

**Structure 2:** Undisturbed oval grave located on a south-facing slope. Oval 2 x 2.7 m. built of flat stones; filled with smaller stones. Low, compared to the surrounding terrain. Vegetation: Lichens and grasses.

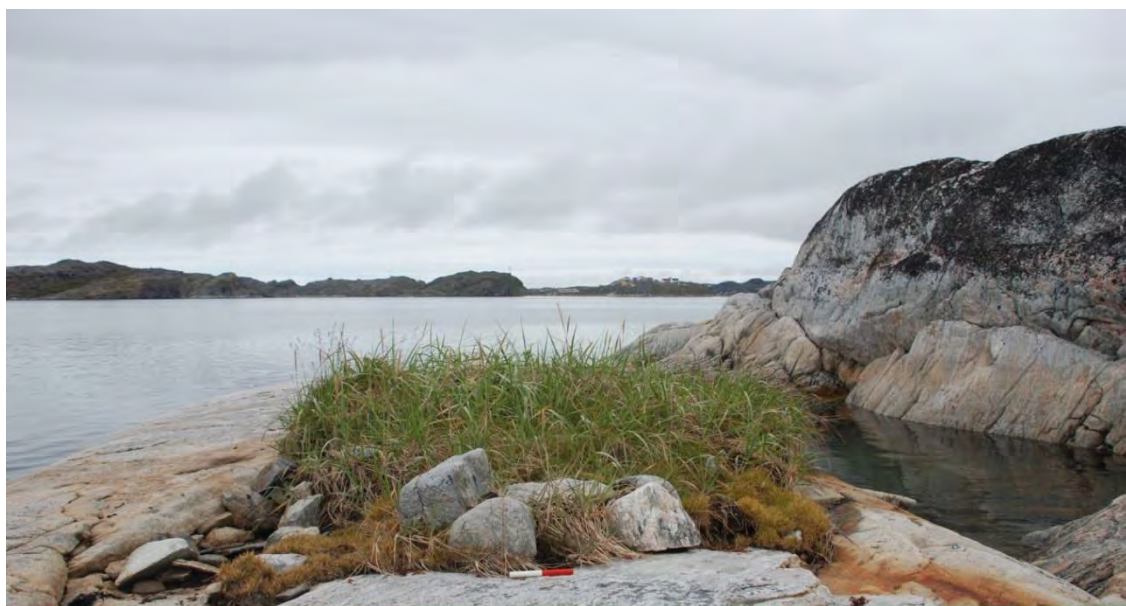
Fig. 4.42 Upernivik, structure 13: the last remains of a tenthouse located in the breakwater zone

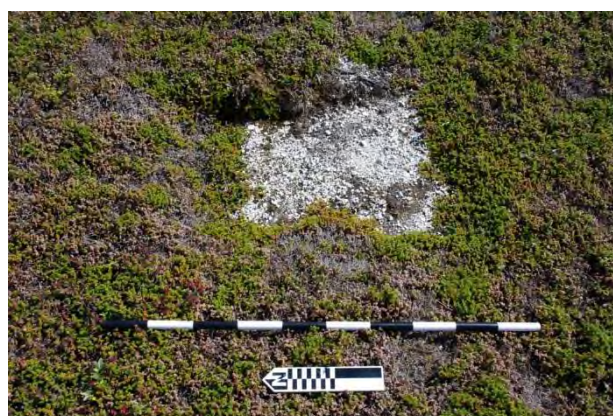
Fig. 4.53 Kangillermiut, structure 3.

**Structure 3:** Rectangular pit 0.65 x 1.1 m. filled with white quartz gravel and few hand- to egg-sized stones. Two flat overlapping flat stones are located in the NW corner. Interpreted as a pit from turf-collecting or playhouse. Well preserved. The pit is located 3.5 m. from the shore.

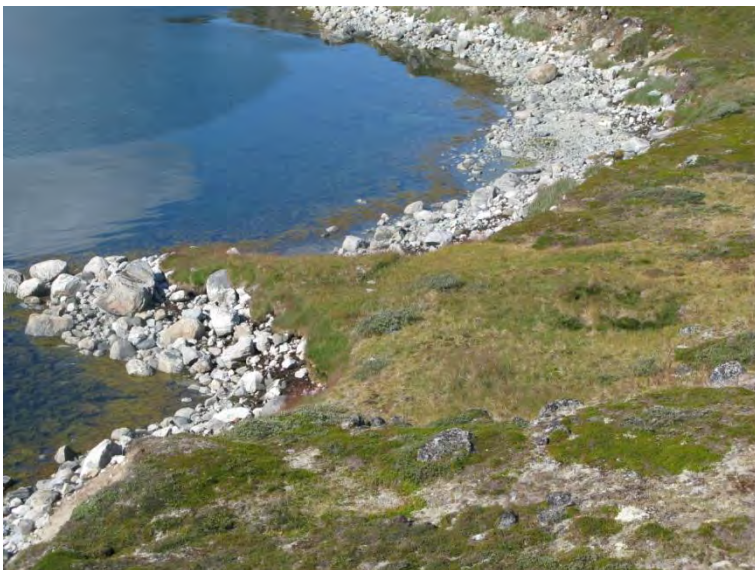
**Structure 12:** Tent house foundation with square room and ante-room with entrance in the south. Inner measurements 4.6 x 3.07 m. Many stones fallen down from the northern wall. Vegetation: Crowberry, willow, grass and moss. Well preserved.

**Structure 13:** Hardly visible turf wall. 4 large stones are part of the NW part. The wall is broken in several places and low in the NW and SW part. Located 1 m. from the shore. Overgrown with willow, crowberry and grasses.

**Fig. 4.58** Kangillermiut, structure 12 (right) and 13 (left) is located on a small point. Structure 13 is at present located only 1 m. from the beach ridge.

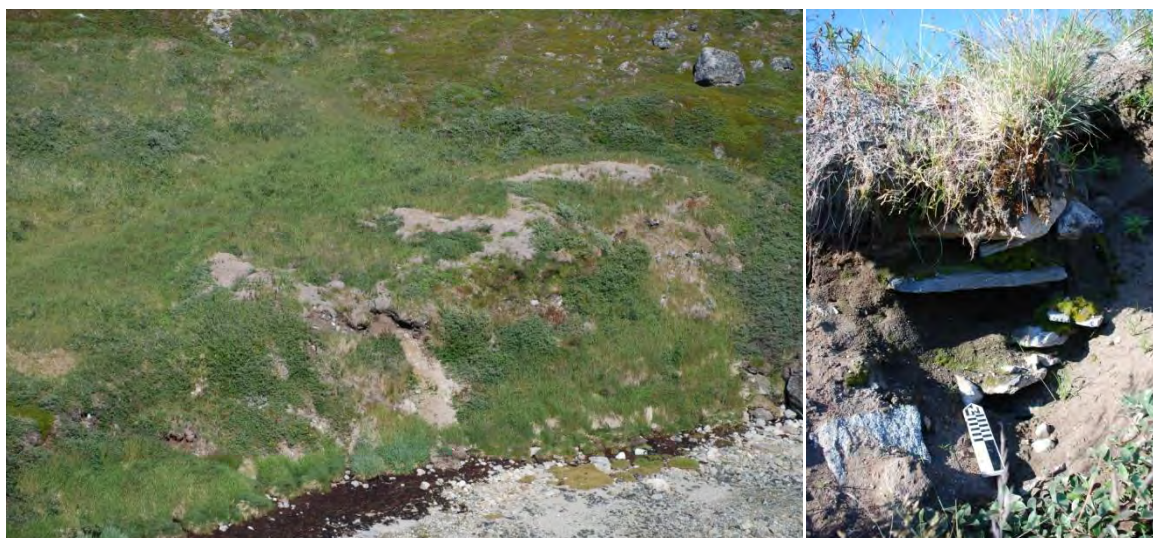
**Fig. 4.72** Three houses at Kangillermiut under erosion; structures 58, 59 and 57 (left). The middens of these houses have already vanished and the passages are now collapsing into the fjord (right).

Erosion from water/ice, including erosion from waves, boat-traffic, and freshwater	The lowermost 4 houses at the western part of the site is under erosion from the sea.
Other erosion (wind, animals, visitors)	None
Vegetation, roots	None
Drainage	None
Melting, heating	?
Soil movement (including creeping, cryoturbation, slide)	?
Decay of organic materials	?
Other threats	?
Future threats?	Possibly the erosion of the 4 houses already under erosion.
<b>Comparison to earlier descriptions</b>	The site was visited by archaeologists for the first time in 2012
<b>Monitoring</b>	
Already initiated	Photo documentation of the coastline of the eastern part the site and measurements of the coast line by precision GPS.
Suggested	
<b>Important unknowns/ research needed</b>	Location and monitoring of middens and coastline.
<b>Mitigation</b>	
Erosion protection	
<b>Field worker</b>	PKK, PTO

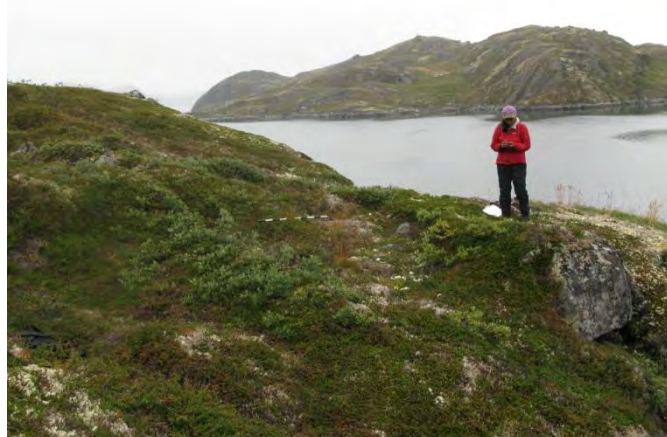
Fig. 4.77 The tent house at the name Unknown 1 site.

**Structure 1:** Trapezoid tent house. Inner measurements; length from entrance to back wall: 4.2 m., width of back wall: 3.7 m. Vegetation: Crowberry, heather, moss, lichens, willow and arctic birch. Well preserved. The tent house lays app. 1 m. from a steep erosion front.
