# PEOPLE OF ALL TIMES

## FIELD REPORT

## **Field report for the pilot project “People of All Times”**

*Submitted January, 2014*

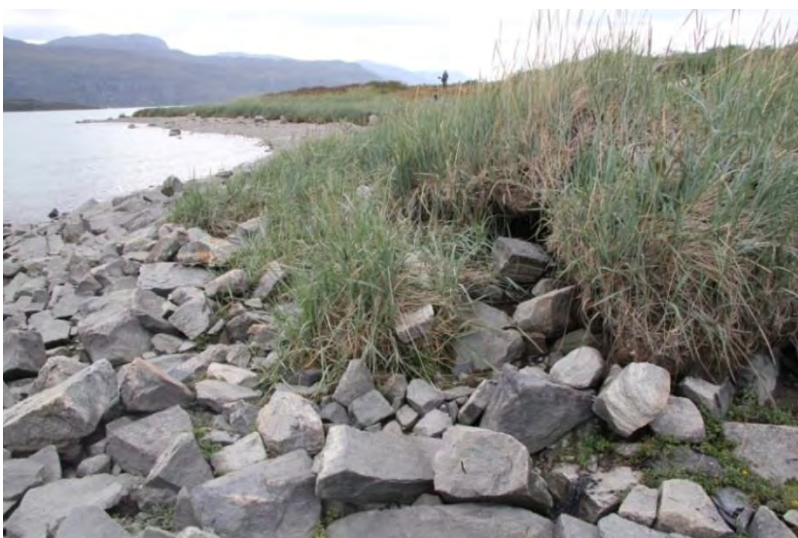
Fig. 5.12 The location of area F VIII prior to excavation. Note how a chunk of the overlaying vegetated midden has broken off and the tide has been undercutting the erosion front. Note also the many stones (photo: C.K. Madsen 2013).

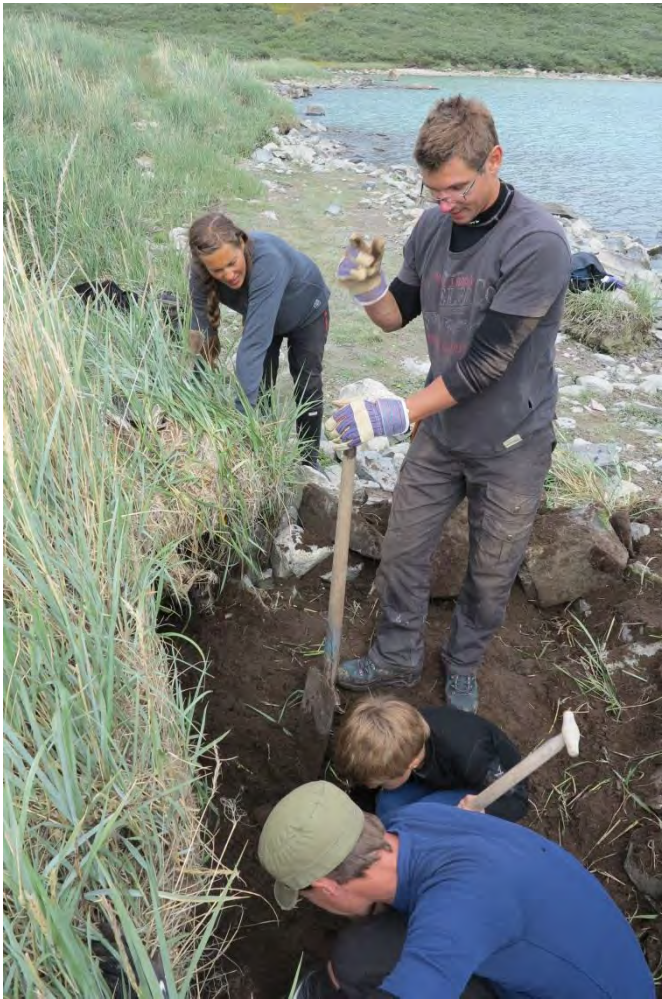
**Fig. 5.13 Opening of the F VIII trench. Note the area clear of stones just behind the trench (photo: M. Meldgaard 2013).**

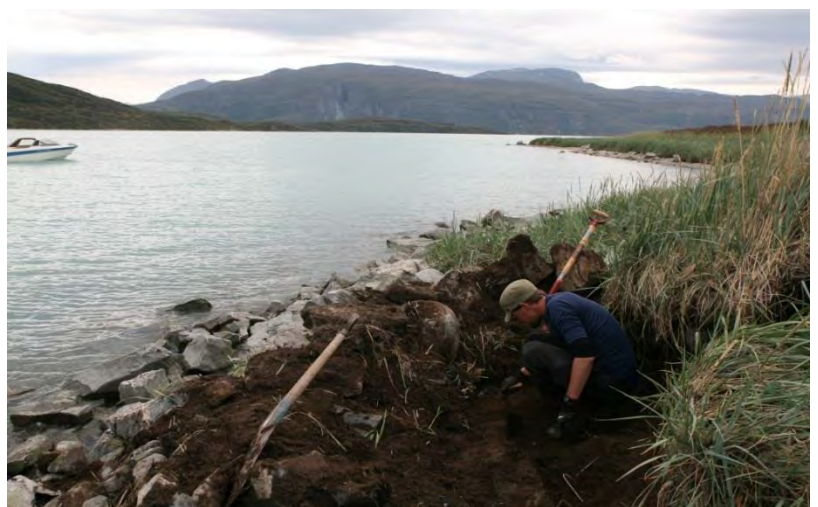
**Fig. 5.14 Excavation of area F VIII: the excavated soil and collapse stones was used to build a dike around the excavation area in order to keep out the tide (photo: M. Allentoft 2013).**

We staked out a c.1x2m area and then began clearing out the heap of stones and loose blocks of sedge turf lying just below the erosion front (fig.5.14-15). With spade and shovel, we removed the loose stones and intermittent soil and used this to build a low wall around the trench in the hopes that this would keep, at least, delay the high tide from spilling into the trench (fig.5.16). In the soil between stones were some poorly preserved animal bones from the eroded midden deposits, all of which were collected (x25).

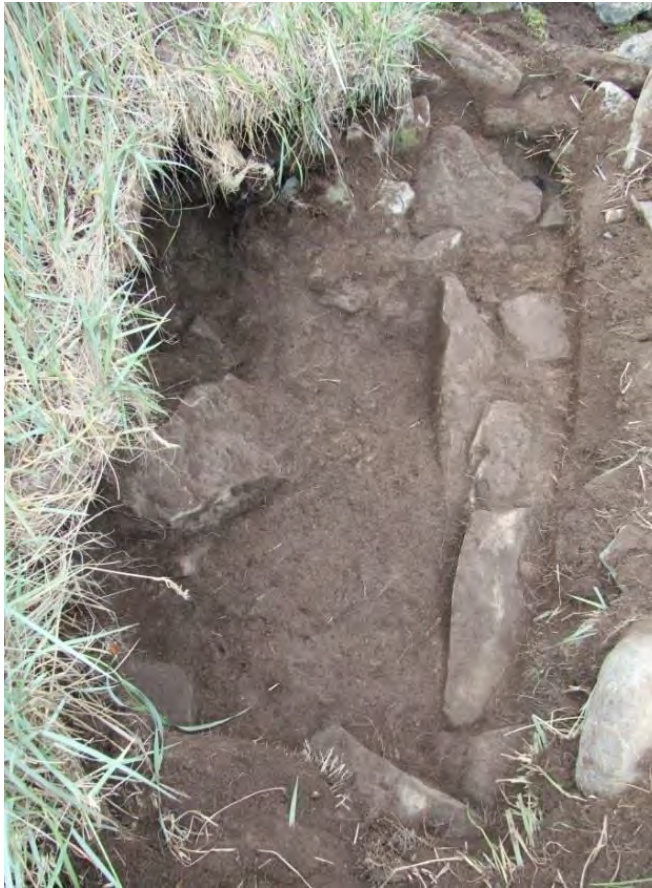
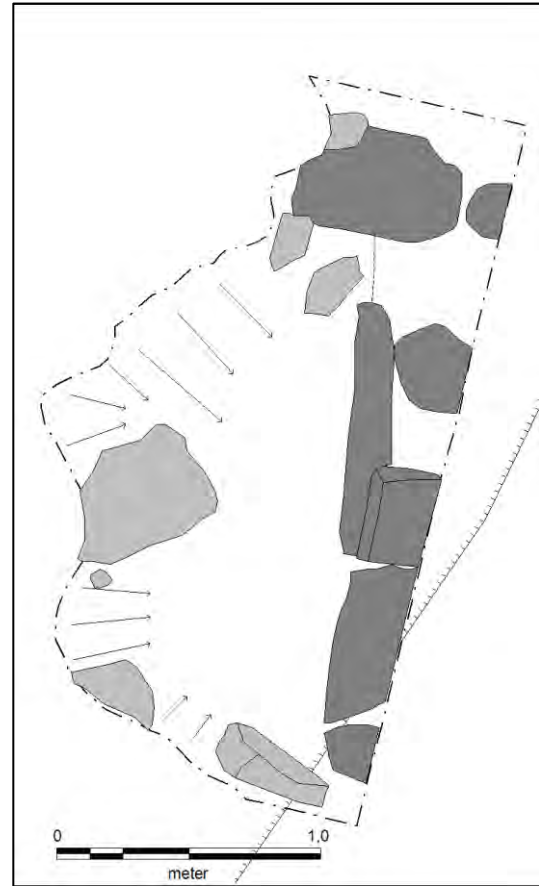
Having found the first horizontal stones, we were quickly able to trace others in continuation of this line. Observing how the stones mostly lay horizontally with a flat side facing upwards and with thin layers of turf on top and in between, it seemed very likely that we were dealing with part of some kind of stone-turf wall, most likely a small part of the churchyard enclosure wall. From the midden deposits resting against the line of stones and their slope to the east, it is probably the western boundary of the enclosure wall, which seems to have slumped into the churchyard.

**Fig. 5.15** Left: photo of cleaned area F VIII after ended excavation (photo: C.K. Madsen 2013). Right: Digitalized plan of area F VIII: Dark grey filling signifies *in situ* stones interpreted as part of the churchyard enclosure wall; light grey are interpreted as collapse stone.

The interpretation of the feature in area F VIII as the churchyard enclosure wall was reinforced during the digitalizing and georeferencing of the excavation plans: extending the short stretch of wall in F VIII in straight lines to the N and S results in the projected western extent of the churchyard shown in fig.5.13. This line corresponds extremely well with the general layout of the other projected churchyard enclosure walls, and with the observation of Roussell of faint traces of collapsed wall beyond which no more interments were found (west of his area 2, fig.5.11) (Roussell 1936:15). However, it should be noted that we had no precision-GPS available to survey the area, wherefore the projection of enclosure wall and the location of the trench may be slightly inaccurate. Nonetheless, adjustment of the projected enclosure wall would likely effect minor changes in extend and plan rather than any drastic alteration of the enclosure wall.

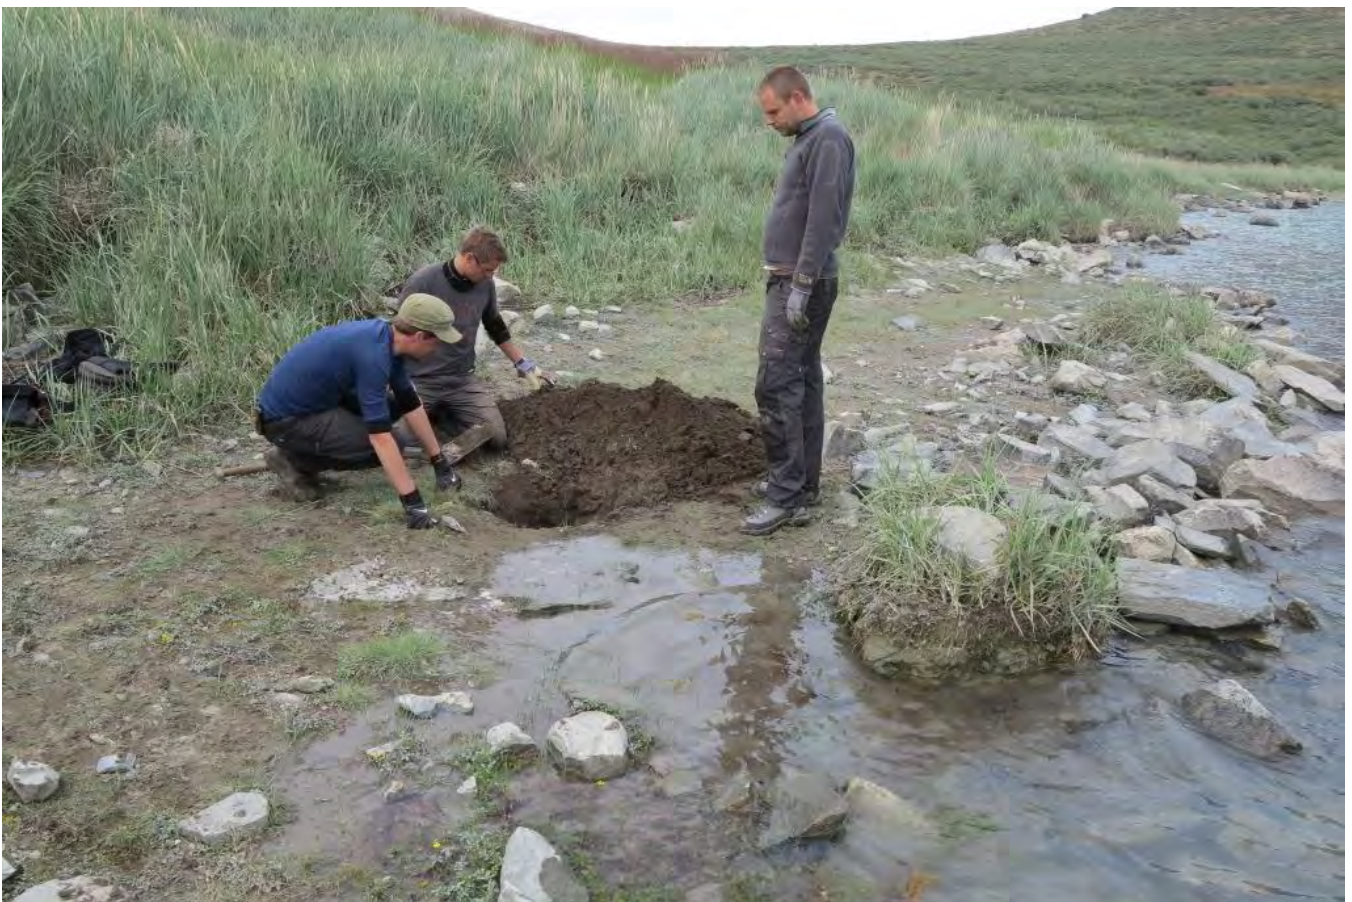
Fig. 5.16 The stretch of flat beach with little stone just north of area F VIII, where a test-pit revealed human bones. Visible in the photography is the slight grass cover of the beach indicating that the surface is rather stable, yet flooded during at high tide. This is where we decided open area IX (photo: M. Meldgaard 2013).

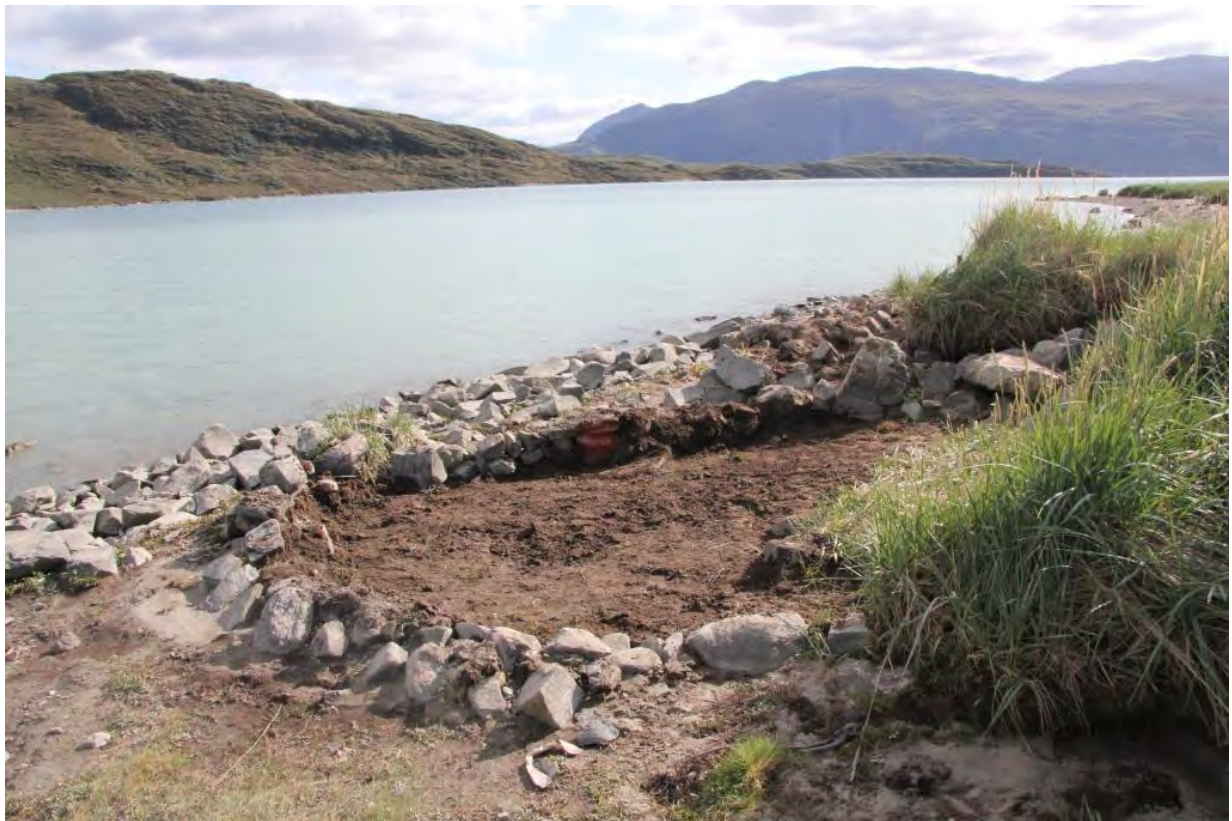
**Fig. 5.24 Area F IX after ended excavation.** We decided to leave the low protection wall to mark and protect the area for future excavation (*photo: C.K. Madsen 2013*).

Having finished sampling and documentation, the bottom edge of area F IX's second trench was marked out with plastic tape, the skeletal parts nicely and gently packed in loose soil to protect them, and the trench then backfilled. We decided to leave in place the low protection wall we had built to protect and mark the area for future excavation (fig.5.24).

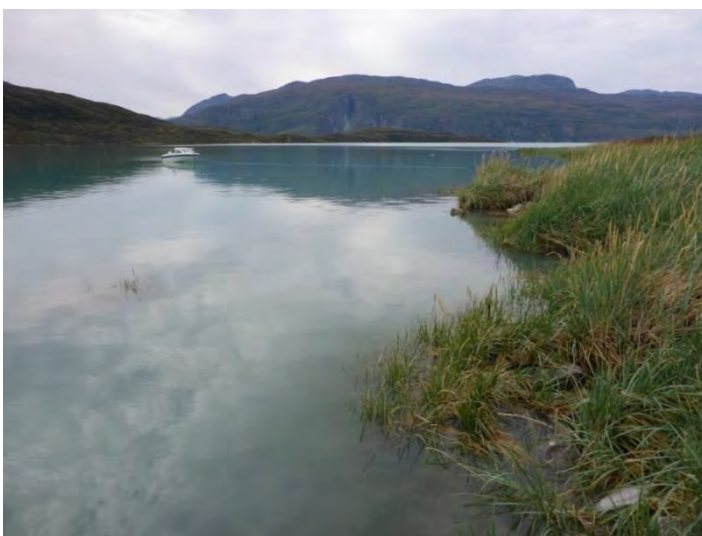
**Fig. 5.25 The beach and erosion front of area F VIII and F IX at highest tide** (*photo: C.K. Madsen 2013*).

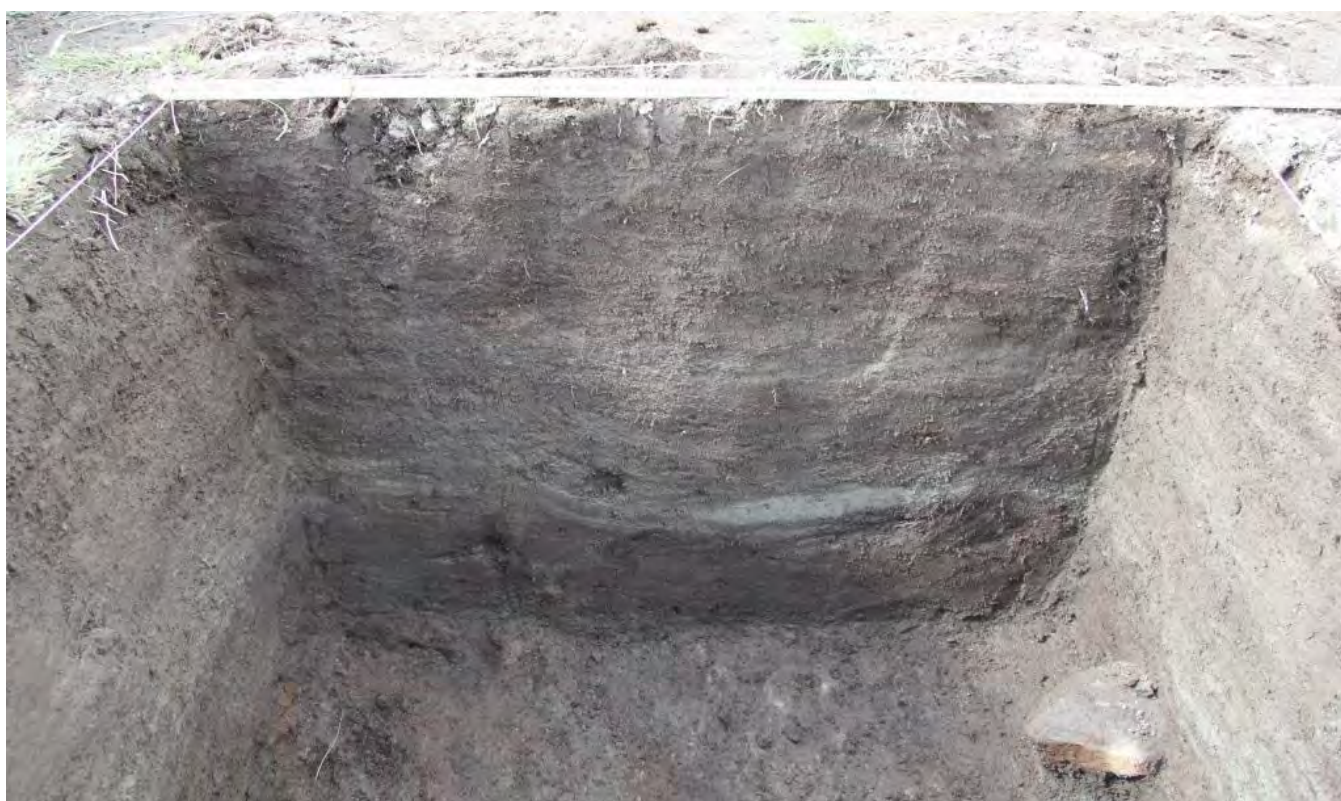
**Fig. 5.28** W section of the first 1x1m F IX area. Even though the section has dried out, the grave cut [04] and [05] is fairly visible in the lower left part of the section (*photo: C.K. Madsen 2013*).

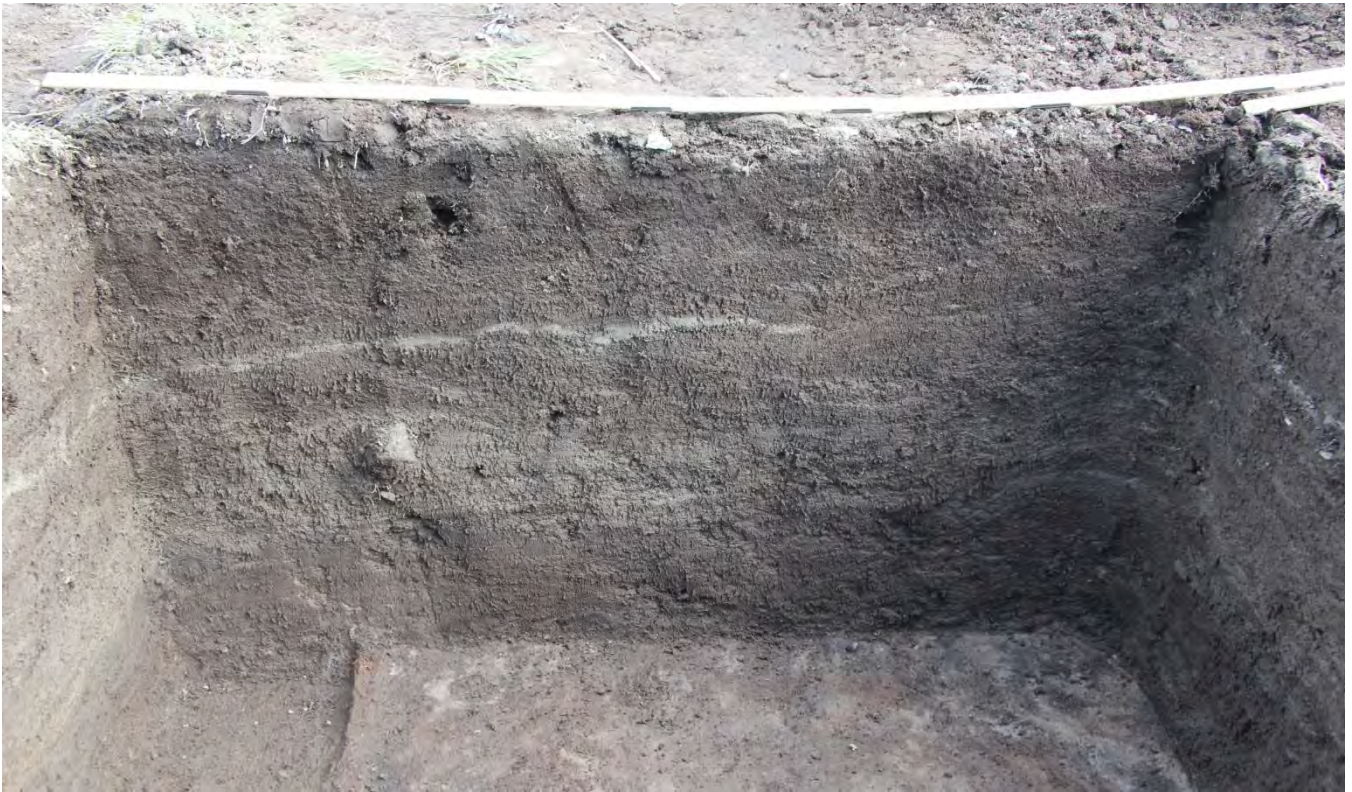
**Fig. 5.29** E section of the second 1x1m F IX area. Even though the section has dried out, the grave cut [04] and [05] is clearly visible in the lower left part of the section, as is layer [02] sealing the grave cut (*photo: C.K. Madsen 2013*).

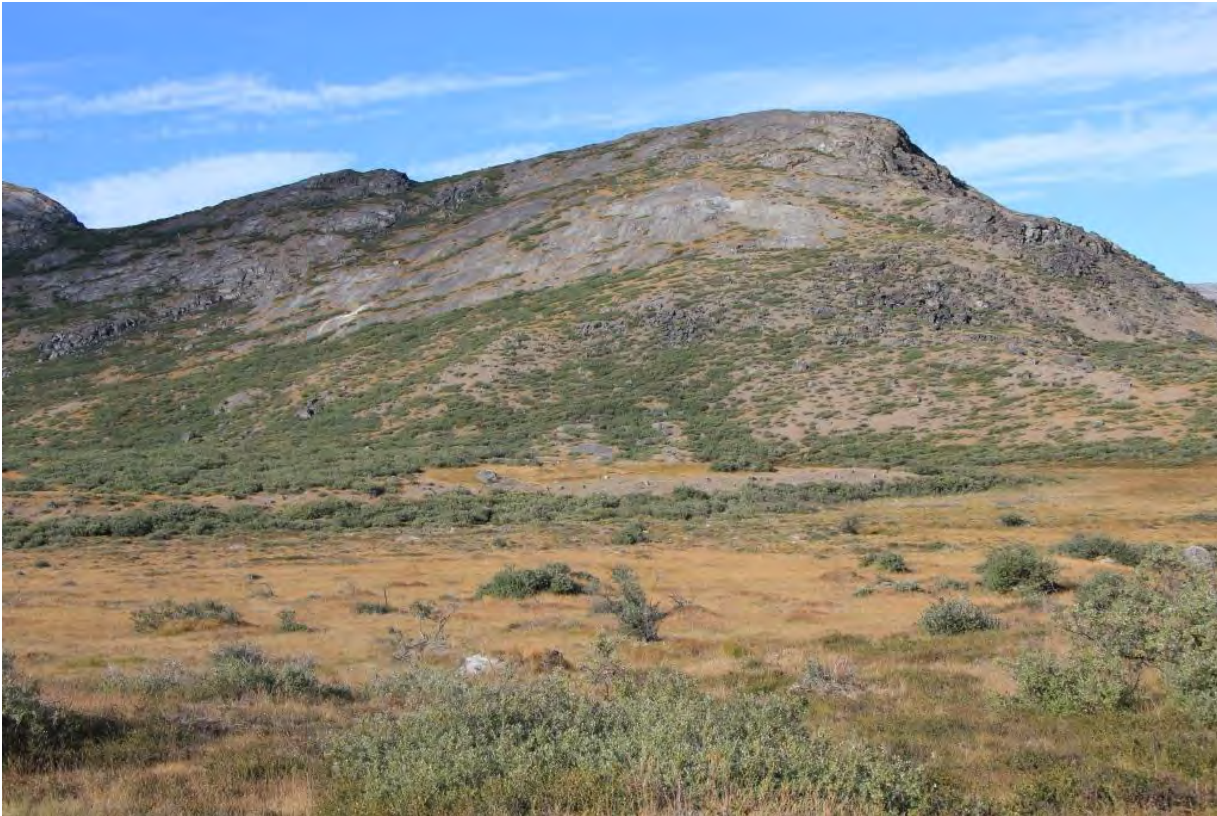
Fig. 5.31 The low knoll with the main dwelling of Nipaatsq/V54 towards the N (photo: C.K. Madsen 2013).

*Threats from vegetation increase:* is scored at 2 for the features and 1 for the midden. It is clear that the willow scrub is encroaching on the excavated rooms of the Nipaatsq dwelling, some rooms already having been invaded. As excavation of the dwelling was never finished, any evidence of earlier phases and additional material, as well as unexcavated parts of the feature, is moderately threatened by increased scrub cover and root nets. The relict homefield and midden seems less threatened as it still virtually free of scrubs (fig.5.31).

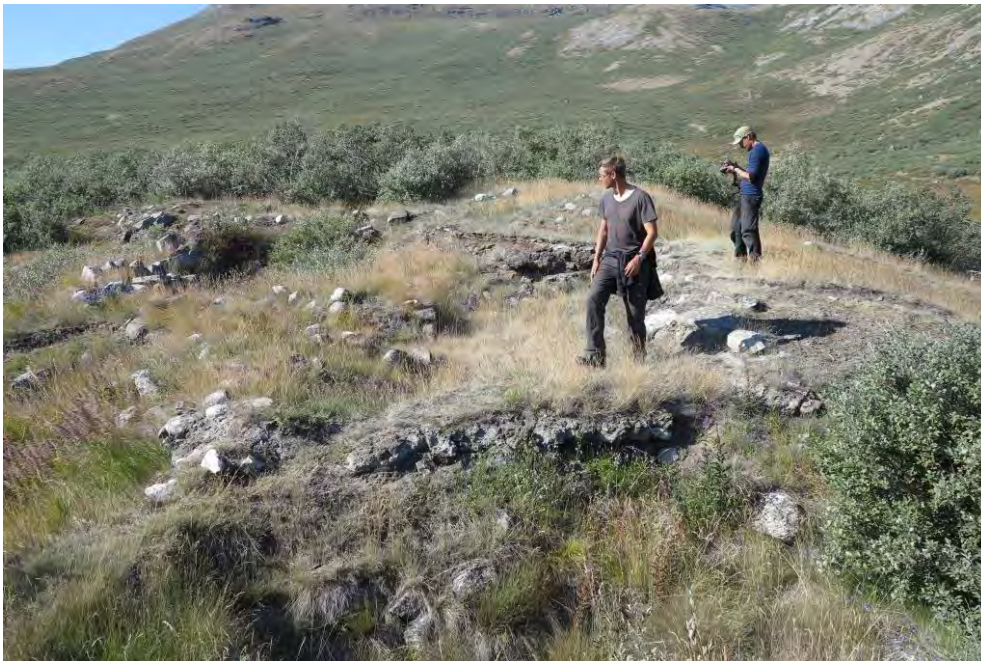
**Fig. 5.33** The northern limit of the 1977 excavation of V54 (photo: M. Meldgaard 2013).

*Threats from erosion:* is scored as 1 for the features and 0 for midden. Wind erosion and erosion from precipitation is biting at the excavated walls of the ruins (fig.5.33-34), slowly breaking down the turf parts and making the walls slump and, eventually, tumble or collapse. However, presently erosion during 36 years has done fairly little damage.

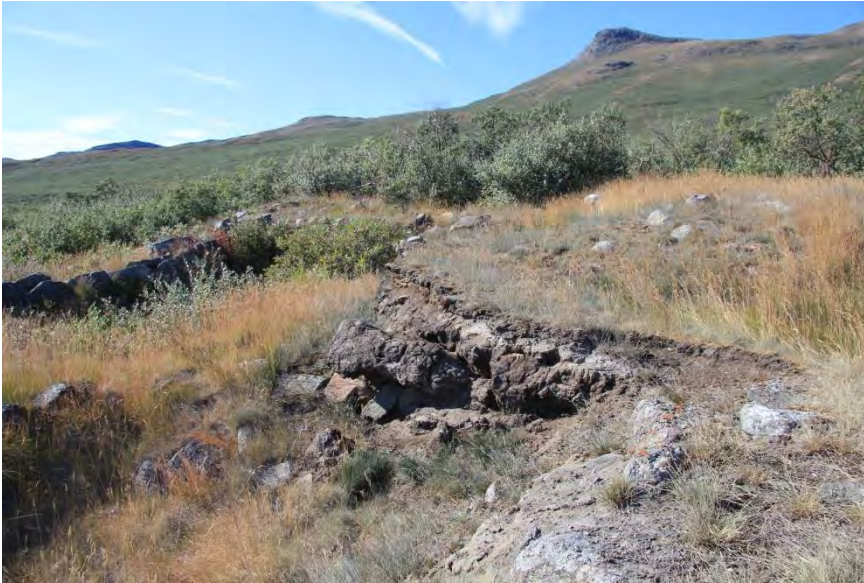
**Fig. 5.34** eroded part of the northern wall of the dwelling, where the turf is breaking off and stones spilling into the rooms (photo: C.K. Madsen 2013).

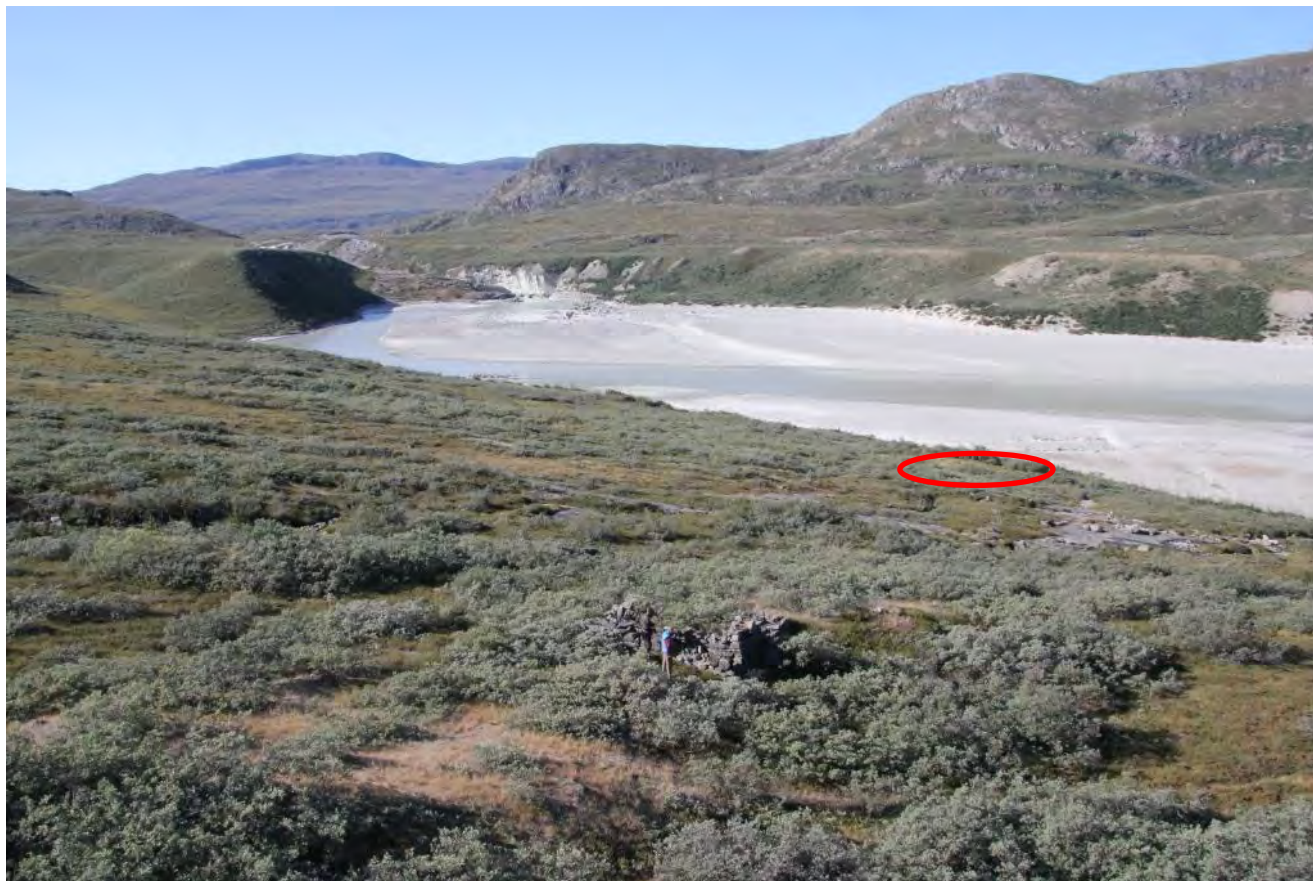
Fig. 5.35 View towards the SSW of the slope with ruin group V63. In front, the nicely preserved skemma is seen, whereas the site of the supposed dwelling is circled in red (photo: C.K. Madsen 2013).

At the suspected main dwelling (red circle fig.5.35) – a grassy and scrub vegetated area with the outline of a few spaced rooms – we cored for frost with a 1cm spear: two transects were cored across the green patches w. outlines of rooms. In the upper transect, stones were hit at a constant depth of c.45cm. In the lower transect, less even soil covered the stones and no permafrost was detected. A few spears were put in the suspected midden even further towards the coast, finding permafrost in one at c.90cm and only after having speared through some more compact and gravelly deposits.

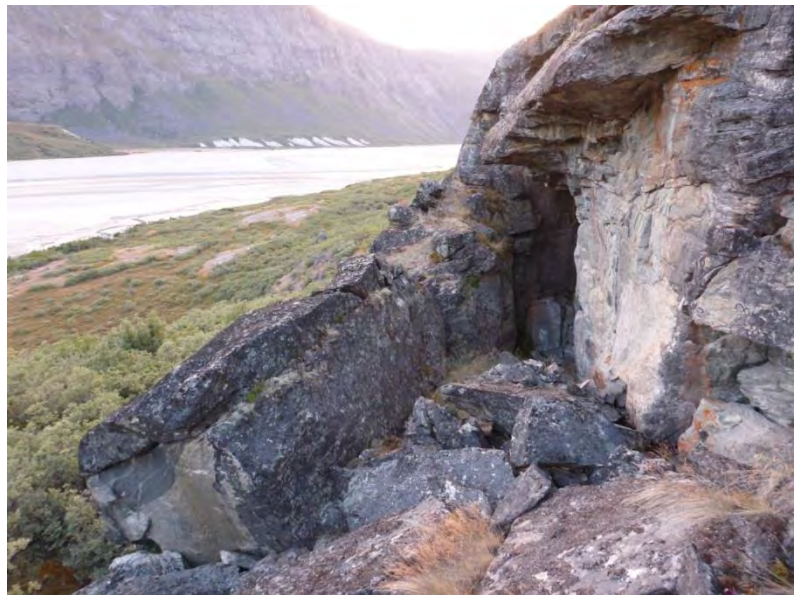
Some 400m's north of the nicely preserved skemma and c.200m up the slope is a vertical cliff face with a boulder field in front. Upon closer inspection, part of this steep cliff face has split clean off from the bedrock, creating a 3-4 wide and c.25m deep crevice between the two (fig.5.36). At the south facing entrance of the crevice, a low foundation – a single row of stones c.30-40cm wide – for a wall has been built on top of naturally deposited boulders, thereby creating a perfectly sheltered compartment, possibly a Norse enclosure. This compartment would likely only have been some c.6m deep, because at that point one has to climb a large boulder to gain access to the innermost c.20m of the crevice, where natural overlies supplies roofing and give it a cave like impression.

**Fig. 5.36** The opening of the crevice with Ruin 13\_01 seen towards the NW. A stone foundation for a wall has been built on top of the boulders blocking the entrance to the crevice (photo: C.K. Madsen 2013).

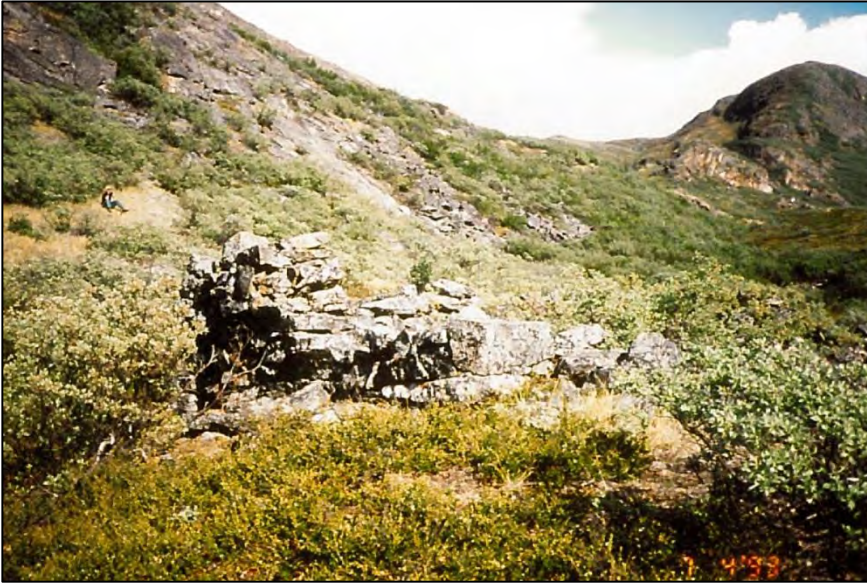
**Fig. 5.38** The skemma of V63 in 1993. The willow scrub stands high outside the ruin, but low in the inside (photo: J. Arneborg 1993).

- damage from roots on the archaeological remains was observed at several sites (e.g. fig 3.27) and furthermore increased vegetation cover made it difficult and sometimes impossible to locate sites (fig. 5.38 and 5.39). This shows that changes in vegetation need to be studied and monitored in more detail

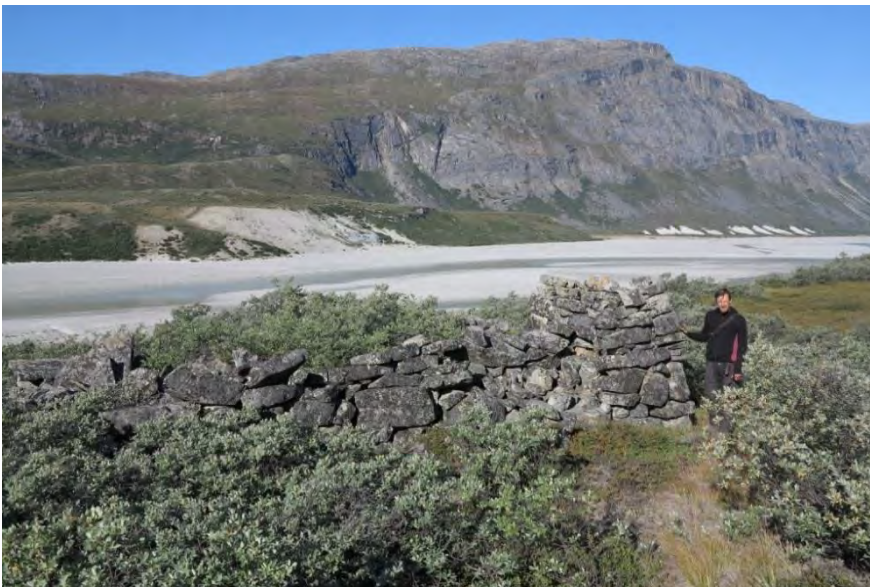
*Threats from vegetation increase:* is scored at 3 for both features and midden. This is because the scrub is increasingly dramatically in the area, which is visible from the photographs fig.5.38-39. Because both the structural features and midden area unexcavated and potentially well-preserved, the root nets of the scrub can cause considerable damage.

**Fig. 5.39** The skemma of V63 in 2013. The willow scrub in the inside of the ruin is now standing almost 2m high and has spread around the ruin as well (photo: M. Meldgaard 2013).

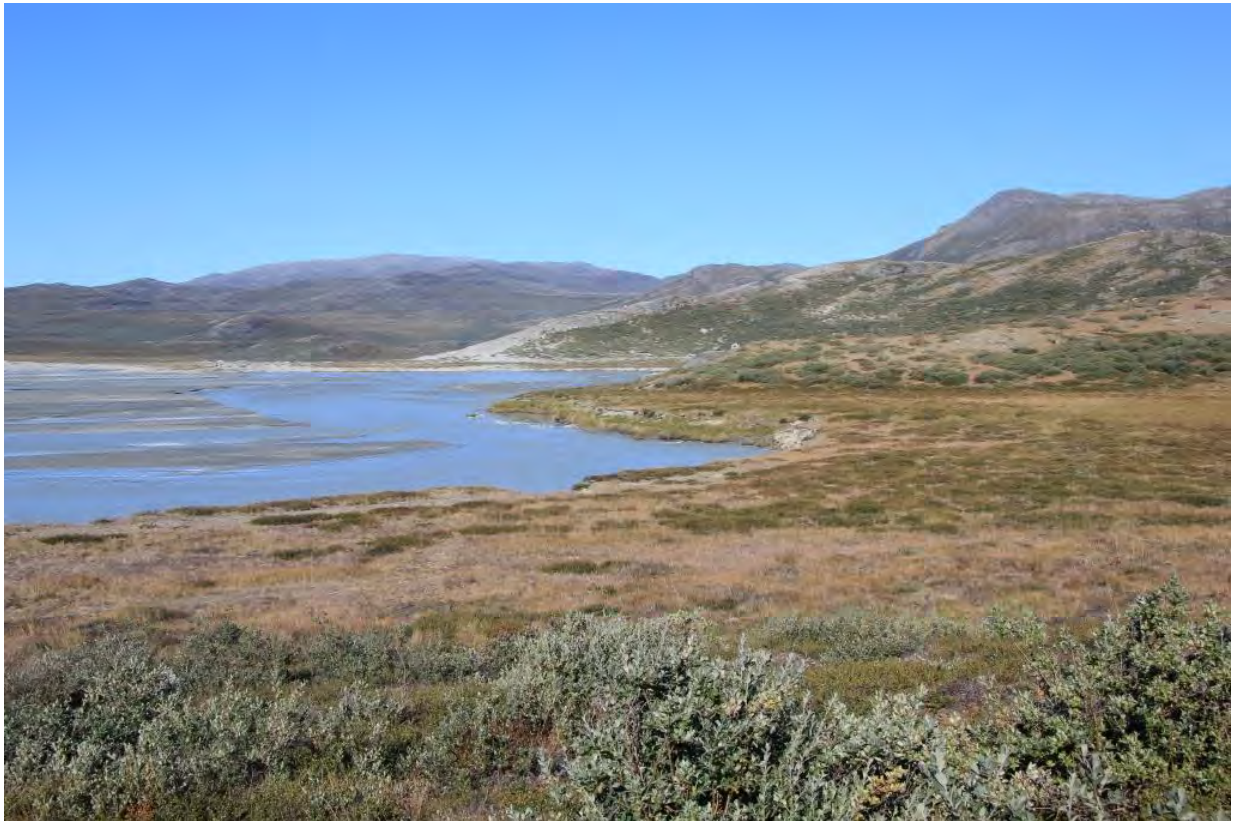
**Fig. 5.43** View of GUS and the melt-water river 2013 (*photo: C.K. Madsen 2013*).

The assessment of the preservation of GUS was primarily based on visual surface inspection: fig.43-44 compares the situation in 1993 and 2013, respectively. Comparing them, it is evident that the river has cut into the river bank, where the excavated dwellings and ruins of GUS were once located (fig.5.44-46). Thus, most of the structural features left exposed at the end of the 1996 excavation seem to have been removed. The river has also deepened the bend or curve in the river just in front (east) of GUS. However, the erosion is not dramatic and as there are no ruins in that area. Generally, the vegetation on the slope of the riverbank where the ruins were located suggests that the erosion has largely stabilized (fig.5.45).

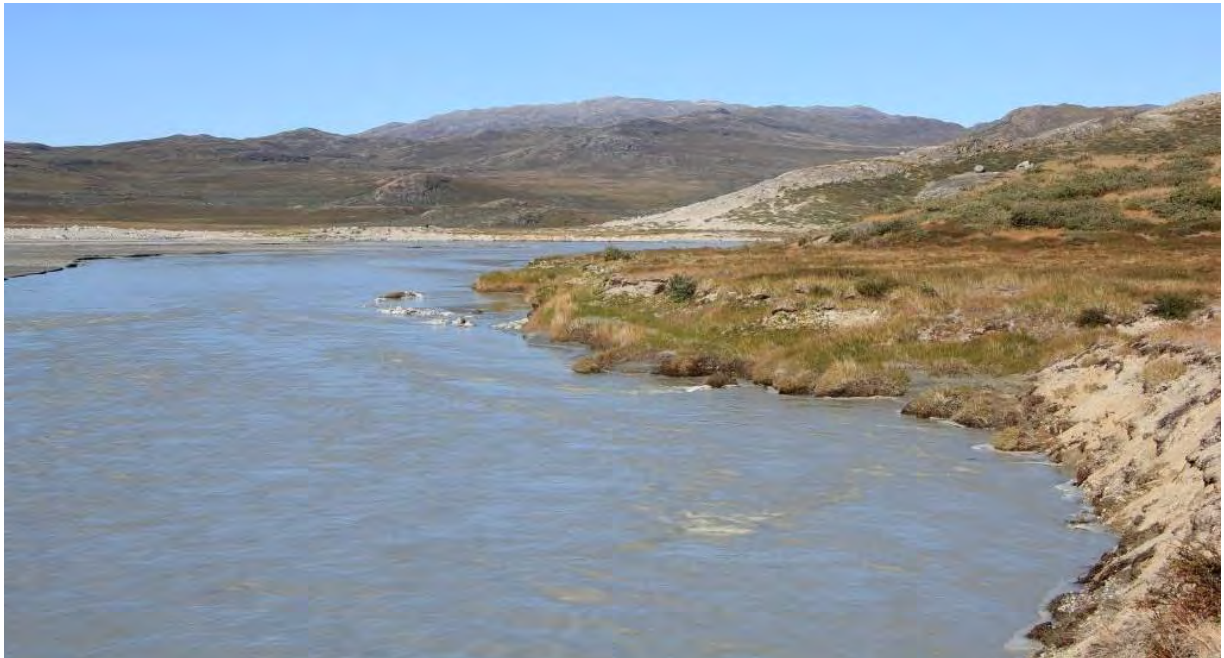
**Fig. 5.44** Close up view of the stretch of river bank where the ruins of GUS were excavated seen towards the W. The stones lying in the river just off the bank are likely building remains from the last phase of the excavation (*photo: C.K. Madsen 2013*).

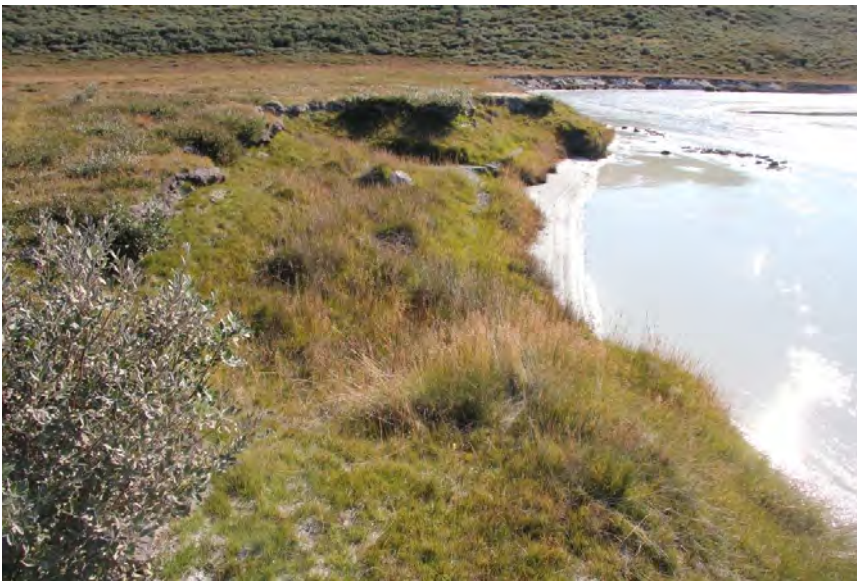
**Fig. 5.45** View of the erosion into the river bank where the ruins were located. The vegetation on the slope of the river bank suggests that erosion has largely stabilized (*photo: C.K. Madsen 2013*).

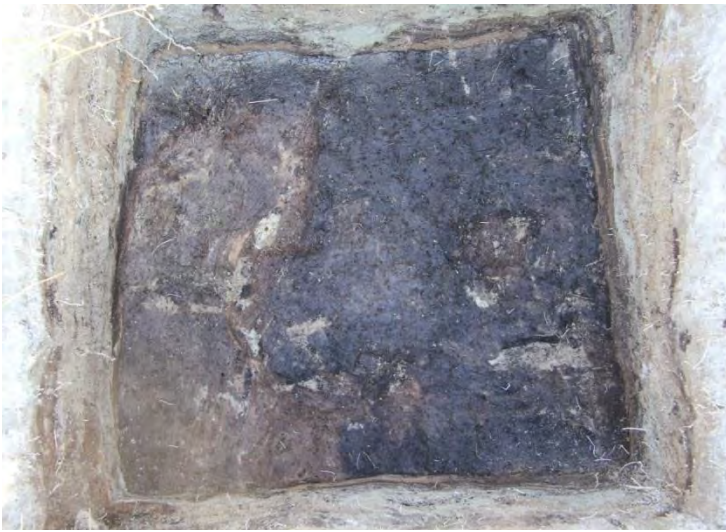
Fig. 5.48 The cleaned of surfaces of layer 16-17. Turf lumps which could be part of wall collapse are clearly visible. The black surface displays notable similarity to the black layer in the front of fig.42 during the 1994 excavation (photo: C.K.

Having established that there was intact cultural deposits, possible building remains, fairly good preservation, and not wanting to disturb these cultural layers any further with the means and time available to us, we decided to stop excavating at the top of layer no.16-17 and cleaned these for photographs (fig.5.48). DNA-samples (no.1-5) were then sampled from the top of layer 17. Next we used the metal spear to test for frost: in the southern half of the test pit we found frost c. 40cm below the excavated and cleaned off surface, in the northern half c. 100cm under the surface. We finally drew the section (fig.5.49), measured the corners of the test pit with a handheld GPS, and backfilled the pit.

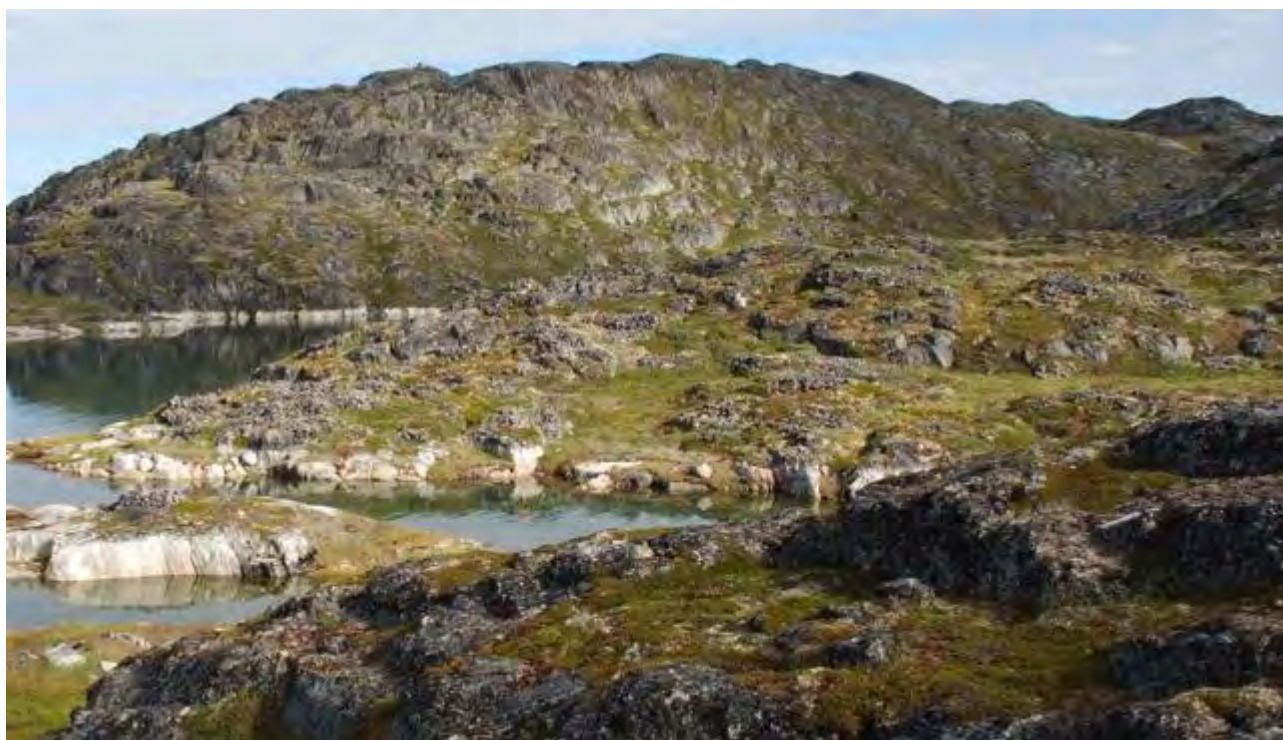
**Fig. 15** The graveyard at Akunnaat seen from southwest. The yard is situated on the headland at the centre of the picture. On the small island between the graveyard and the place from where the photo is taken there is only one grave. According to the local tradition, it is the grave of a witch, as told by H. H. Berthelsen. Photo: P. Toft, 2013

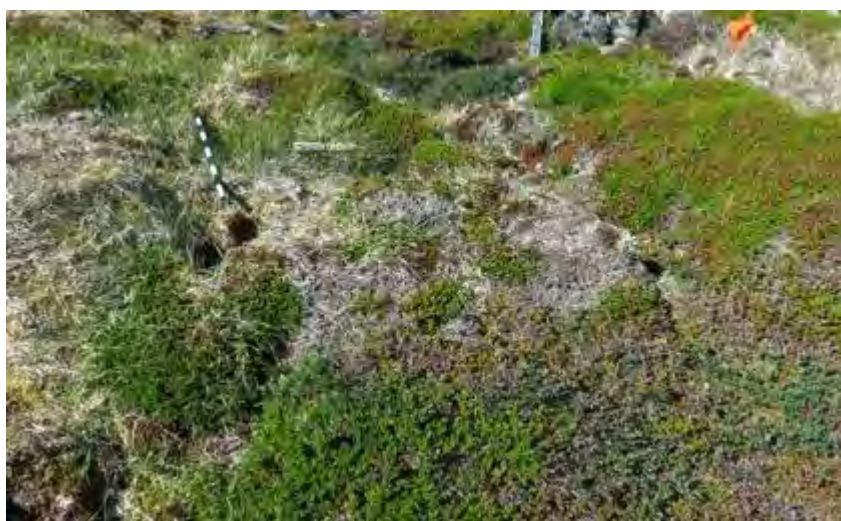
Grave number	<b>G</b>
Location	N63° 03.589' / W050° 44.279'
Dimensions	1.86 x 0.82m. Height: 0.18m
Orientation	SE - NW
Photo number	54 - 56 (NKA)
State of preservation	
Vegetation	Heavy
General description	Rectangular and built of turf. The grave has sagged in the center.

**Fig. 16** Grave G, one of the turf-built graves which have sagged at the Centre. Photo: Pauline Knudsen, 2013.

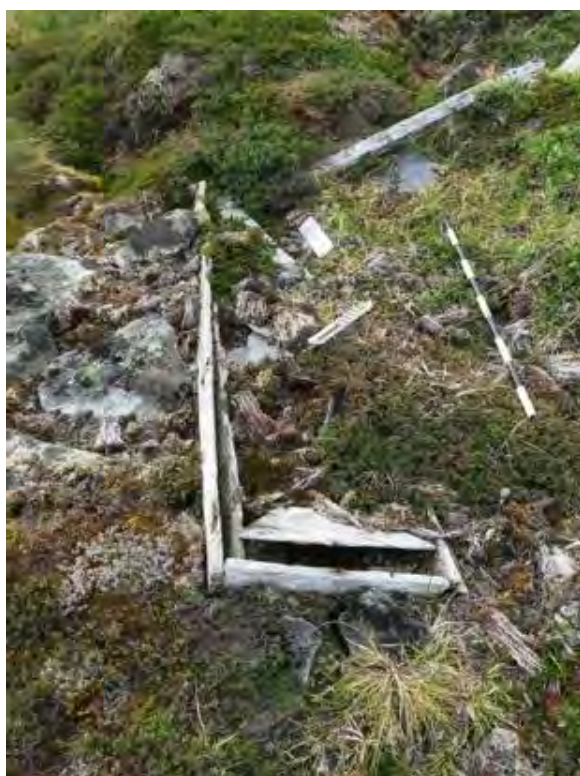
Grave number	<b>AD</b>
Location	N63° 03.585' / W050° 44.281'
Dimensions	2.5 x 1.35m. Height: 0.5 m
Orientation	SE – NW
Photo number	96 - 97 (NKA) 112 (PTO)
State of preservation	Badly
Vegetation	Heavy
General description	Rectangular. Wooden coffin fully visible and collapsed. Big stones are keeping the coffin in place. The southern stonewall is 0.7m wide. Six nails, all machine-made. Cross in NW end of grave

**Fig. 17** Grave AD. The wooden coffin are exposed and demolished. Photo: Peter Toft, 2013

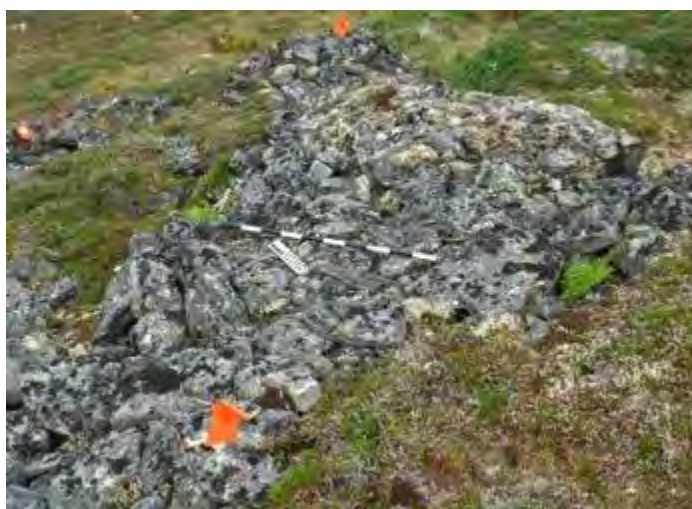
**Fig. 18** A cluster of stone built graves.  
Photo: Pauline Knudsen, 2013

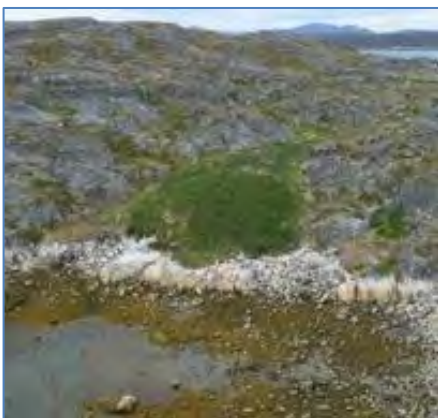
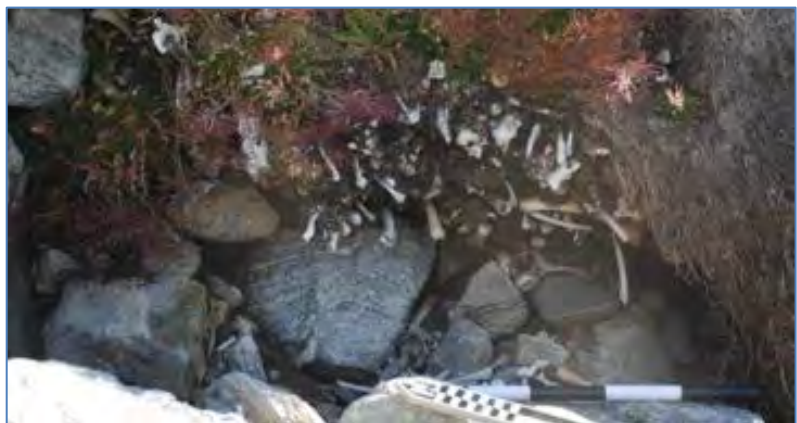
**Qeq16B-F:** A huge kitchen midden is situated at the head of the southern cove. The midden is in an advanced stage of erosion. Plenty of animal bones are visible in the beach zone in the midden profile. The bones are chalky white, light and the surface is peeling of. Wood or metal are not visible. The preservation conditions seems to be equal through the 45m thick eroded profile. Photos: 952 - 959 (PTO).

**Fig. 25** The kitchen midden in Akunnaat is situated in the southern part of the settlement on a slope toward a cove. The sea is eroding the lower part. The bones in the midden by the beach are in an advanced

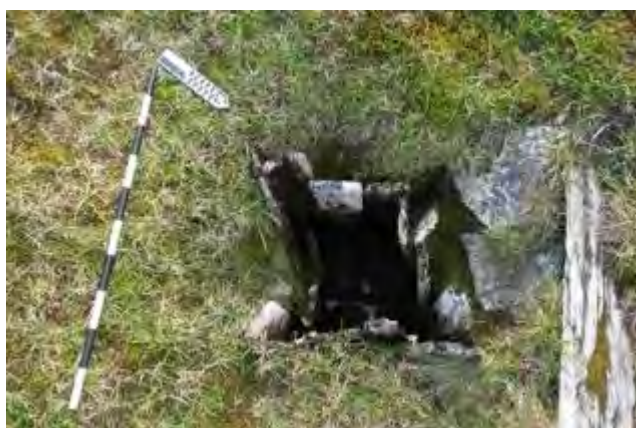
**Qeq16B-O:** Quadrangular well made of 0,17m wide planks. A modern beer bottle can be seen at the bottom of the well. The timber is preserved but has started to decompose. The well has growth of moss. One plank is laying on the ground on the E side of the well. Depth of well: 07m Photos: 329 – 331 (NKA)

**Fig. 26 The well at akunnaat. Photo: Peter Toft 2013**

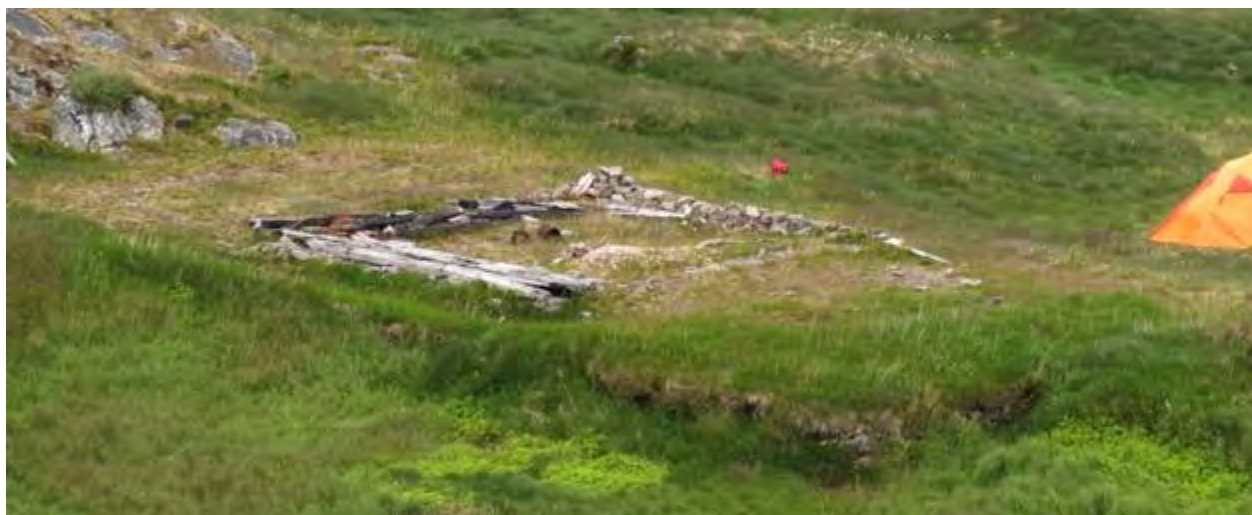
**Qeq16B-R:** Quadrangular foundation built of stones. The foundation has a maximum height of 0,55m and the thickness is 0,65 m. A lot of charcoal is seen inside the ruin, in the southern part. Fragments of yellow bricks are spread out along the southern wall in a 2,5m wide zone. Along the W, N and E walls the remains of ochre red roof construction are to be found. At the center of the ruin two parts of a heating stove can be seen. Both have the inscription: J. S. Hess & søn, Middelfart”. More fragments of the heating stove are found in the NW corner, together with a jerry can. The ruin is the remains of the burned down church building. Parts of the burnt roof is situated 4m NW of the ruin. The foundation continues 6,9m towards N. Probably the church building was earlier rectangular and has later been shortened, as on the northern side of the partition nothing is to be found. Along the E wall two hearths have been established with stones and bricks from the church. By the SE corner of the ruin is a sign made of plywood put together with Phillips screws. The inside of the ruin is overgrown with grasses and moss is growing on the foundation. The wood is well preserved, but iron parts have corroded.

Fig. 27 The foundation of the former church building. Photo : Pauline Knudsen, 2013.
