# PEOPLE OF ALL TIMES

## FIELD REPORT

## **Field report for the pilot project “People of All Times”**

*Submitted January, 2014*

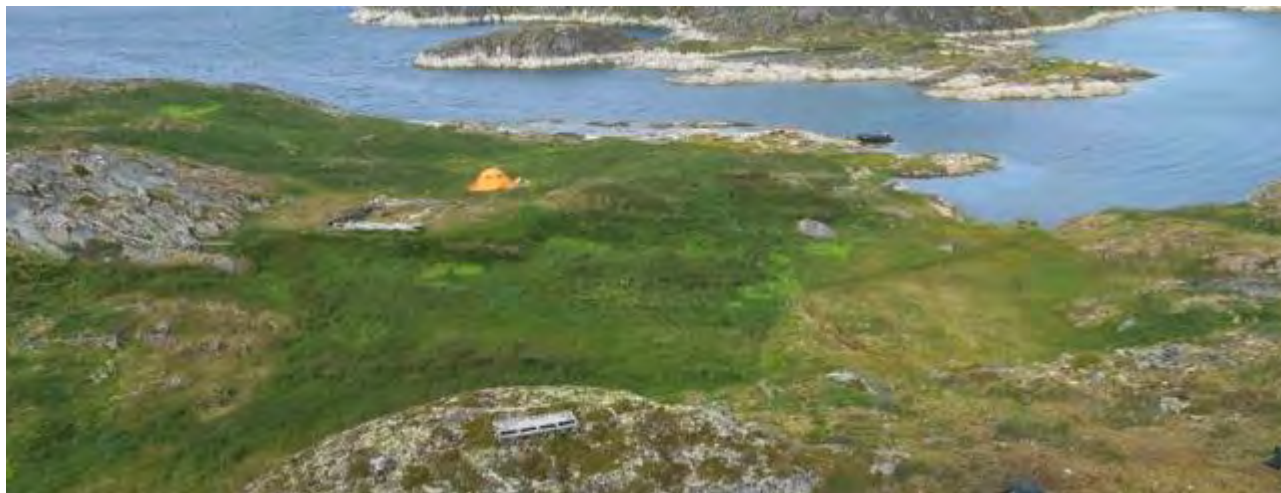
**QEQ16B – T:** A triangular area with three drainage ditches. Probably it is a garden area.

**Fig. 28** The area S and AW of the church foundation makes the two garden areas. The triangular area S of the church has a green to yellowish colour, several ditches are barely visible. Between this and the darker green garden area W of the church foundation a path connects the hilly area to the SW with the central settlement area. Photo: Pauline Knudsen, 2013.

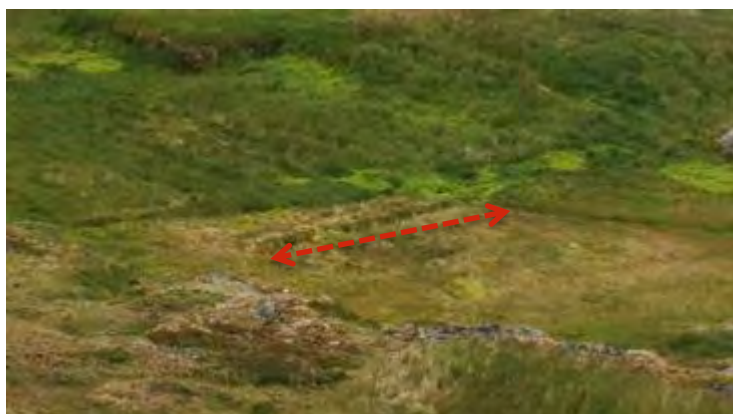
**Fig. 29** A path connects the the hilly area to the SW with the central settlement area. Photo: Pauline Knudsen, 2013

**QEQ16B – U:** Pathway edged with a row of stones on each side. Heavily overgrown with grasses, willows and moss.

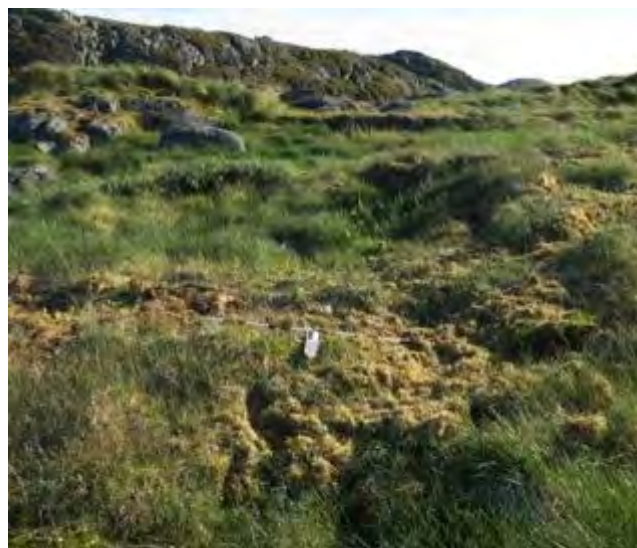
**EQ16B – AE:** Large rectangular winter house built of stones. Entrance to E. Behind the W wall is a storeroom. Stones have fallen of the wall at several places. The walls are preserved up to 0.3m. The structure is overgrown with grasses. This house was by a mistake not mapped with G-GPS Photos: 430 – 432 (NKA)

**Fig. 31** Ruin of winter house AE. Photo: Peter Toft, 2013

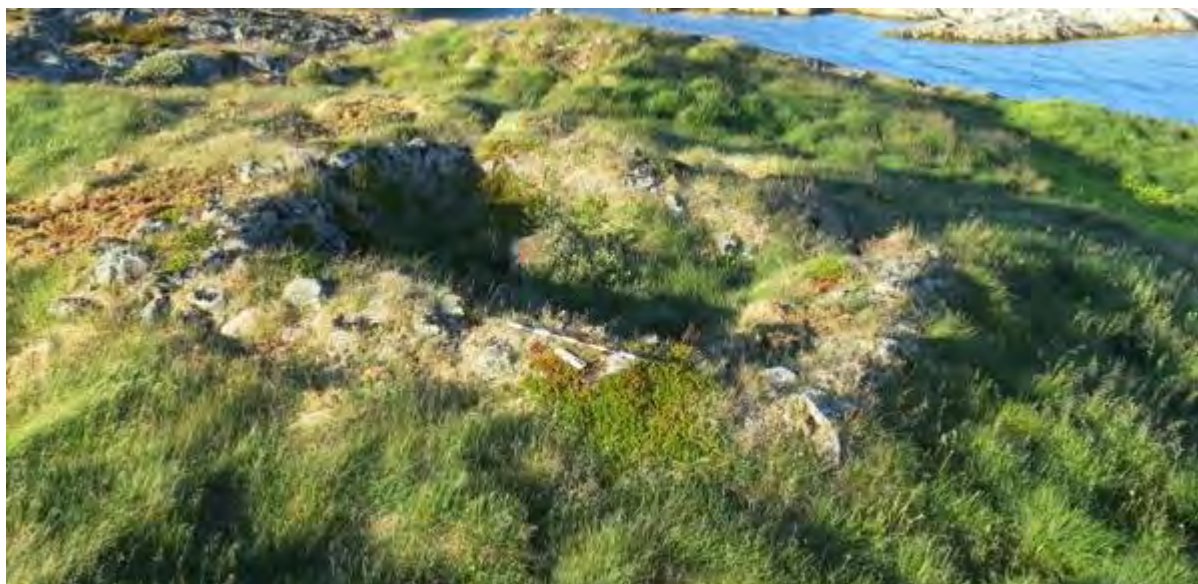
**QEQ16B – AP:** Rectangular winter house with a house passage to E. A storeroom is built into the passage. By the southern wall on the inside may stones have fallen out. Walls preserved up to 0.77m. Inside the structure is a corroded iron stove. The structure is overgrown with grasses and heather. Except from the S wall the structure is well preserved. Photos: 463 – 468 (NKA)

Fig. 34 House ruin AP. Photo: P. Toft, 2013

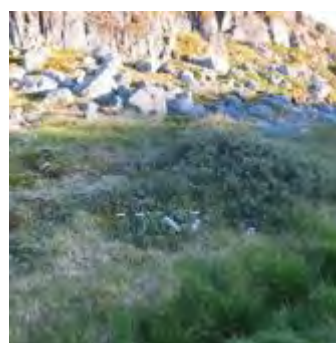
**QEQ16B – AQ:** Oval structure built of stones. NE – SV oriented. The W wall is best preserved. The walls are up to 0.72m in high. Overgrown with grasses, willow and heather. Photos: 469 – 470 (NKA)

Fig. 35 structure AQ. Photo: Pauline Knudsen, 2013.

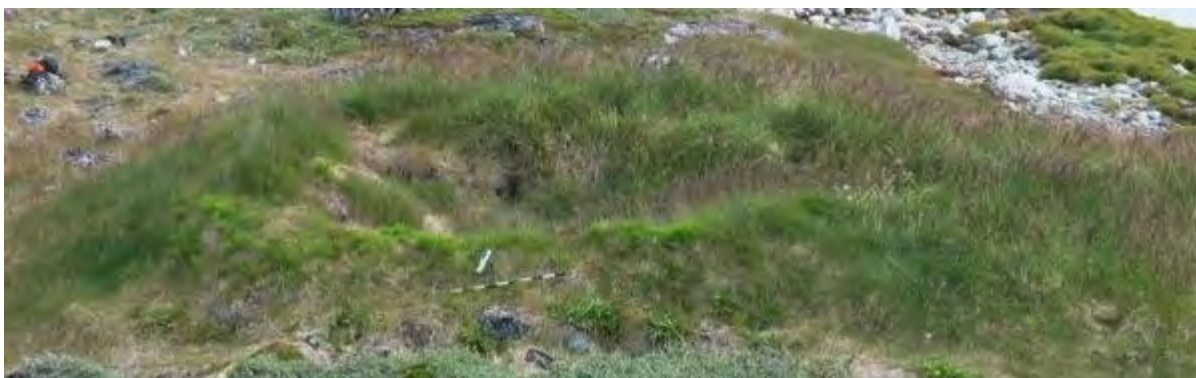
**Fig. 39** Winter house ruin at Akunnaat area C. It is most probably belong to a member of the Moravian congregation. The trapezoid form of the dwelling is a special feature of this congregation. Photo: Pernille Ødegaard, 2013.

**Qeq16C-D:** Trapezoid, turf built ruin of a winter house. N side of the structure is widest. On the S side the entrance has an approximately 3m long house passage. The structure is situated E of a small lake and is overgrown with grasses. The headland where is house is situated is being eroded. The house is only one meter and a half from the beach to the NW and SW.

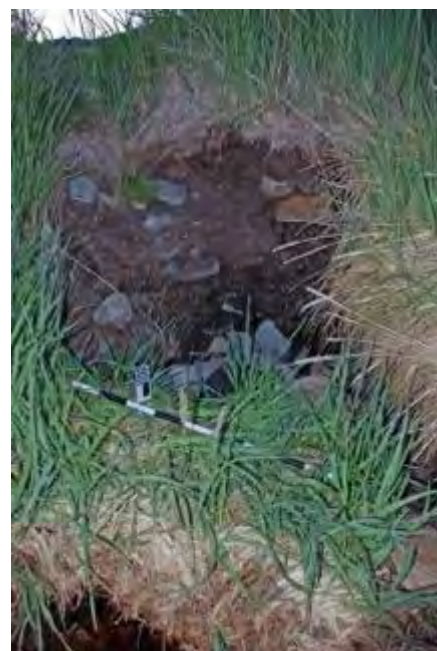
**Qeq17-A:** A turf built, rectangular, communal house. The house with an entrance to the W has a partition. The wall on the west side is being eroded. The SW corner of the house is badly eroded. At that part very decomposed wood, slabs of stone and white, light and porous animal bones. A small storeroom is placed at the S wall of the house. The house is threatened but mainly well-preserved. The walls are preserved up to 0,85m. The structure is overgrown with grasses and lyme grass.

**Fig. 43** Midden below house A, eroded by the sea. Photo: P. Toft, 2013

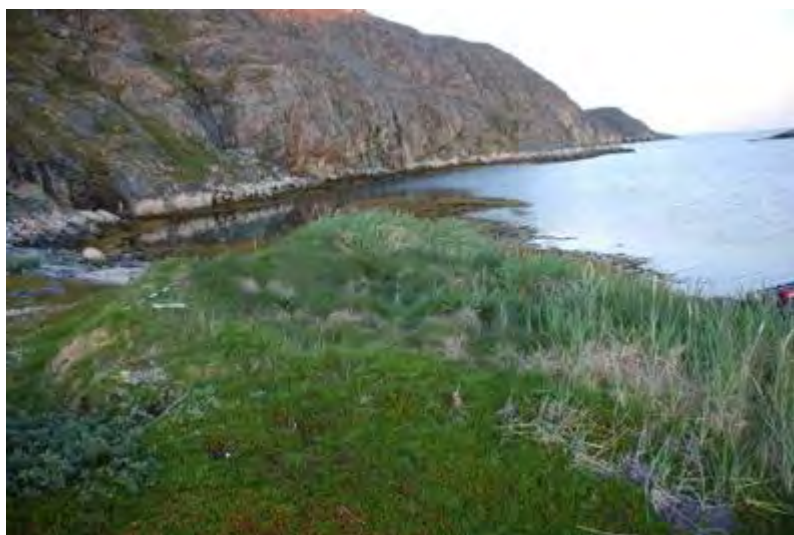
**Fig. 44** Communal house A seen from east. Photo: P. Toft 2013

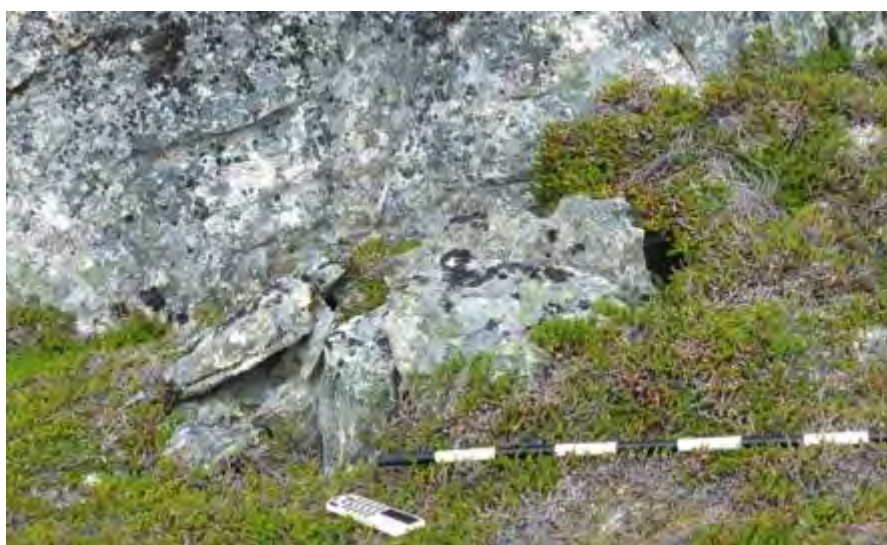
Grave number	<b>18A-A</b>
Location	N63°05.575' / W050°58.682'
Dimensions	2.32 x 0.81m. Height: 0.54m
Orientation	NW - SE
Photo number	276 – 277 (NKA)
State of preservation	The grave is disturbed and the bones are decomposing
Vegetation	Most of the grave is heavily overgrown with heather. Only the stones in the ends are visible.
General description	Grave is built of stones into the bedrock. Just E of the settlement high up in the landscape. Inside the chamber some bones are visible. From the grave the view toward the sea and the archipelago to the NW are excellent.

**Fig. 49** Grave above the settlement of Itersarmiut area A. The three graves almost at the top of the hill seems older than the grave that are situated further down the hill. Photo: Pauline Knudsen, 2013.

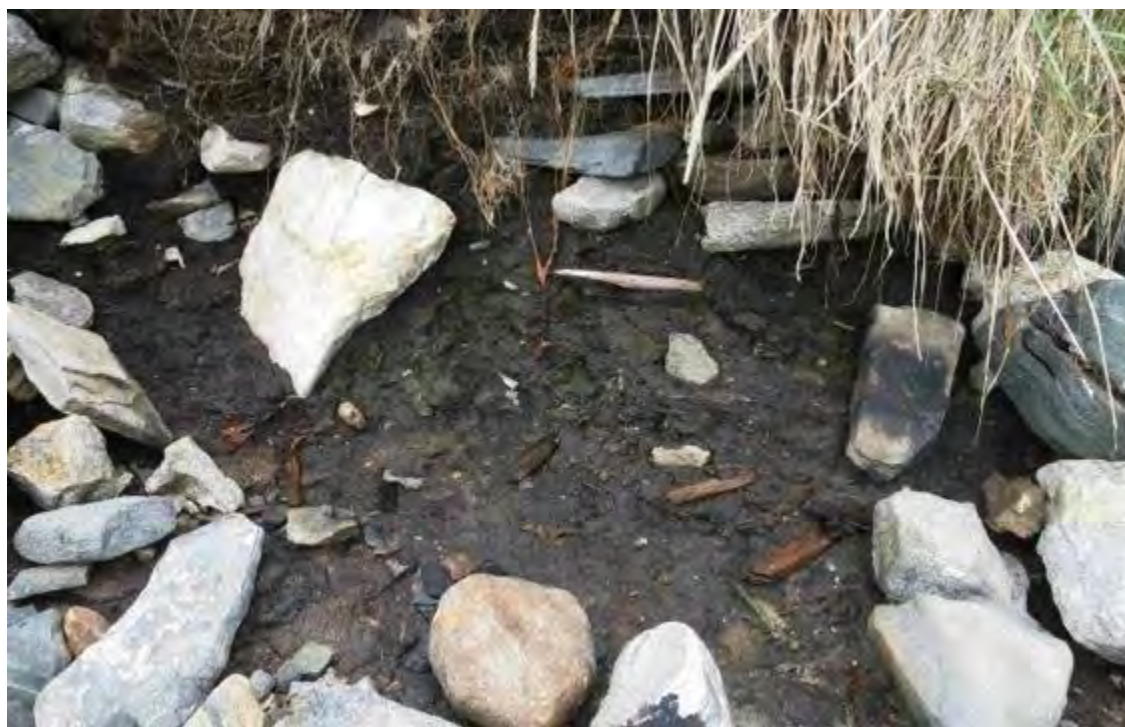
Fig. 53 Part of the eroded profile below structures L and M . notice the pieces of wood and bones. The photographe areas cover approximately 1 x 1,5 m. Photo: Pauline Knudsen, 2013

**Structure M:** Four sided winter house built of turf. The two entrances are on the S side of the house. Benches along W and N wall are partly eroded. East of the entrances is a cooking niche. Walls are preserved up to 0.63m. A lamp support stone is in the eastern part of the living room. The house is situated next to a slope leading to the cove. The house is overgrown with heather and grasses. The kitchen midden is situated W of the house and is overgrown with lyme grass. The midden that is eroded by the sea has a high content of seal bones and other animal bones. Some wood can also be seen. The surface of the wood has decomposed, but the heartwood seems to be well preserved.

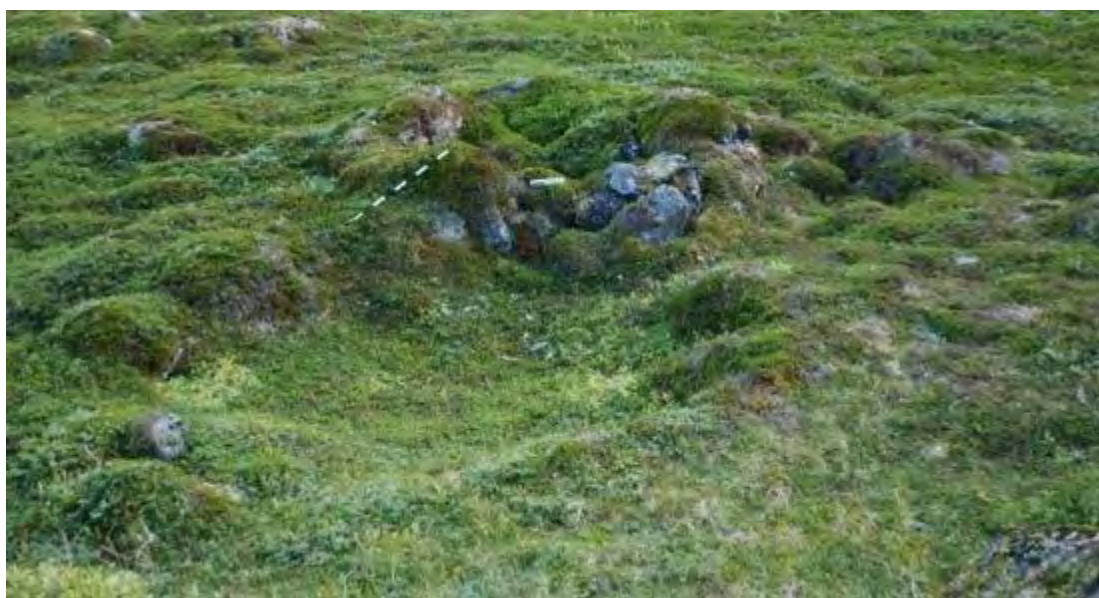
**Structure O:** Round winter house structure. The house has a storeroom in the front, which have its own entrance.

**Fig. 54** Round winter house (O) with a niche in the front wall and entrance passage to the right.

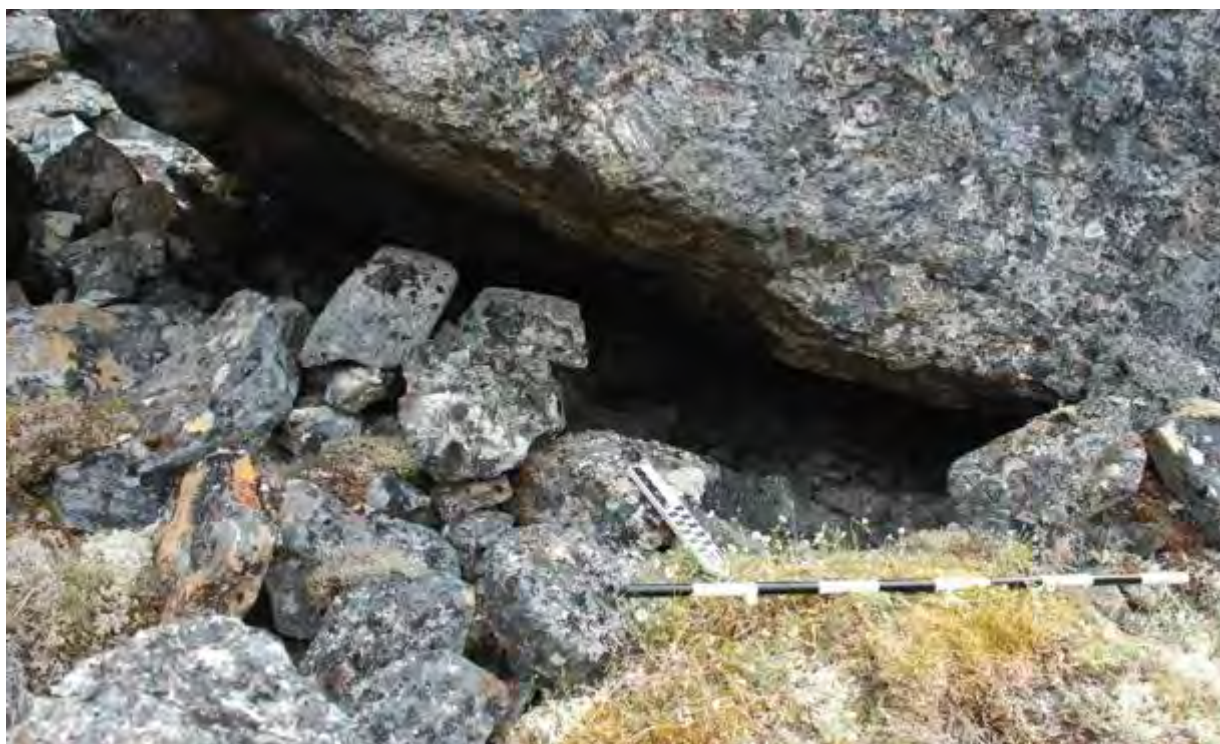
3 more but smaller storerooms. Two on the western side 1.3 x 2.6m and 2.1 x 1.7m). In front of those there is a low wall, which is overgrown with willow, heather and grass. The cache on the southern side got the measures: 2.1 x 1.3m. In this cache well-preserved seal bone can be found  
Location: N63°05.758' / W050°58.397'

**Fig. 58** One of the caches blow a boulder that has a complex of caches. Photo: Peter Toft, 2013.

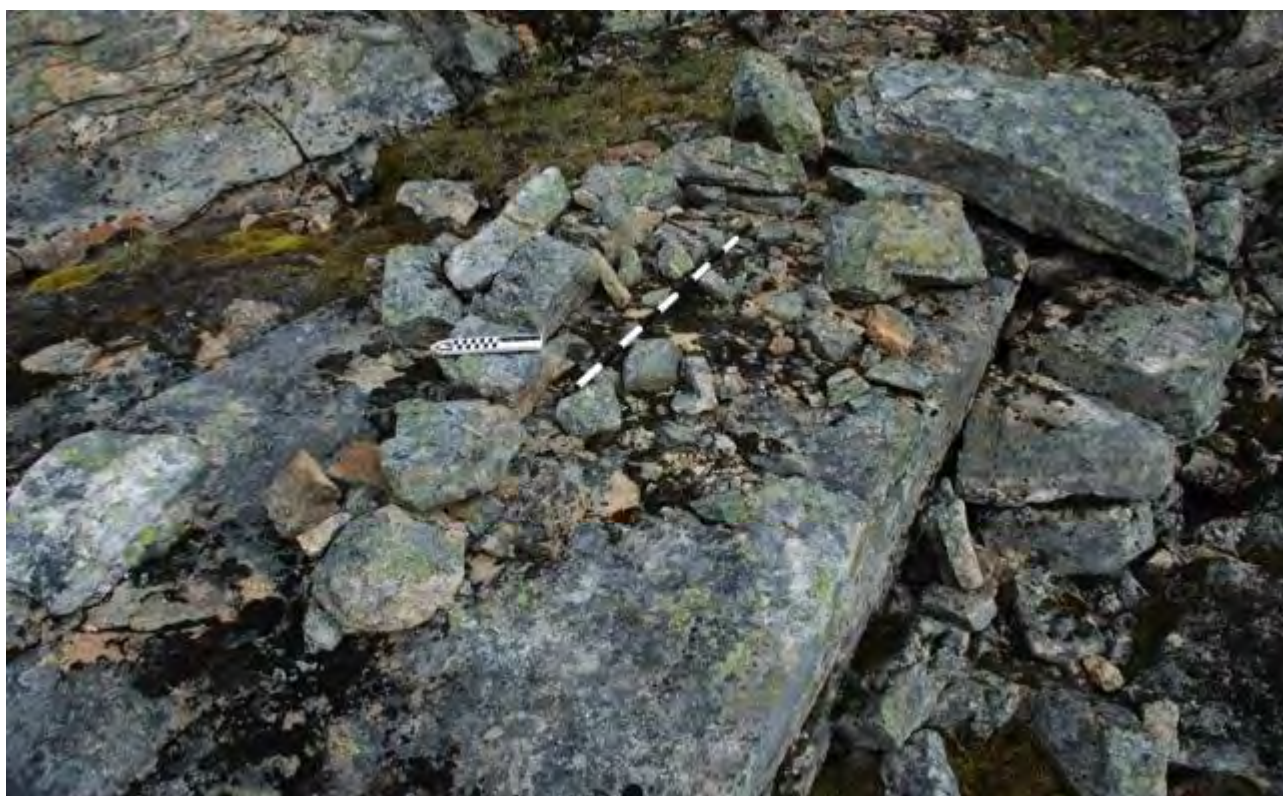
Fig. 59 Demolished fox trap at Itersarmiut site B. Photo: Peter Toft, 2013.

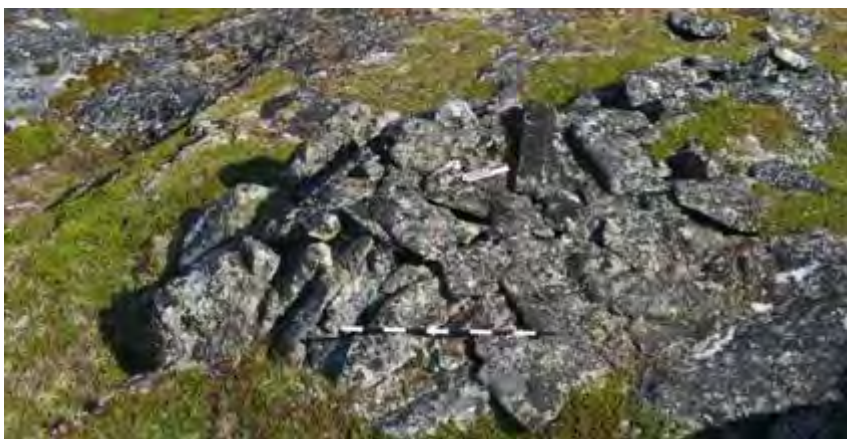
**Fig. 64** Grave E. The antechamber is situated behind the grave to the right. Photo: Pauline Knudsen, 2013.

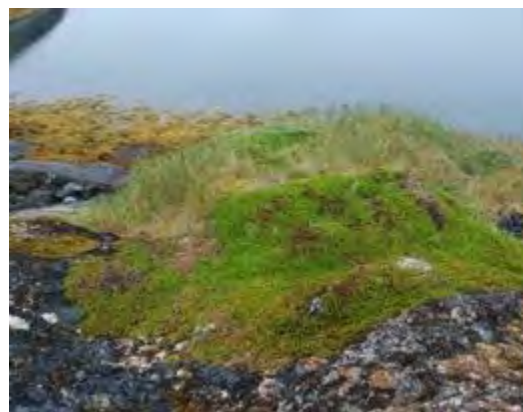
**Qeq20F:** Turf and stone built tent foundation. Barely discernable in the vegetation. The structure is situated 40 cm S of C. Overgrown with heather and grasses. The SE wall is being eroded.

**Fig. 66** Photo of tent foundation F. At high tide the sea is reaching the structure. Photo Pauline Knudsen, 2013

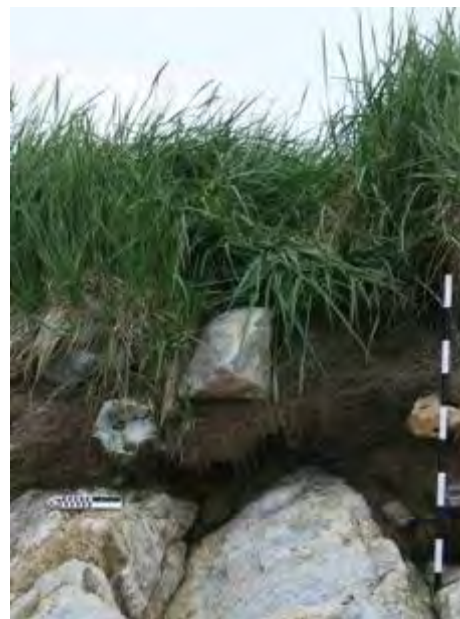
Fig. 71 Part of the erode profile to SW. Below the stone to the left a skull from a hooded seal is visible. Photo: Peter Toft 2013

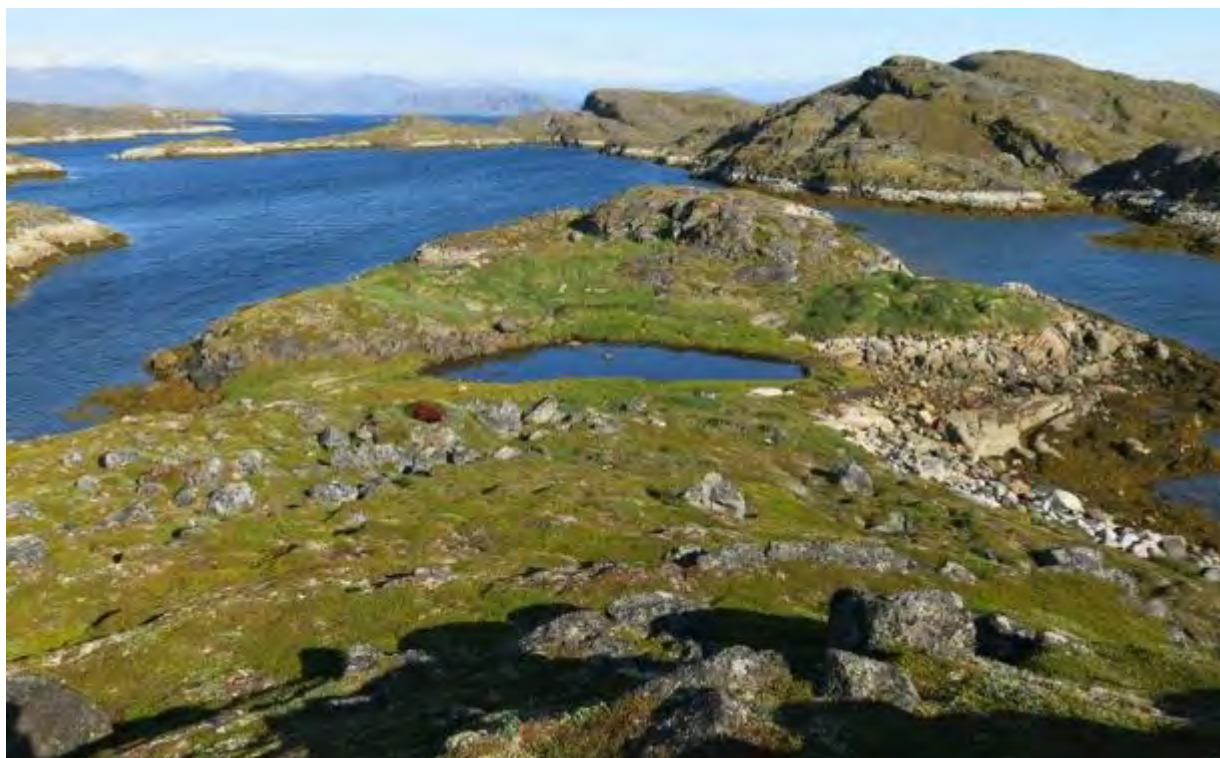
Fig. 72 Overview of the site of Natersuarmiut. Photo: Pauline Knudsen, 201.

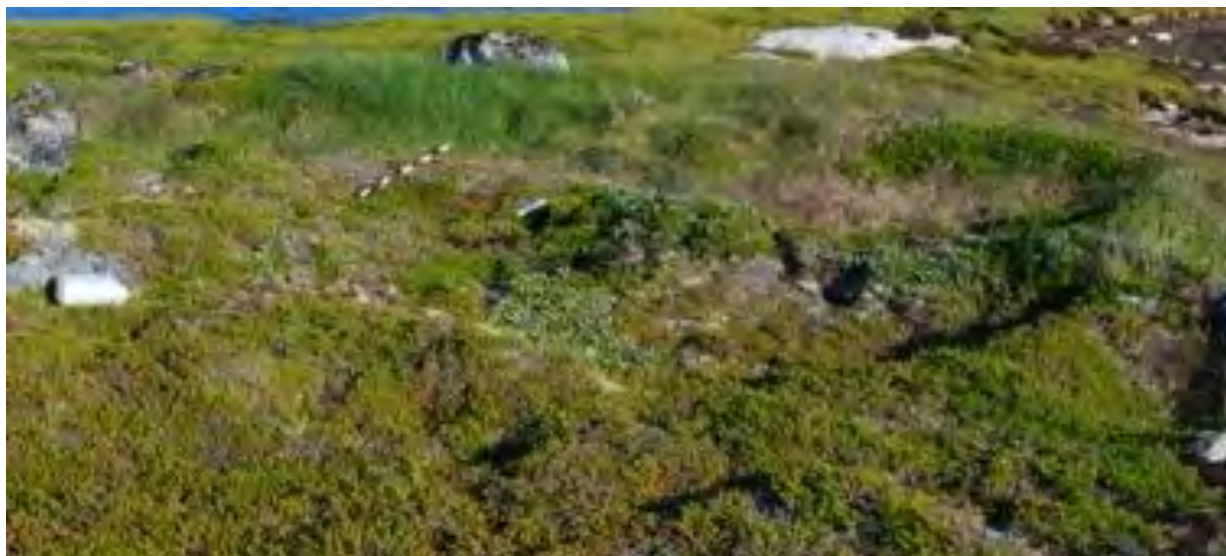
**Fig. 74** Two tent foundation at Natersuarmit. Photo: Pernille Ødegaard, 2013.

**Qeq22D + E:** Two horseshoe shaped tent foundations. The two structures share the wall between them. Structure E has a cooking niche to the SW in the entrance.

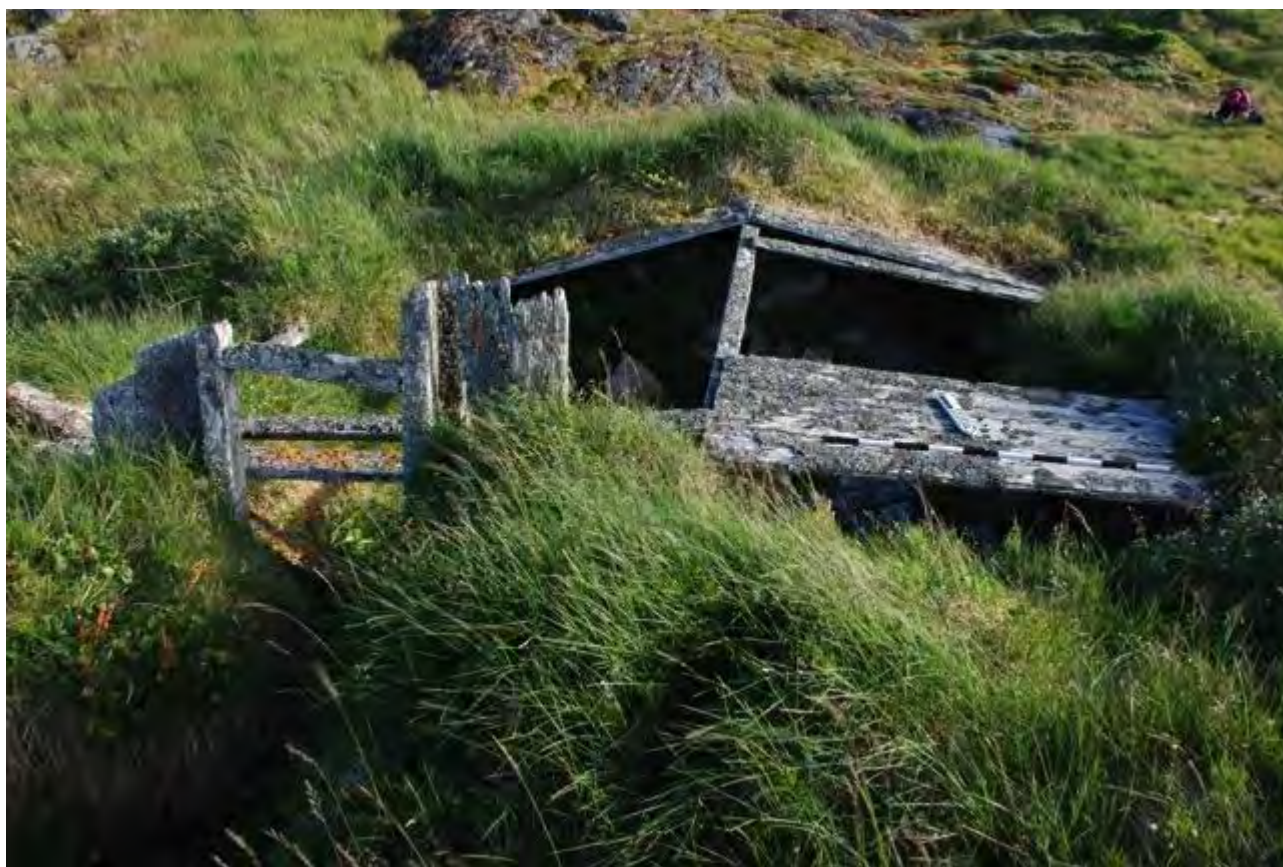
**Fig. 75** Wooden cabin, probably built inside the ruin of a communal winter house. Photo: Peter Toft, 2013.

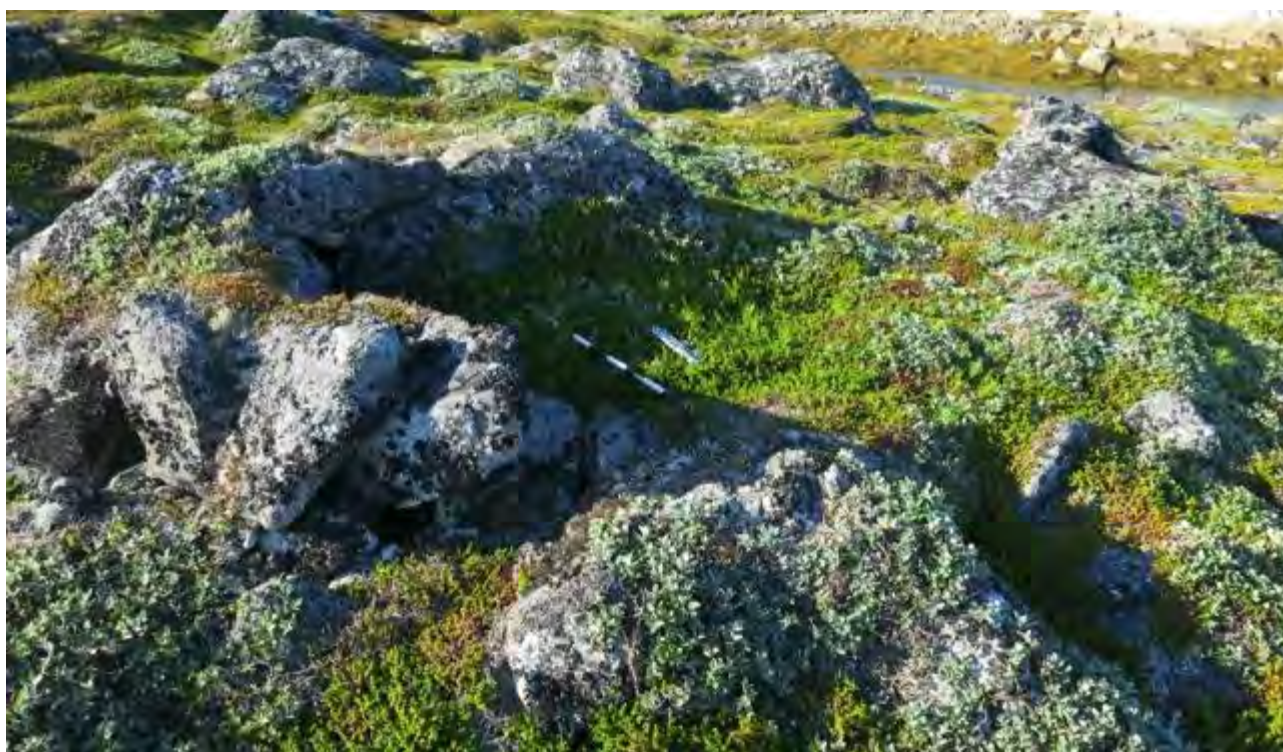
**Fig. 76** A storeroom or cache at Natersuarmiut. Photo: Peter Toft, 2013.

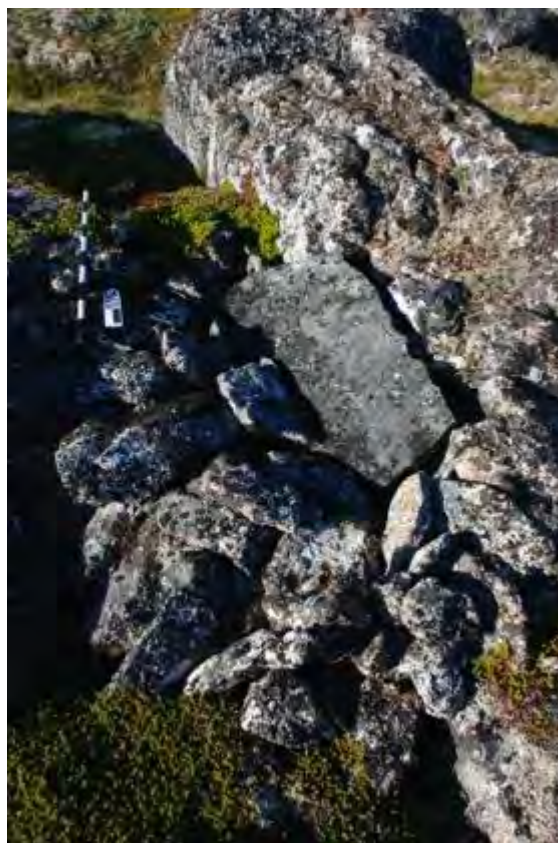
**Fig. 77** Grave O at Natersuarmiut. Photo: Peter Toft, 2013.

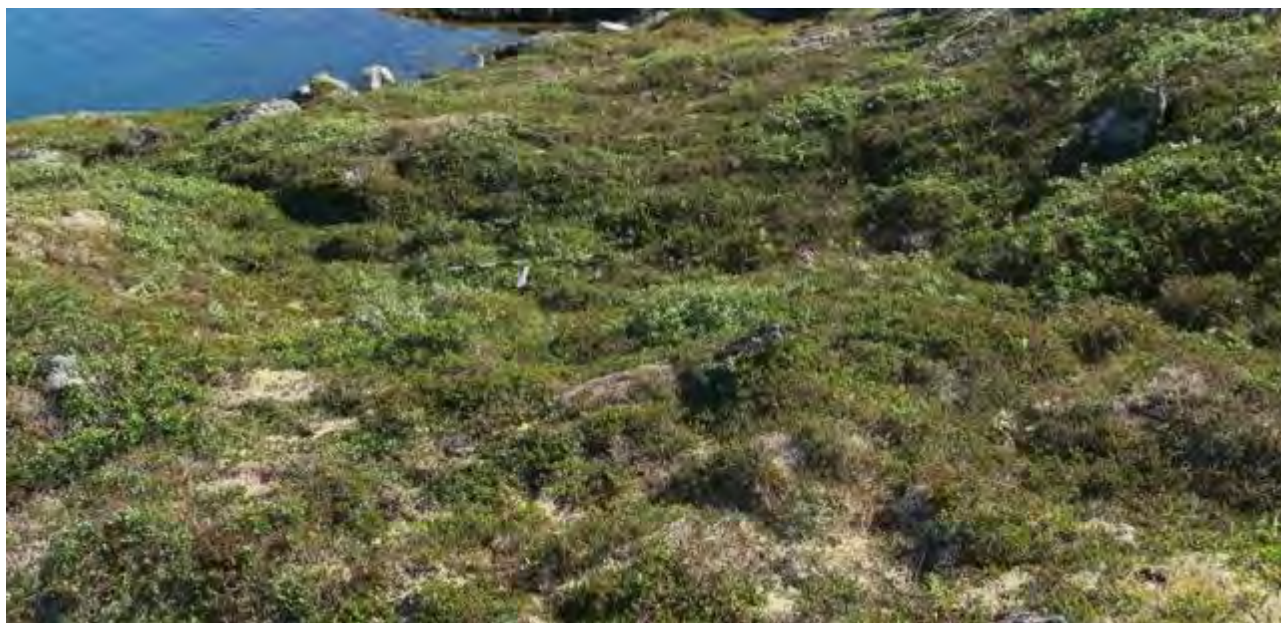
**Fig. 78** A barely visible winter house ruin. The entrance passage is visible at the upper left part. The measuring stick is placed at the centre of the houseroom. Photo: Pauline Knudsen, 2013.

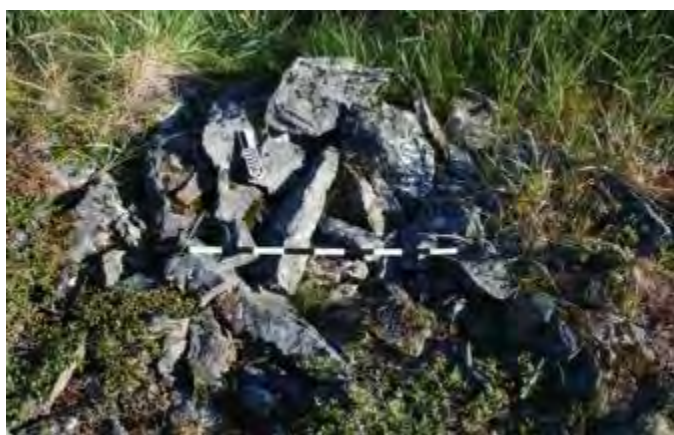
Fig. 79 Meat cache at Qasertoq. Photo: Peter Toft, 2013

**Qeq 23F:** Meat cache

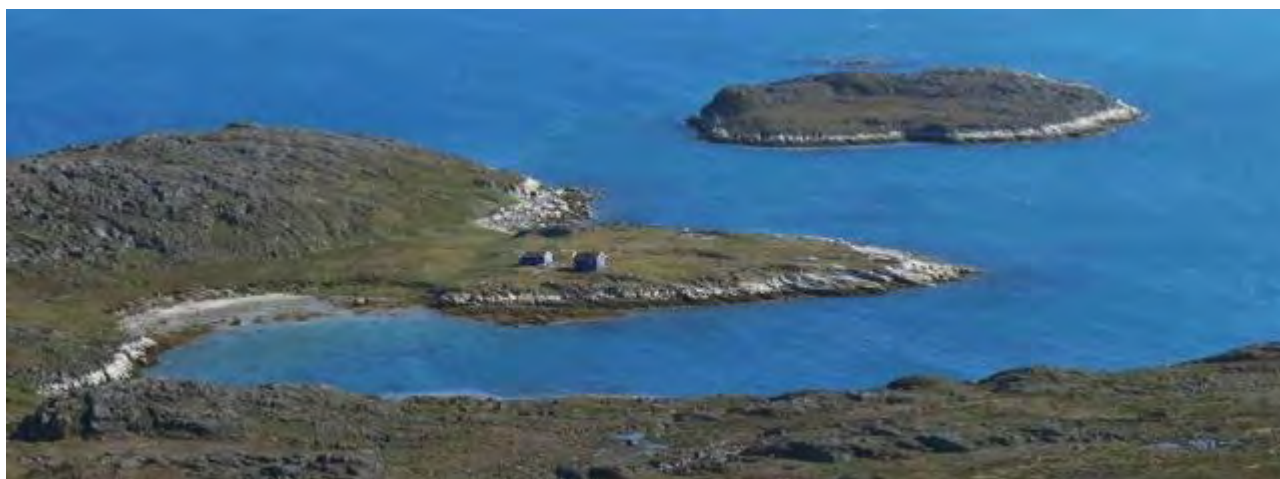
**Fig. 80** Overview of Kangillermiut. The newer part of the settlement is on the plain area where the two cabins are situated. The older part with Inuit style winter houses is further out on the headland. Photo: Pauline Knudsen, 2013.

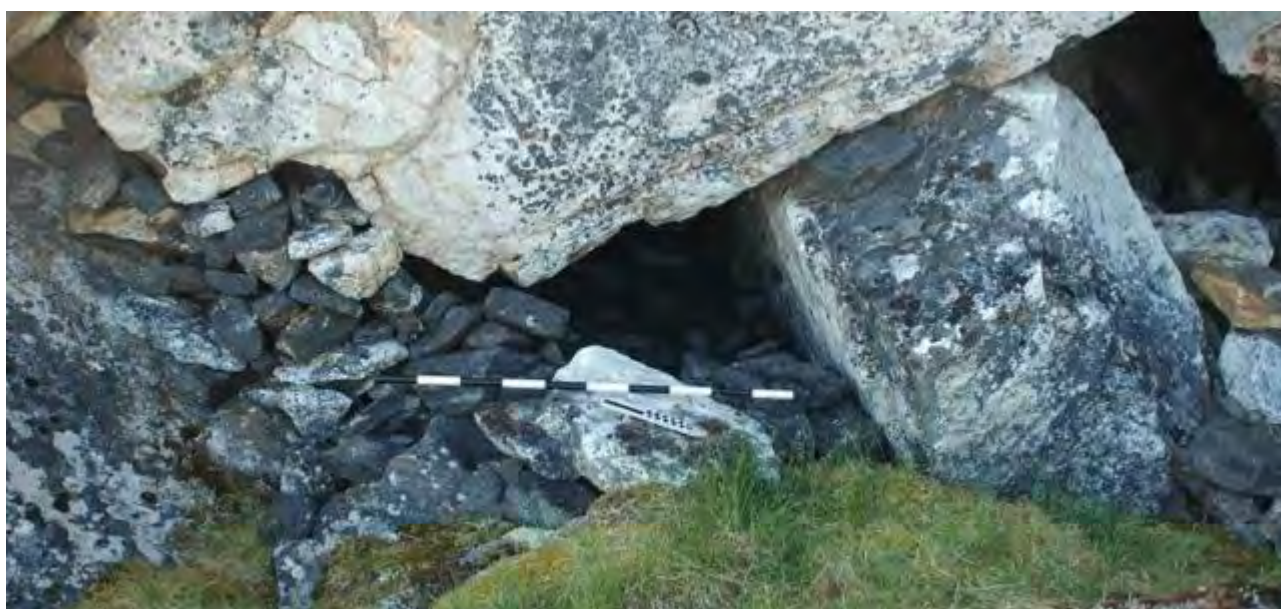
Fig. 82 Shelter and cache under a rock in the eastern part of Kangillermiut. Photo: Peter Toft, 2013.

**Qeq 24 F:** Cache consisting of a room made upon a boulder under a rock overhang. The cache is made of piled up stones. A small passage leads into the chamber.

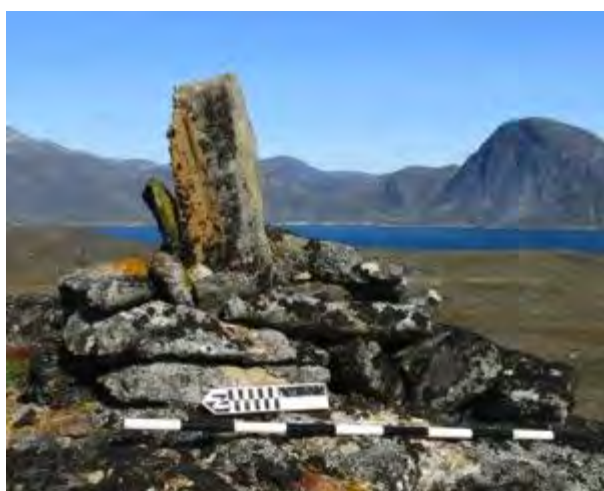
**Fig. 83** Cairn probably marking the seasonal campsite East of Kangillermiut. Photo: Pauline Knudsen, 2013

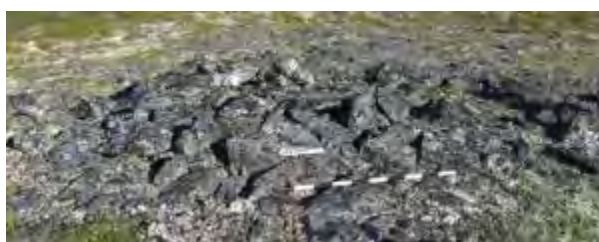
**Fig. 84** Grave P situated east of Kangillermiut. Photo: Pauline Knudsen, 2013

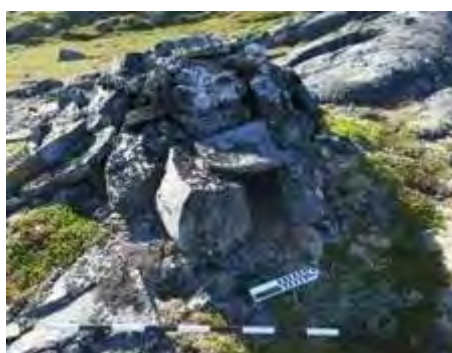
**Fig. 85** Fox trap east of Kangillermiut. Photo: Pauline Knudsen, 2013

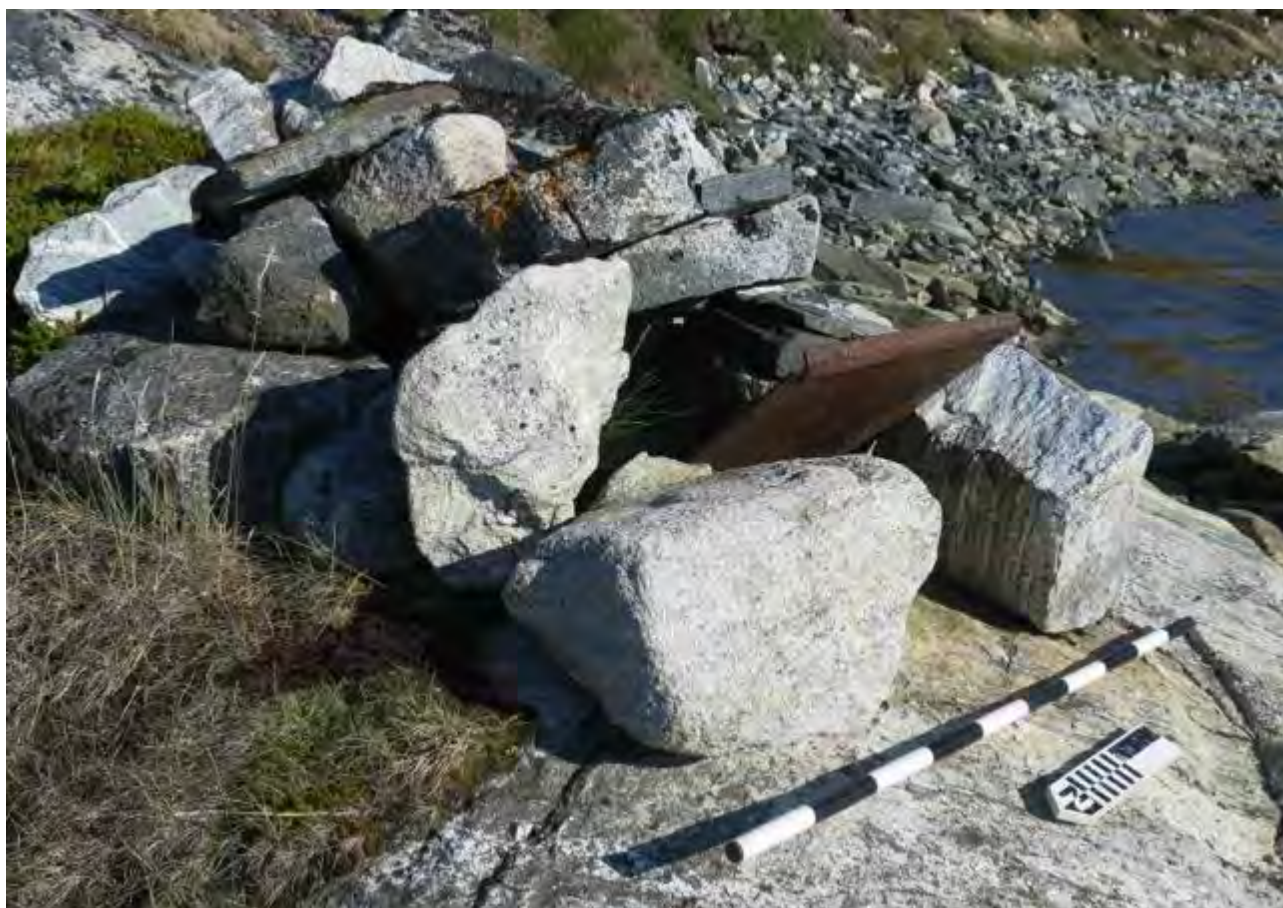
**Qeq24V:** Fox trap. A piece of iron sheet has been used as trapdoor.

Fig. 86 Fox trap with an iron sheet used as trap door. Photo: Pauline Knudsen, 2013

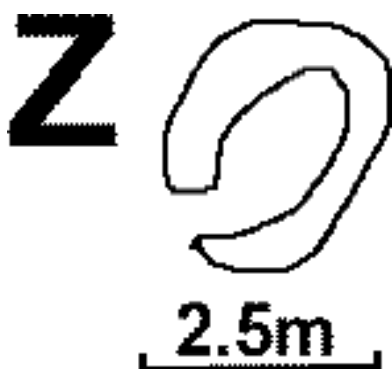
**Qeq24Z:** U shaped stone built tent foundation. Entrance to W. Overgrown with heather. The walls are preserved up to 0.47m

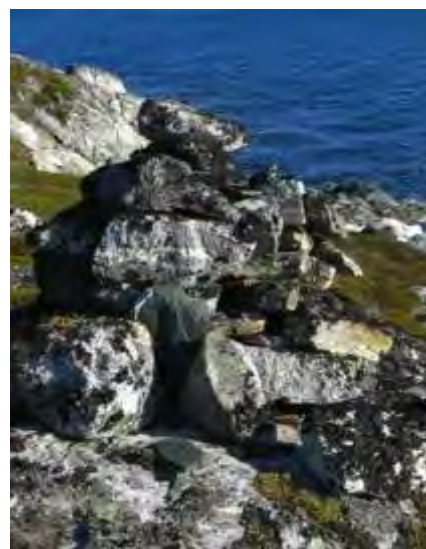
**Fig. 87** Cairn.  
Photo: Pauline Knudsen, 2013.

**Qeq24Y:** Cairn. Photo: 525 (NKA)

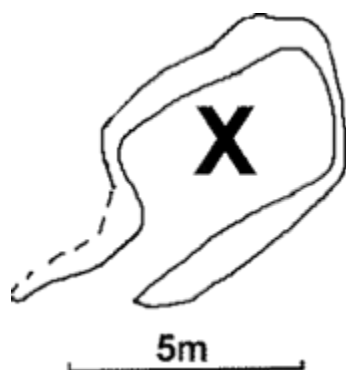
**Qeq24X:** Four sided turf built winter house with entrance and house passage on SW side. The house have several niches: In the NW corner, at the middle of each of the E and W walls. The structure is heavily overgrown with grasses. Pieces of turf from the wall have fallen into the interior of the structure. The walls are preserved up to 0.55m  
Photos: 526 – 528 (NKA)

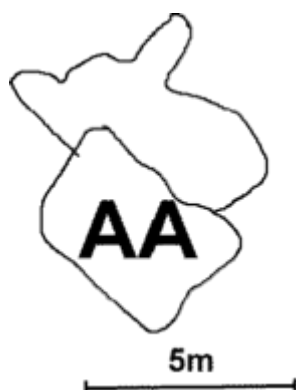
**Qeq24AA:** A quadrangular structure. Walls on the S and N side are built of stones and turf. The inside of the W corner of the wall is cast in cement. Probably the structure is the remains of the isolating wall and cement foundation of a wooden house. Pieces of timer are visible in the heavily vegetated interior of the structure. The vegetation consists of grasses, willow and heather. The walls are preserved up to 0,8m.

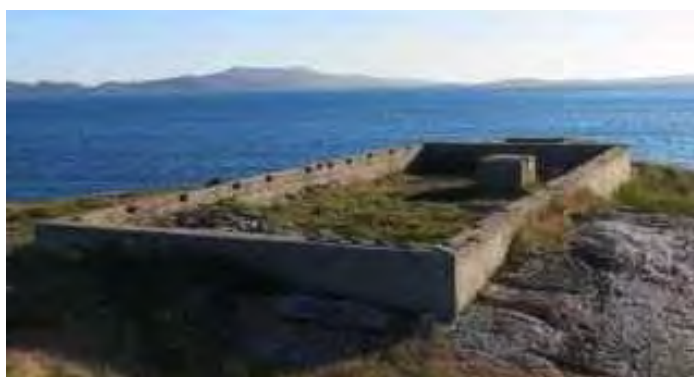
**Qeq24AC:** Rectangular concrete foundation with a quadrangular room on the N side with stone steps on the W side. Iron reinforcements have corroded and the concrete has cracks. Inside the foundation there is a rectangular concrete block. Graffiti are scratched in and painted several places. Measurements approx.: 5 x 10 m. Height of foundation: 0.4m and thickness: 0.24m.

**Fig. 88** Cement foundation of the largest building at Kangillermiut. Photo: Pauline Knudsen, 2013

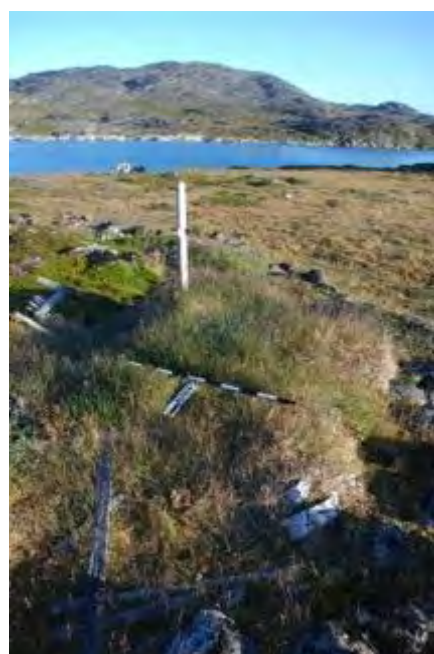
**Fig. 89** Part of the churchyard dike is visible at this photo by: Peter Toft, 2013.

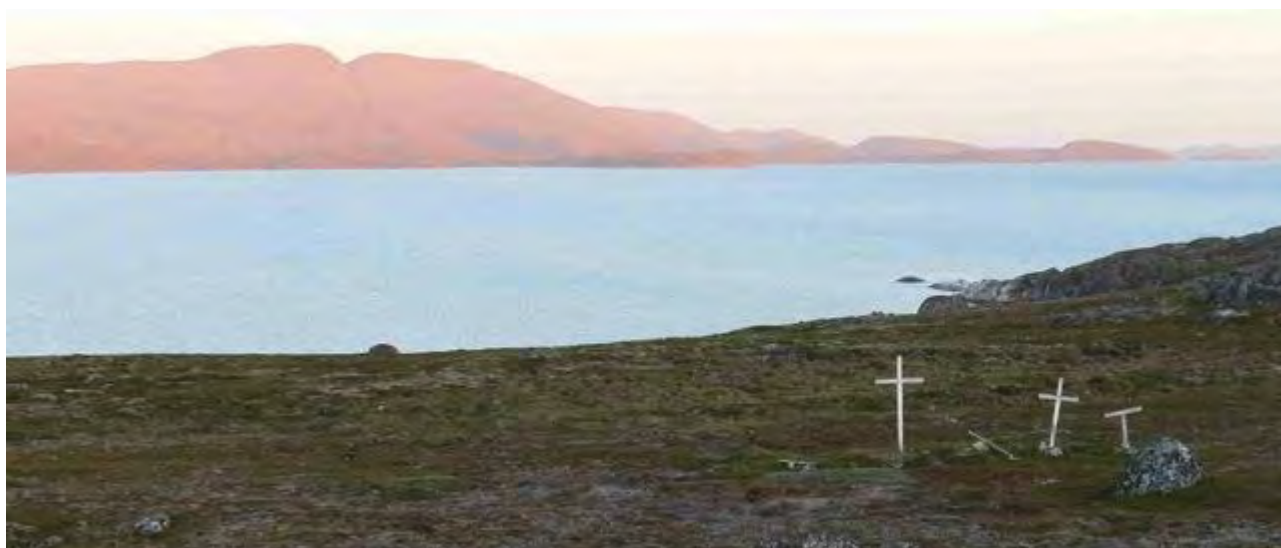
**Fig. 90** The new graveyard at Kangillermiut is situated behind the hill to the southeast. Photo: Pauline Knudsen, 2013

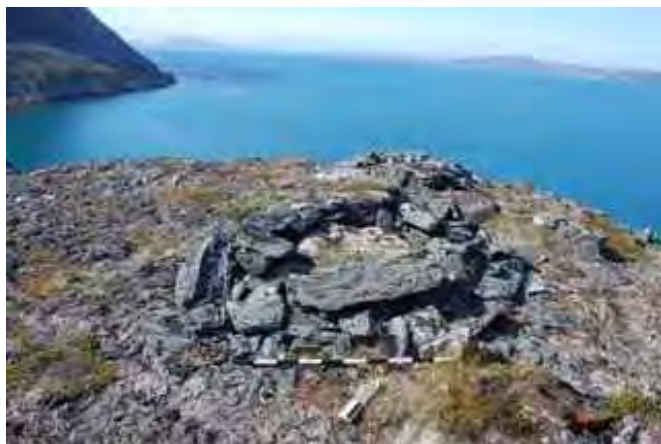
**Fig. 92** One of the graves at Miagguup Alanngua.  
Photo: Peter Toft, 2013

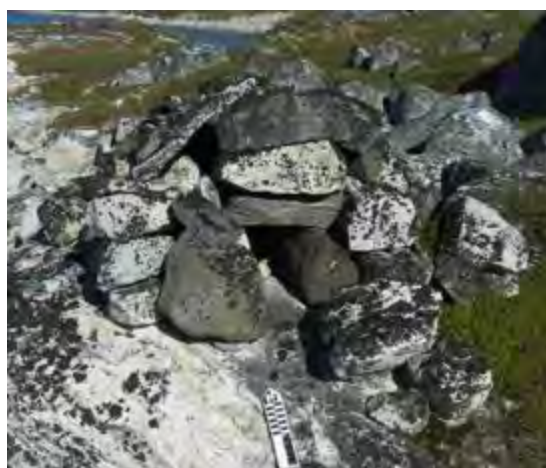
**Fig. 93** Another grave at Miagguup Alanngua.  
Photo: Peter Toft, 2013

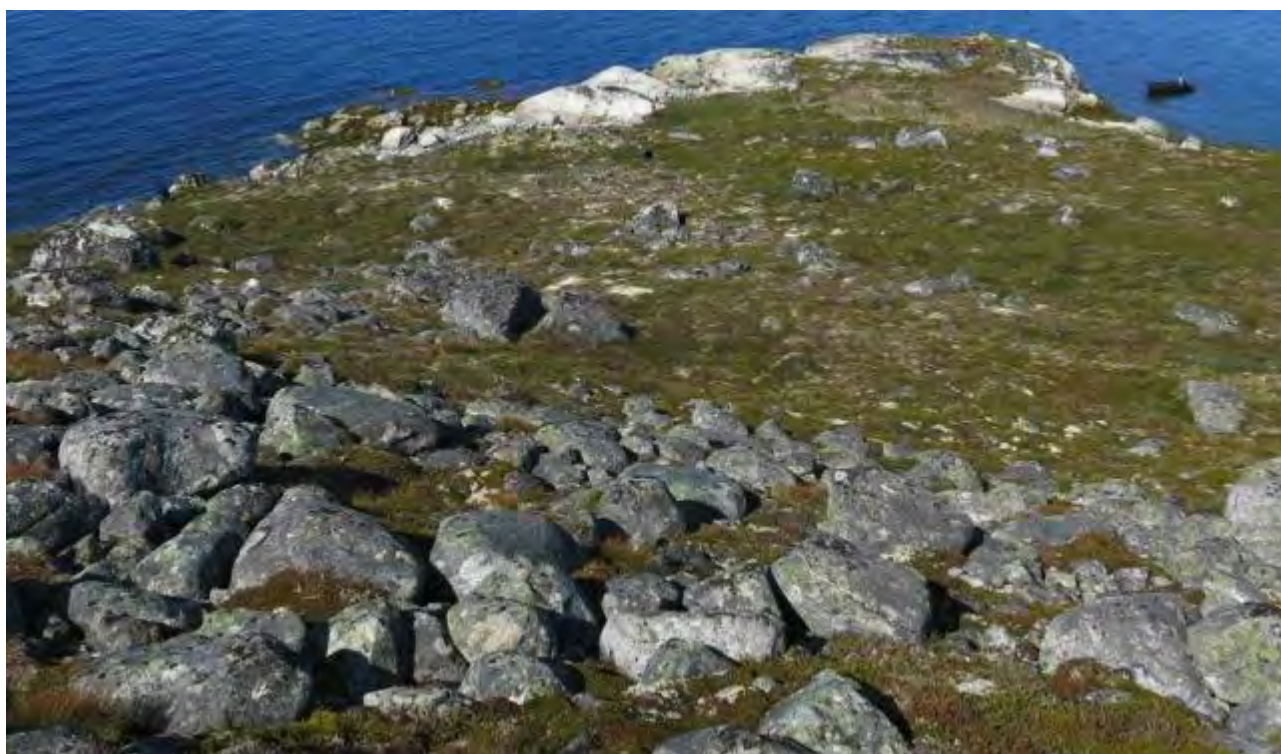
**Fig. 94** The small headland with four tent foundations. Photo: Pauline Knudsen, 2013.
