# PEOPLE OF ALL TIMES

## FIELD REPORT

## **Field report for the pilot project “People of All Times”**

*Submitted January, 2014*

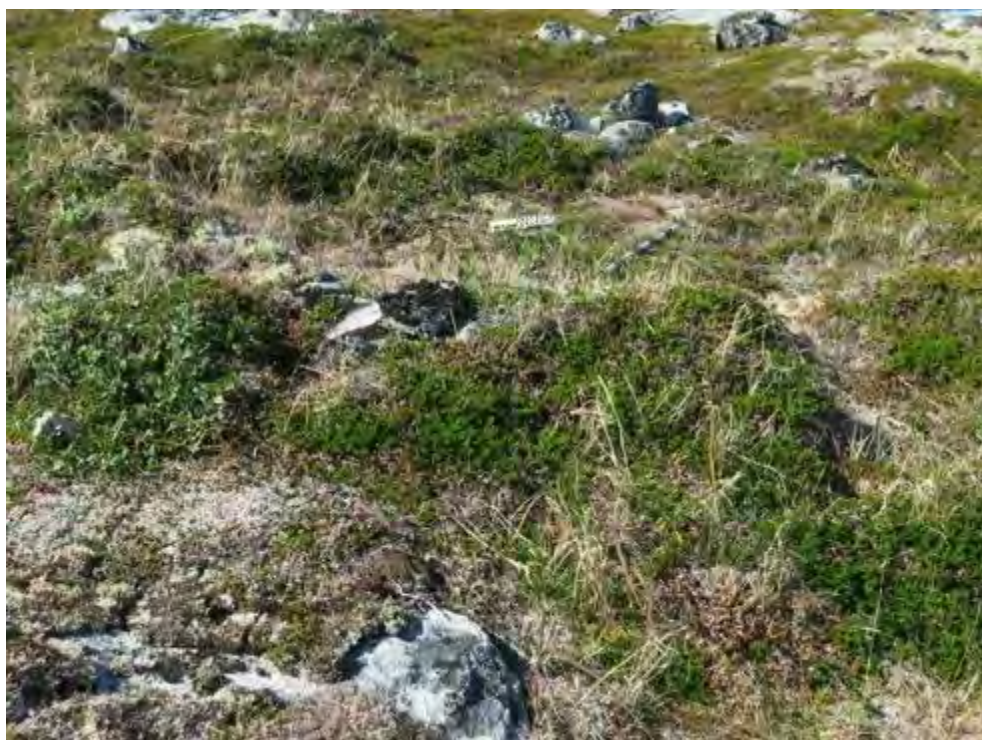
**Fig. 95** Part of tent foundation at Miagguup Alanngua. Photo: Pernille Ødegaard, 2013.

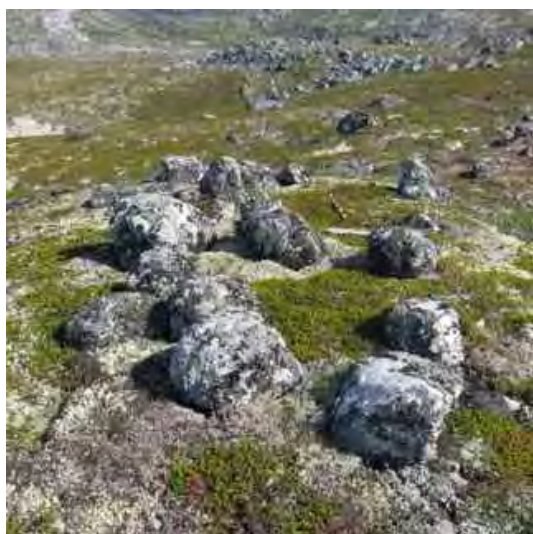
**Fig. 96** Structure above campsite interpreted as a play umiaq structure. Photo: Pernille Ødegaard, 2013

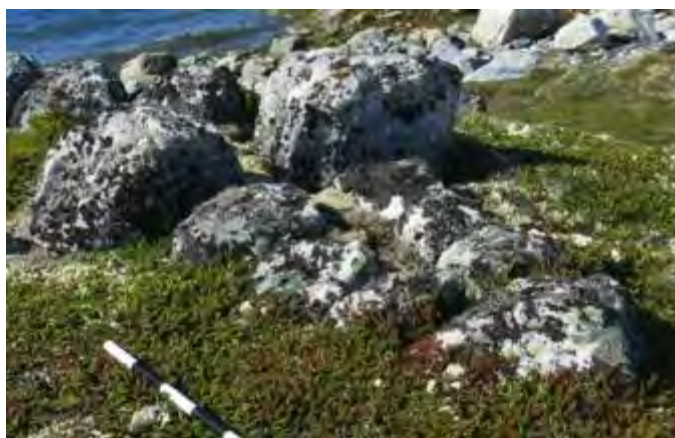
**Fig. 97** Detail of umiaq structure. Photo: Pernille Ødegaard, 2013

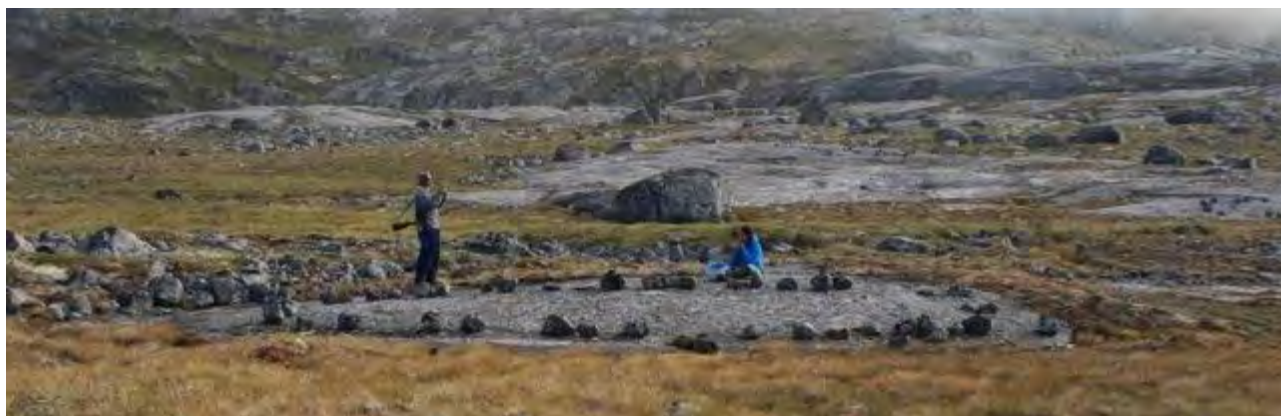
**Fig. 98** Meat drying structure above the campsite at Miagguup Alanngua. The site was unfortunately not described and mapped. Photo: Peter Toft, 2013

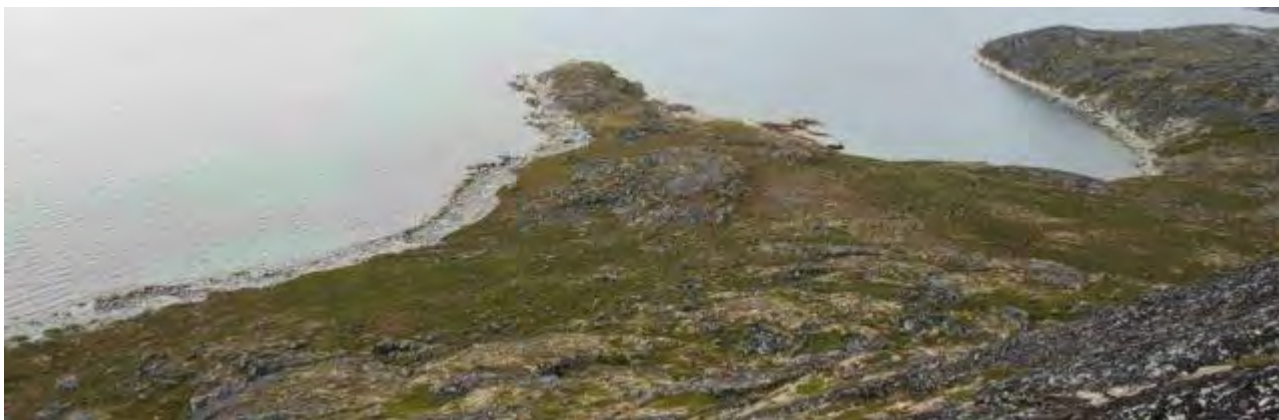
Fig. 99 The Aasiviit site seen from outside the “shamans cave”. Photo: Peter Toft, 2013.

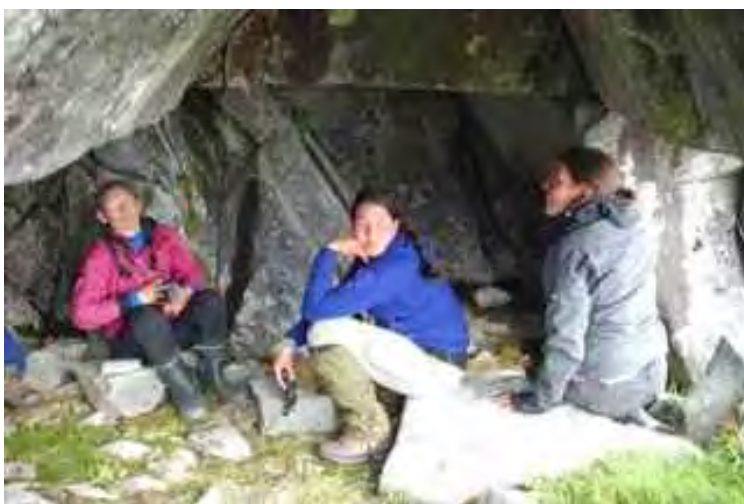
**Qeq26A:** Cave situated high up in the mountain behind Aasiviit. According to HHB “a shamans rubbing stone” that used to be inside the cave have been pushed out for years back. Money, soft drink bottles and a lighter were found inside the cave.

Fig. 100 Inside the shamans cave. Photo: Peter Toft, 2013

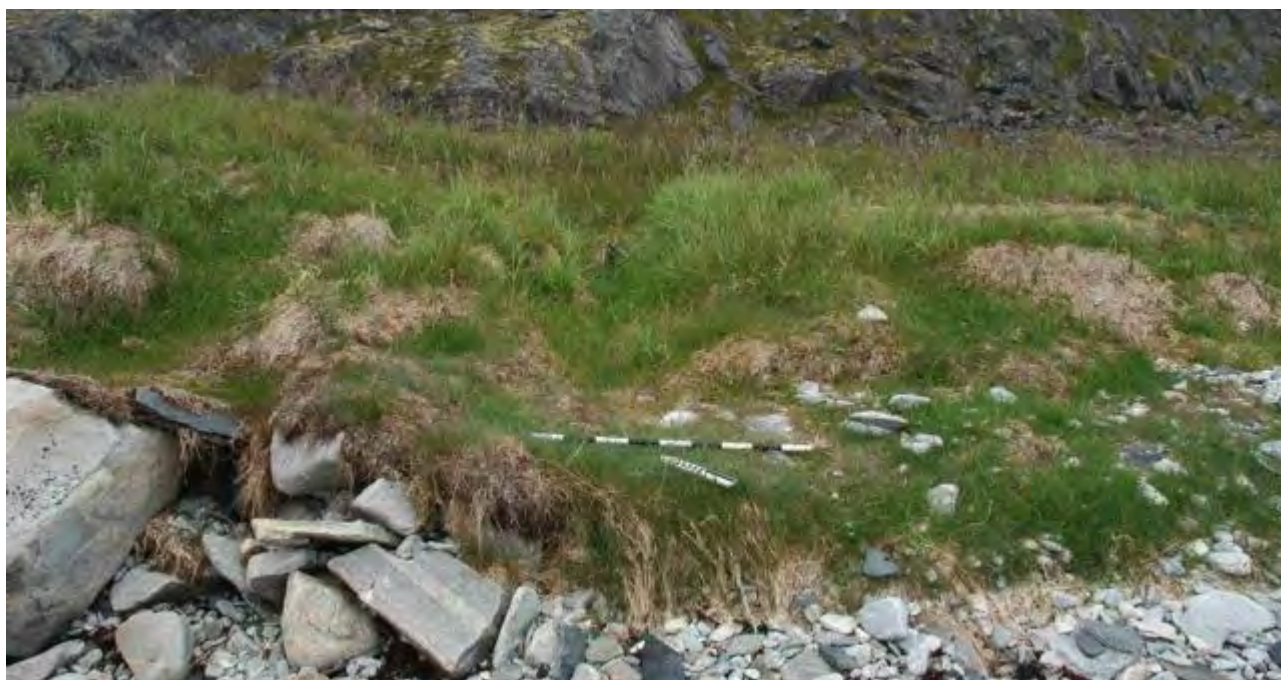
**Qeq26B:** Big communal house immediately by the beach south of the Shamans shelter. The house is E – W oriented and the entrance or entrances are on the east side of the house.

Fig. 101 The communal house ruin at Aasiviit. Photo: Pauline Knudsen, 2013.
