Trucks and Equipment at Ikkatteq Greenland US

Army Air Base

Blue East Two

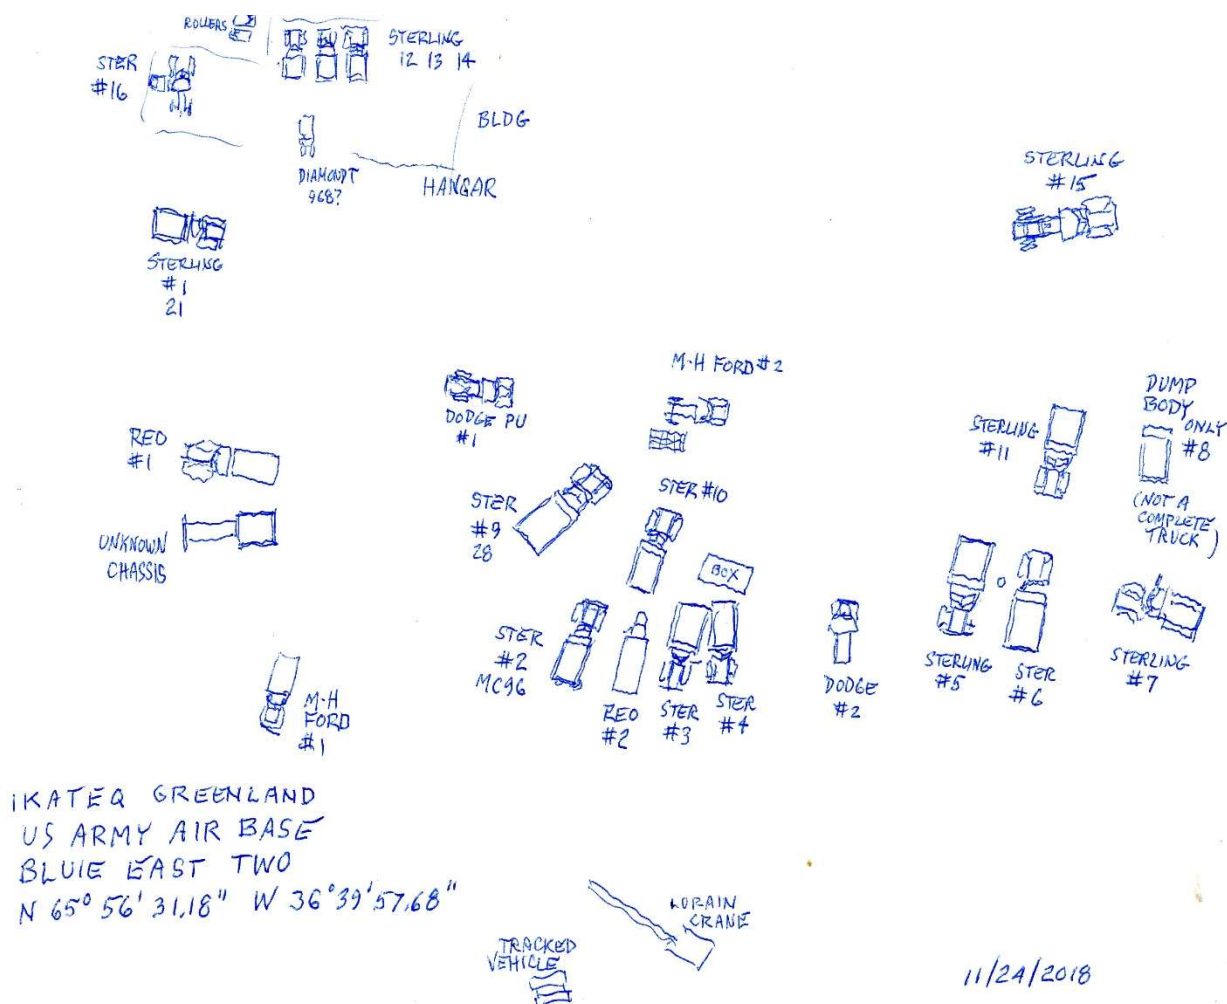
In the above illustration the general position of the various trucks and equipment have been crudely represented. No attempt was made to position the trucks in scale but instead it was my goal to position the trucks and equipment in a general cluster oriented to each other to some degree.

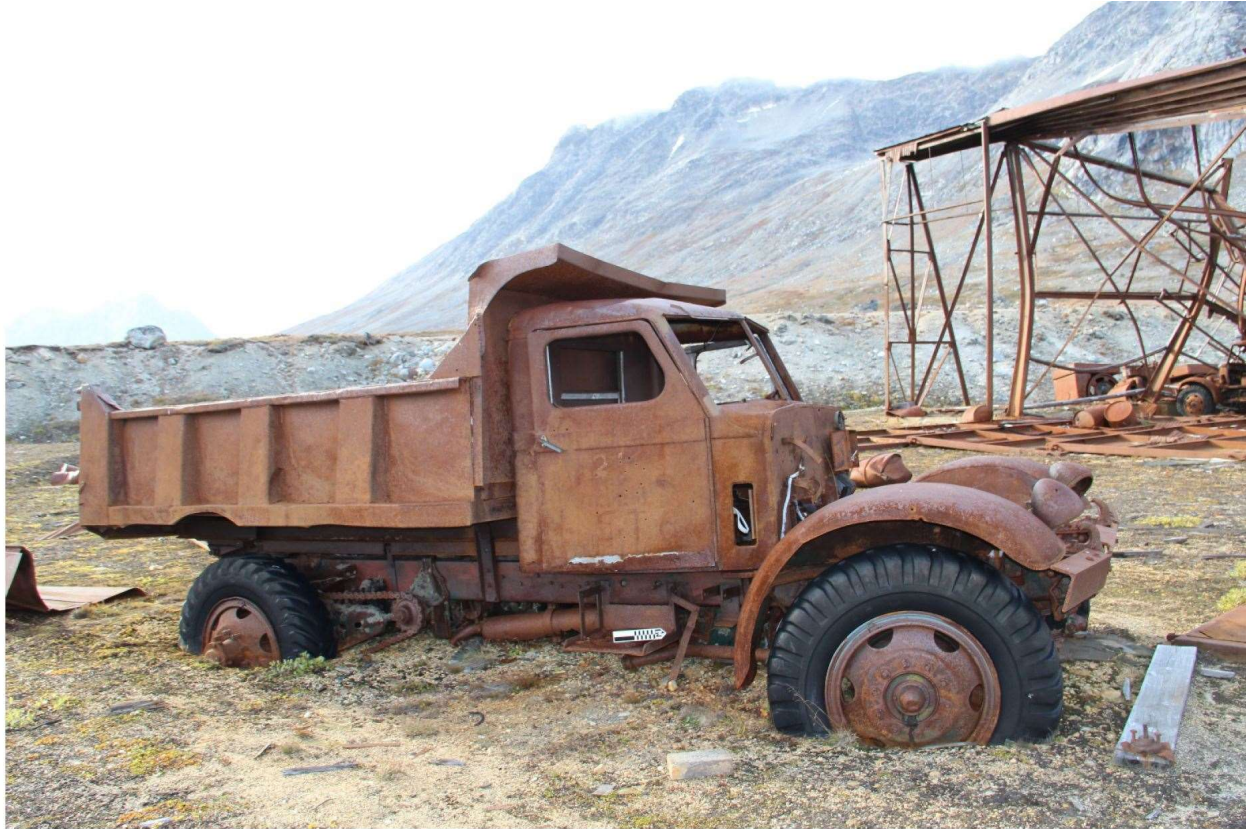
This truck is #1 from my earlier numbering and is perhaps the most complete of the Sterlings represented. The rear suspension with the cast vee radius rod (this positions the rear axle and has an adjustment nut at the forward end to control the position of the rear axle relative to the jackshaft so that the chain tension of the chain drive may be adjusted). By the early 1940s only a few Sterling truck models used this cast Vee radius rod: The HC145, the HC147, the HC156 and the HC165. Also the larger HC200 and HC250 used a similar arrangement. The HC147 and HC165 used underslung rear springs so that they had no visible springs or spring hangers above the bottom of the truck's chassis frame rail. You can clearly see the helper spring and forward spring pad in this photo which rules out the HC147 and HC165. The HC156 was made in a very small quantity and generally were supplied with Dayton cast spoke wheels unlike the Budd type of steel wheels shown in the photo above. The HC145 was rated at 36,000 lbs. gross weight capacity which is towards the upper end of capacity for a single axle truck even today. Sterling built about 500 or so HC145 models from 1939 to 1946. Serial numbers proceeded from 145HC601 in 1939, 145HC662 up in 1940, 145HC6147 up in 1941, 145HC6298 up in 1942, 145HC6506 up in 1945. The highest known s/n was 145HC6517 built in May, 1946. Known s/n's built for George A Fuller, Merritt, Chapman & Scott (builders of US Army Air Bases in WWII) were: 145HC6149 A3673 (3/1941), 145HC6167 A3793 (3/1941), 145HC6404 (A number unknown – likely A4814) and 145HC6405 A4815 (last 2 were delivered in May, 1942). The tires on the trucks in the photographs appear to have

24 inch rims by my eye. Maybe 22 inch. Both sizes were supplied on HC145s. All in all, this looks like an HC145 to me.

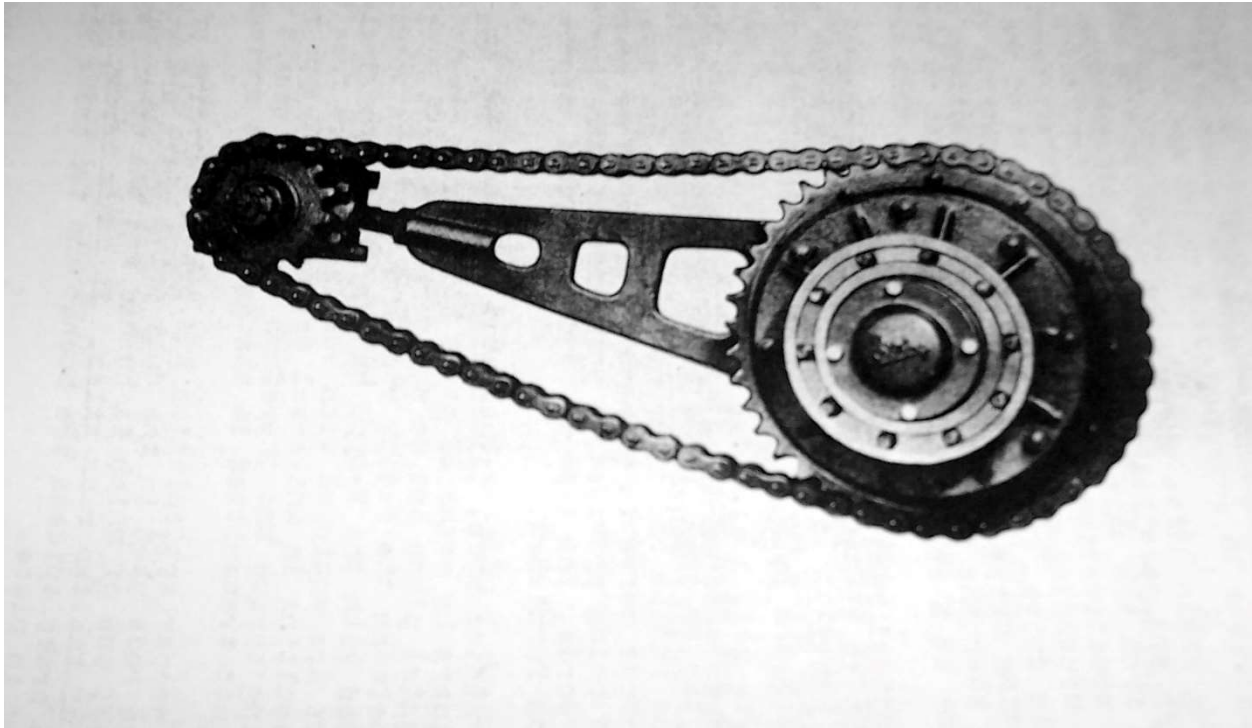
This is a picture of the Sterling cast Vee type radius rod including the front drive sprocket (to the left) and the larger rear hub and drive sprocket to the right. The 1-3/4" pitch roller chain surrounds the assembly. The chain tension is controlled by the adjustment screw and nut on the left end of the cast Vee type radius rod.

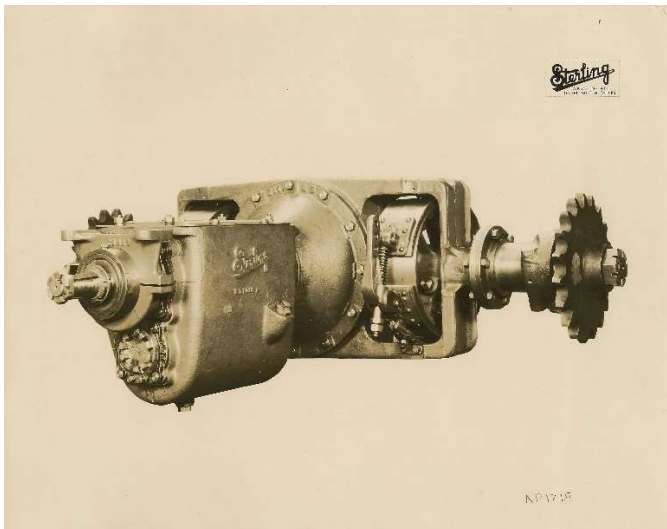
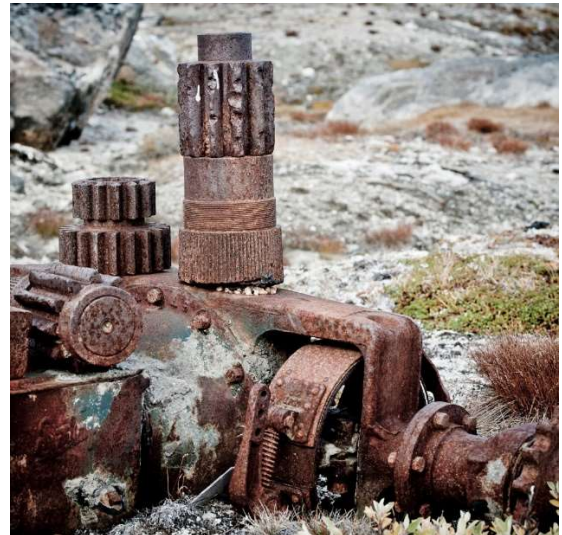
This is a view of the jackshaft and auxiliary transmission assembly as used on the Sterling model HC145. The jackshaft housing encloses the differential gears and surrounds two pulley type brake drums (hand brake assembly) which was unique to Sterling. The photo at the right is of the same jackshaft / auxiliary transmission assembly as photographed at the Ikkatteq Airbase by an unknown photographer. This lends further weight to the theory that the Sterling dumps are model HC145 (or at least several are). This assembly is likely in place on Sterlings #11 and #15 and perhaps others (#12, #13, #14 and #16).

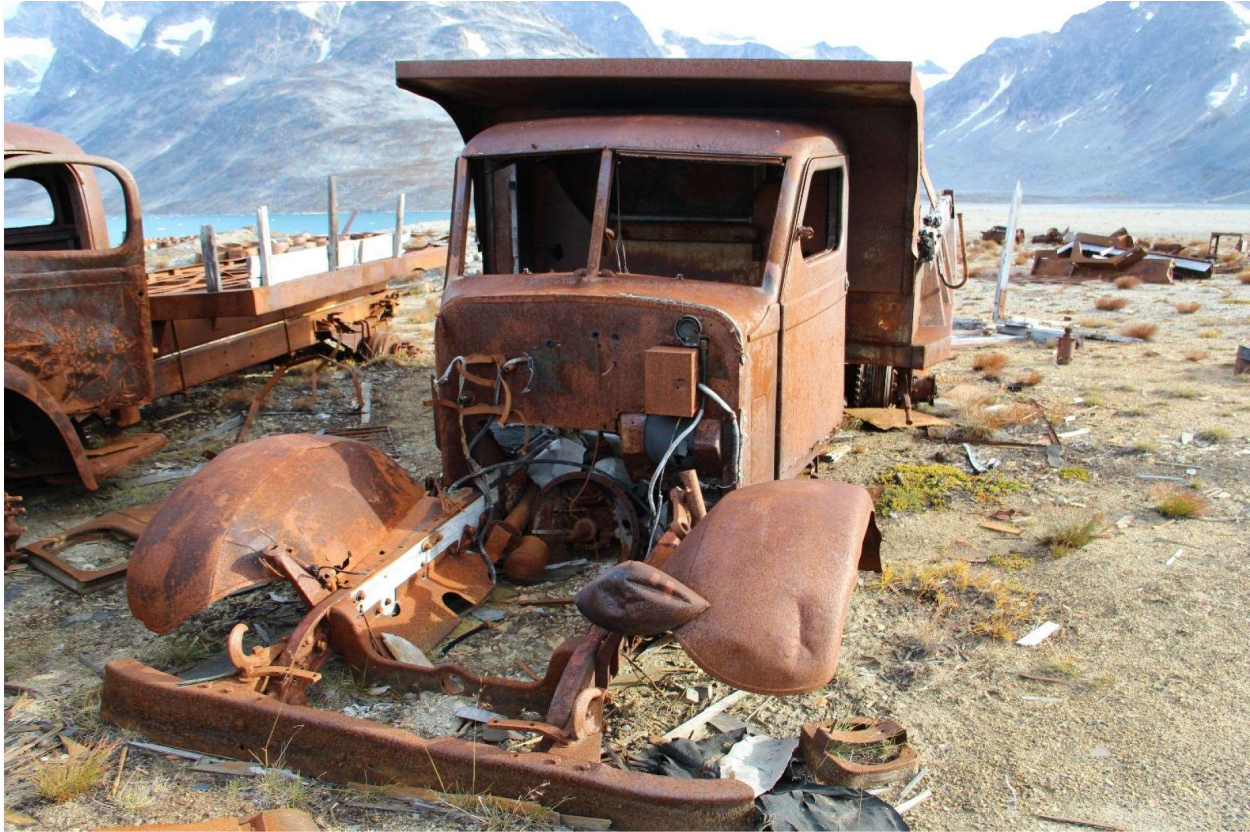
This is Sterling #2 which I believe is an MC96 model. The curved front frame horns (note that the frame rails curve down at the junction to the front bumper) were typical to the M series Sterlings. These trucks also were built with 60 inch wide cabs whereas the HC145 had a 64 inch wide cab. The M series cabs were cut down from the larger cabs and welded together at the center of the roof (and probably at the center of the cowl) This lent a different proportional aspect to the appearance of the truck when compared to the larger models. The MC96 was built from 1939- 1945 and serial numbers proceeded from 96MC601 to 96MC6106 as far as is known (this accounts for 106 units, the 6 in 601 and the 1st 6 in 6106 accounted for the 6-cylinder engine. The serial number along with an "A" number would have been stamped on the left frame rail likely about a foot behind the bumper. "A" numbers proceeded from about A3000 to about A6900 during this period, the A numbers being no longer used after some point in 1945. The observer will also notice that the sides of this dump body are lower than those on the HC145 model trucks. I think that this is the only M series Sterling at Ikkatteq. I think from other photos that this truck has its rear axle and suspension (see photo of Dodge #1). If so, the radius arms would be of the tubular type rather than the cast Vee type and they would be under the frame rather than alongside it. The truck is narrower than would be otherwise as a consequence of this design. This truck model had a 24,000 lbs. Gross Vehicle Weight Rating (GVWR).

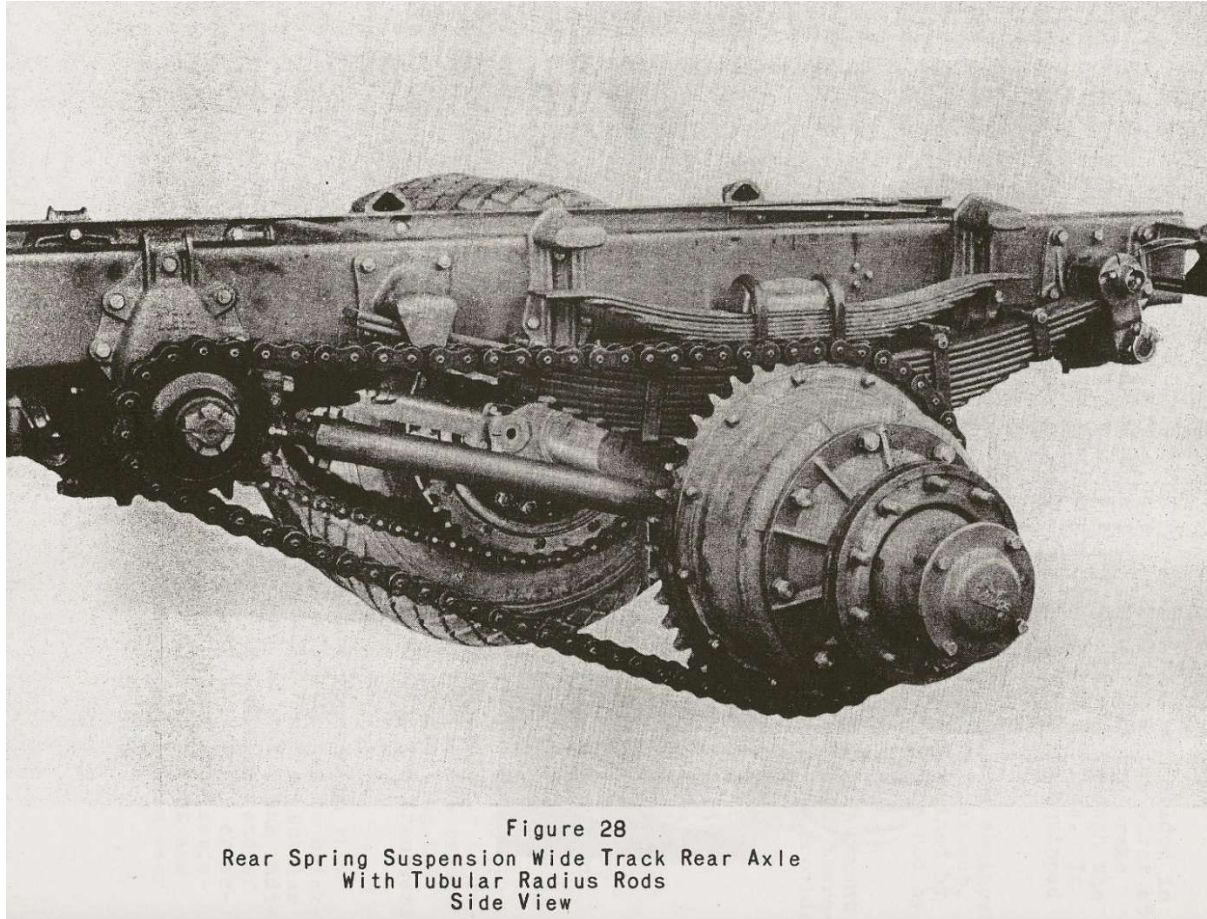
This illustration shows the type of rear suspension used on the MC96 model Sterling as well as the larger HC144 model. One Ikkatteq photo shows that the rear hub is still in place on the truck that is identified as an MC96 which means that much of what is in this illustration is likely also there. These type of radius rods were called tubular radius rods. They were positioned under the truck's frame and did not add to the overall width of the rear axle / suspension assembly whereas the cast Vee type did add several inches to the overall width of the truck since it was not possible to position them underneath the frame.

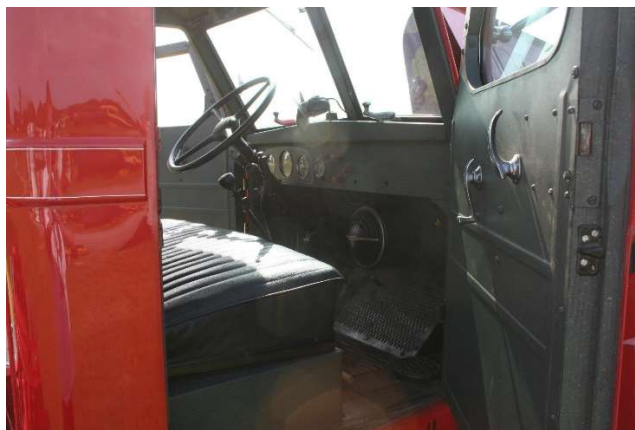
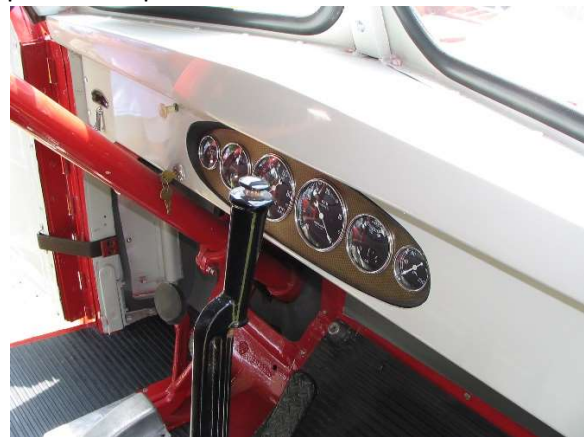
These photos illustrate the dash gauge cluster of the MC96 (left) and HC144 / HC145 (right). The MC96 was in front of the driver and the HC144 / HC145 was in an oval cluster in the center of the cab. Each of these photos are of restored trucks in Pennsylvania. The photo on the left is from the internet; I took the photo on the right.

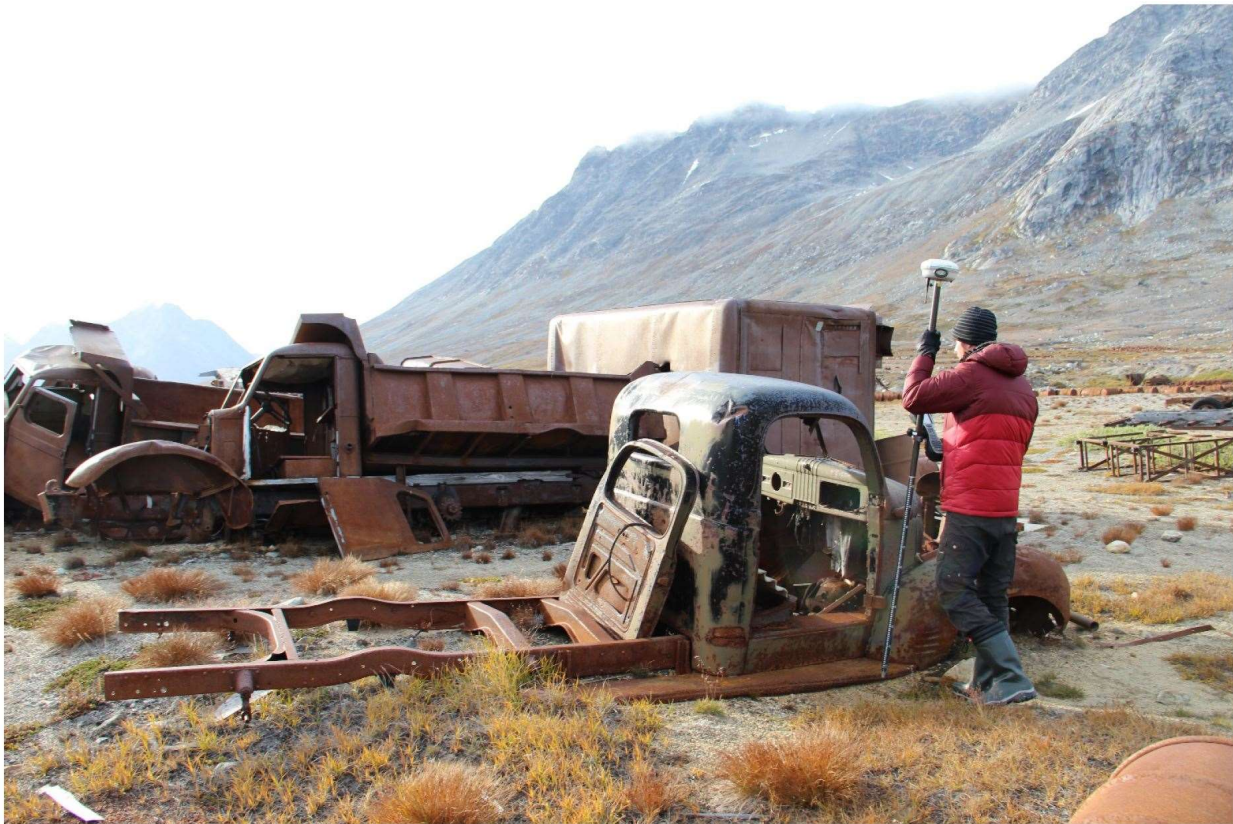
Sterling #3 and #4

The two Sterlings in this photo appear to be HC145 models. The trucks below are the same - #3 & #4.

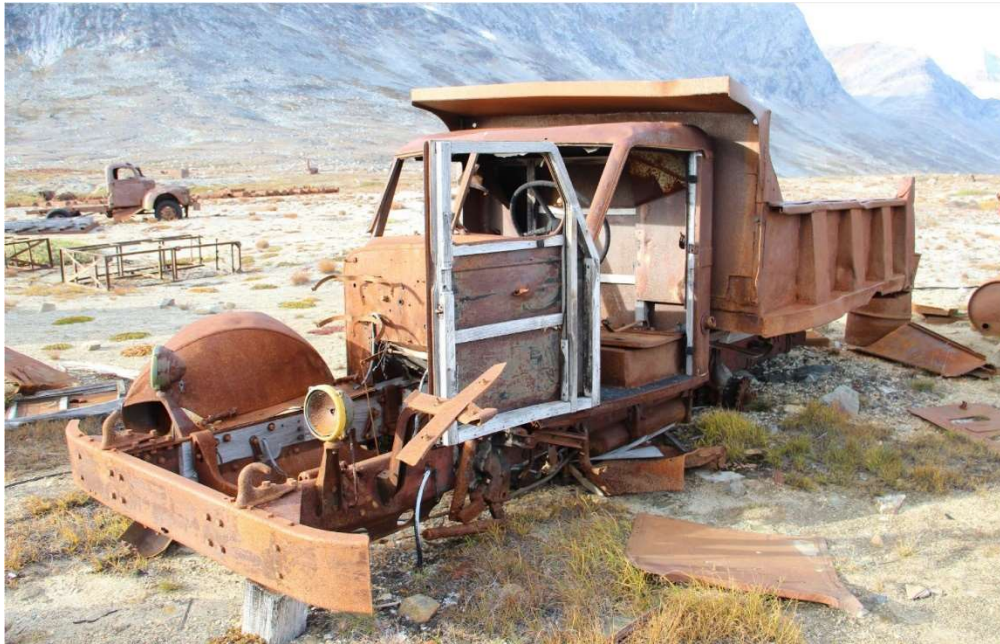
This is Sterling #5 and it appears to be an HC145 model as well. Since the rear suspension is missing as it is on some of the other Sterlings it is possible that this was a model HC144. In my opinion it is likely that this is an HC145 since it is known that several of them were supplied for the purpose of building air bases in the North Atlantic region. The HC144 models also had a 36,000 lbs. GVW capacity but had tubular radius arms like the MC96. This is the only truck missing its left front fender to my knowledge. Marmon-Herrington Ford #2 4x4 truck cab and chassis appear in the background.

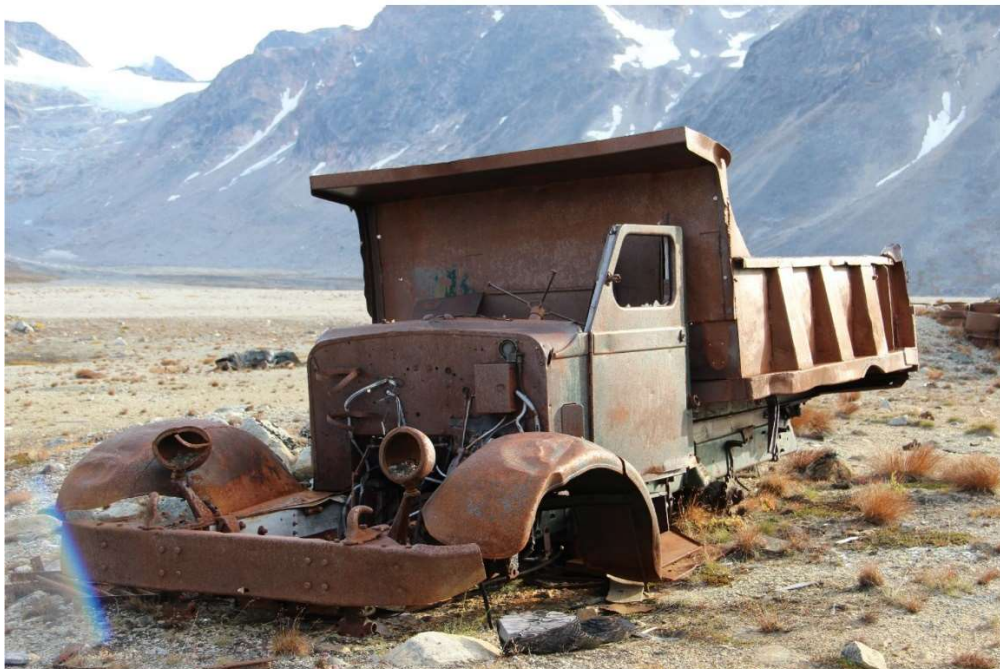
This is Sterling #6 and is likely also an HC145 model. Since much of the rear suspension is missing the HC144 model can not be ruled out. This is the only truck missing the cab roof and windshield to my knowledge at Ikkatteq.

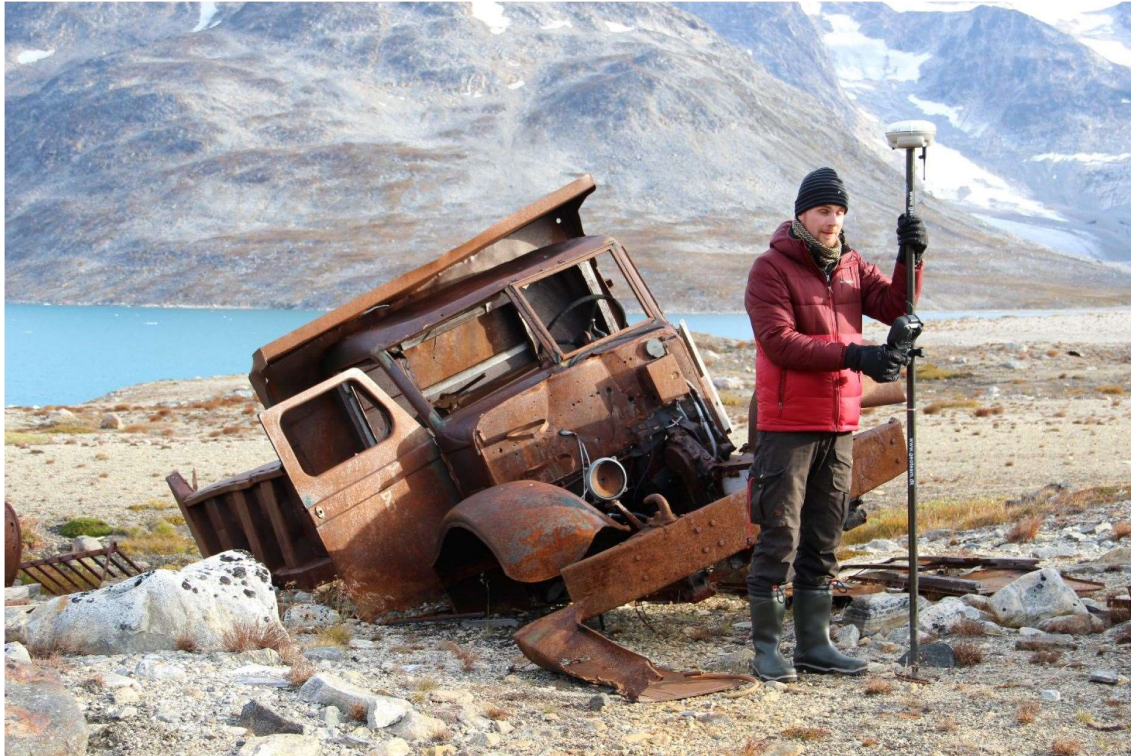
This is Sterling #7 and I think is at the extreme right side of the various Sterlings at Ikkatteq. The original radiator guard appears to be laying on the ground to the left of the truck. Here is another photo of this same truck found elsewhere on the internet (I don't know the photographer):

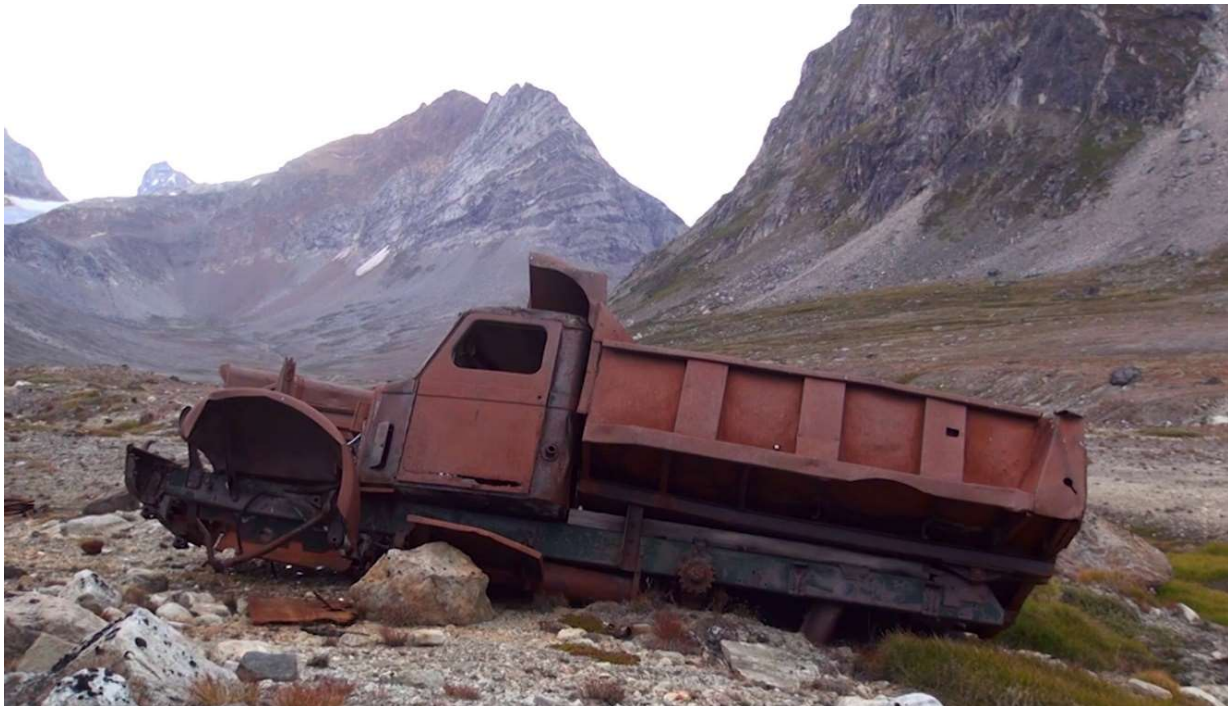
Sterling #7 Left Side View – Likely model HC145. The frame serial number would provide proof.

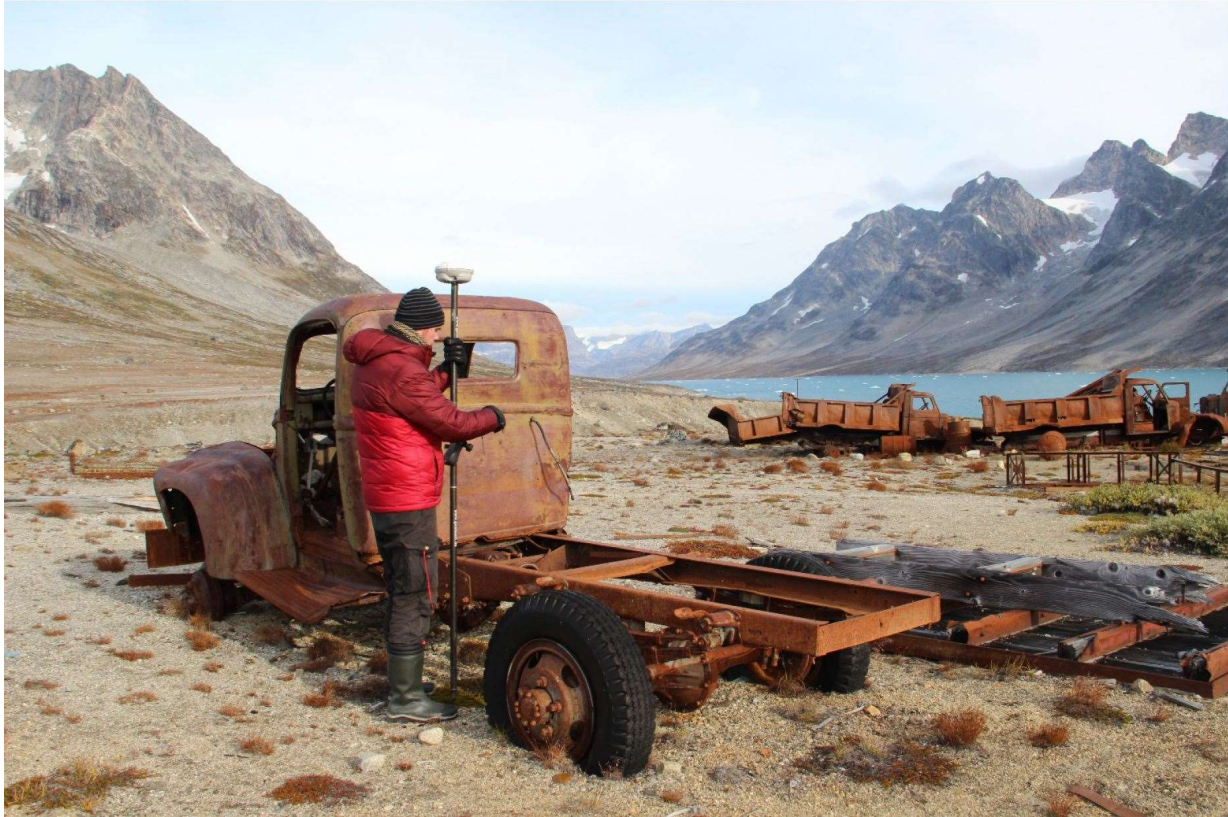
This is Marmon-Herrington Ford #2 at the left, Dump body #8, Sterling #11 and Sterling #5 at the right. Originally, I had thought that #8 was a complete truck and had numbered it as a Sterling, but it does not appear to be so.

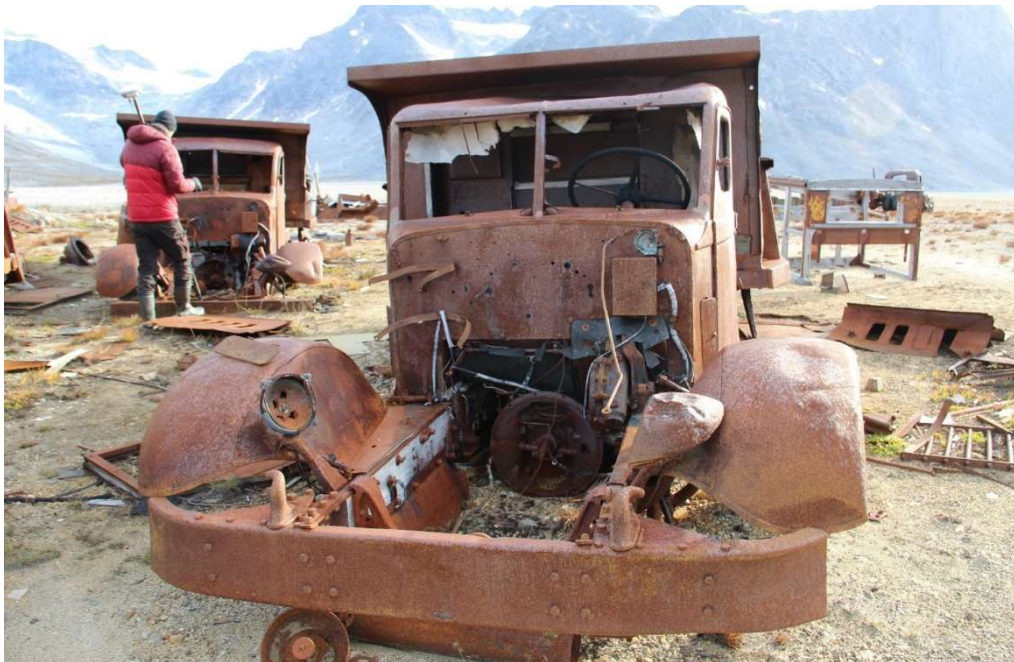
Sterling #2 (MC96) at the left, and Sterling #9 in the foreground. Two Sterling hoods are visible either side of the rear of the truck in the foreground. A front radiator guard for a Sterling is laying on the ground to the right.

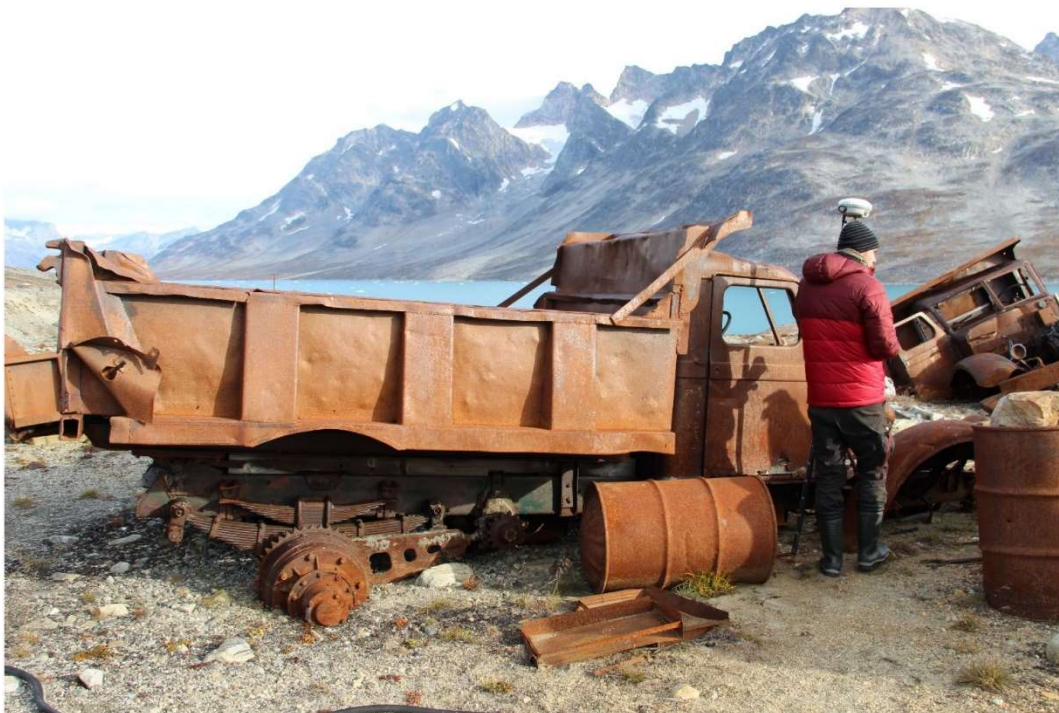
(dump body #8 at the extreme left) This is Sterling #11 and Sterling #7 at the far right. The cast vee radius rod (arm) and rear suspension typical to the HC145 model is quite apparent in this view (Sterling #11).

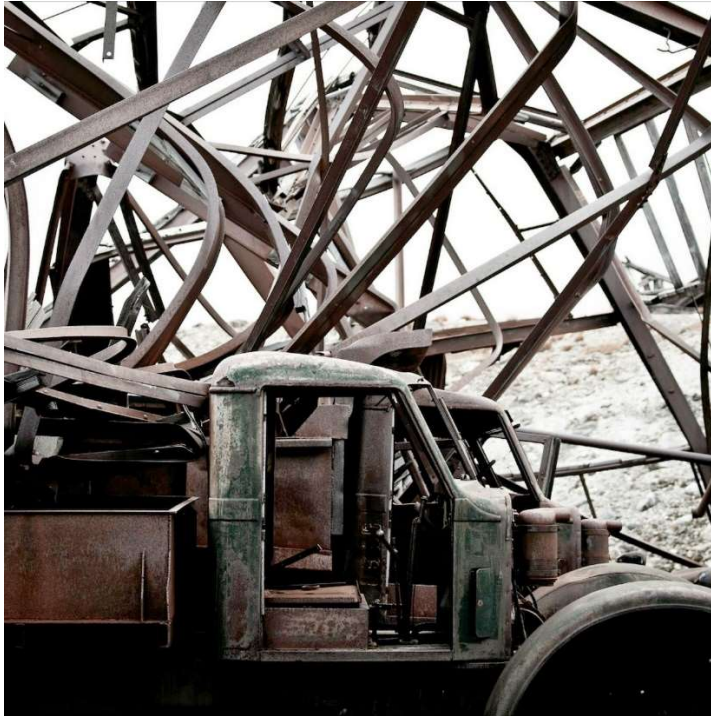
This is Sterling #12 & #13 in the back of the remains of the hangar structure. This truck has some green paint left and a different kind of dump body than the others. I do not know who took this or the next photograph.

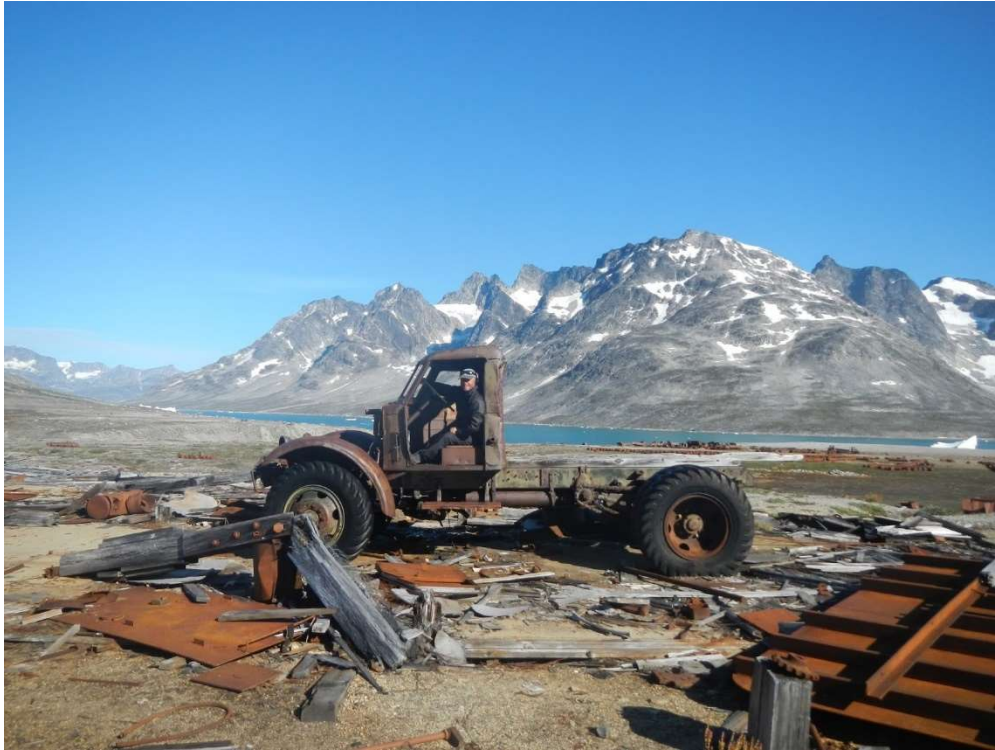
This is Sterling #15 which is apparently a ways away from the other trucks. This truck has all of the identifying characteristics of a model HC145 and is one of the few trucks up on its tires. I wonder if dump body #8 came off this chassis. Photographer unknown.

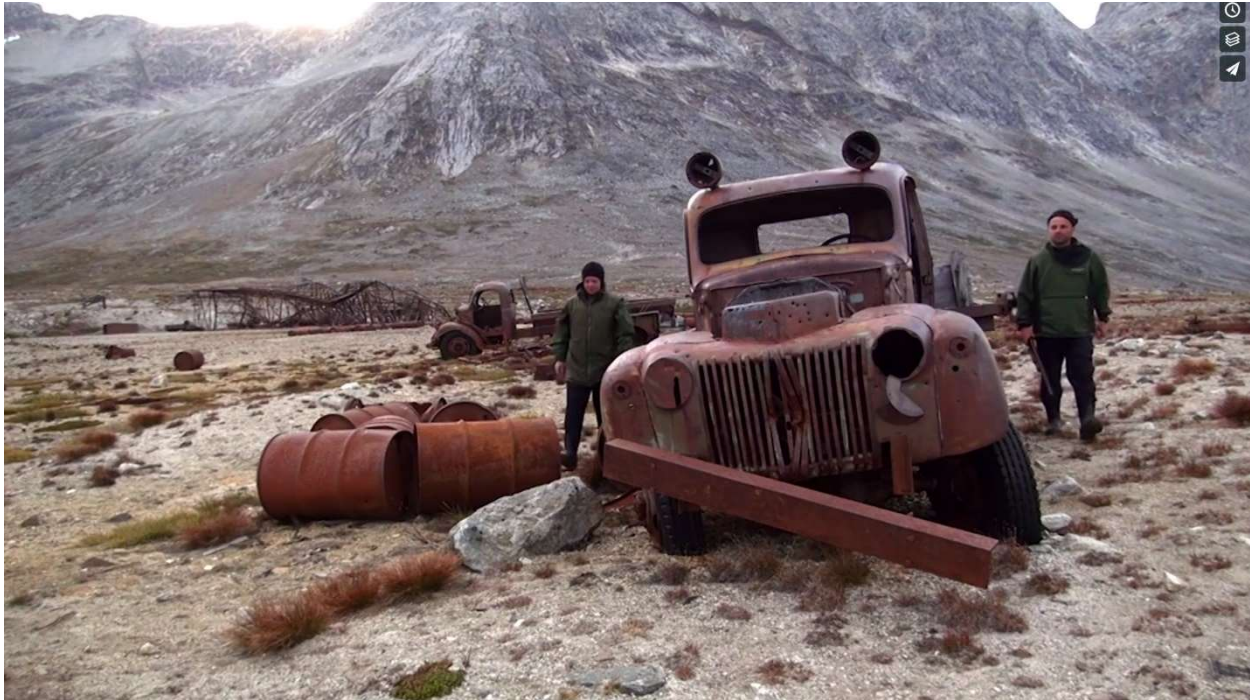
Here is Reo #1 in the middle ground left and Marmon-Herrington Ford 4x4 in the foreground. In the left background is the remains of the building structure. The position of the headlights suggest that this truck was set up for plowing perhaps with a Sicard Sno Go, but the body was a plain flatbed which suggests something else or perhaps it was fitted with that body later-?. It is interesting that none of the Sterlings had a plow frame and apparently were not used for snow removal.

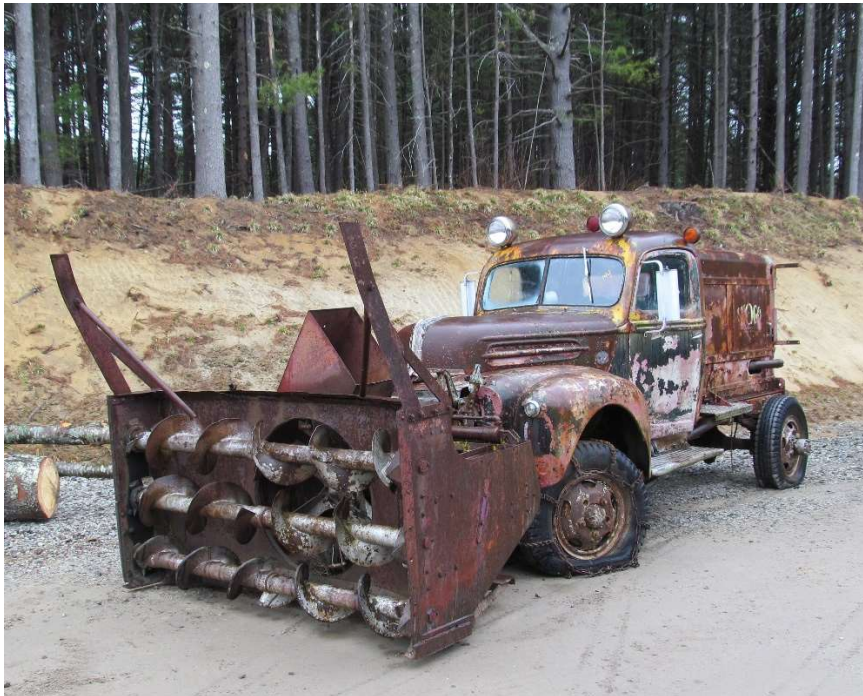
This photo illustrates a typical Marmon-Herrington Ford 4x4 set up with a Sno Go for snow removal. This is my photo of a collector's M-H in Maine.

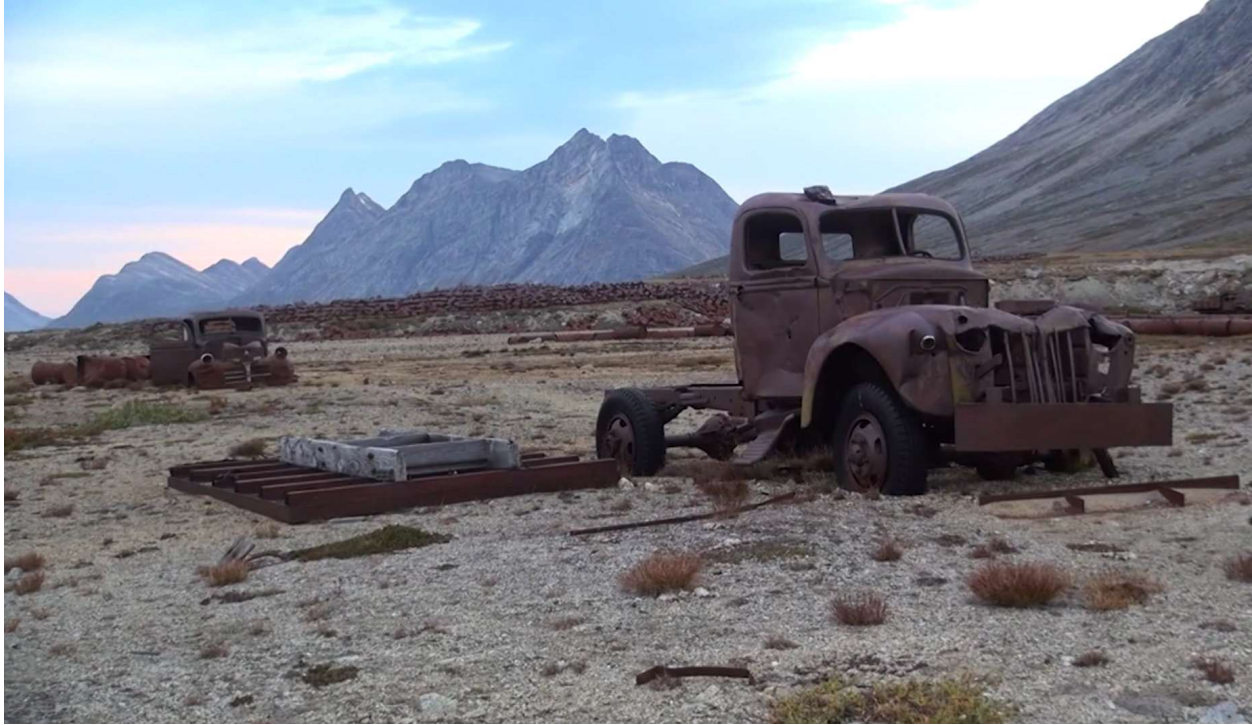
This is Dodge pickup #1 visible to the left and Marmon-Herrington Ford 4x4 #2 at the right. This truck has a reinforcing strut through the front fender possibly for snow removal equipment but does not show signs of the headlights being set up for that. Photographer unknown.

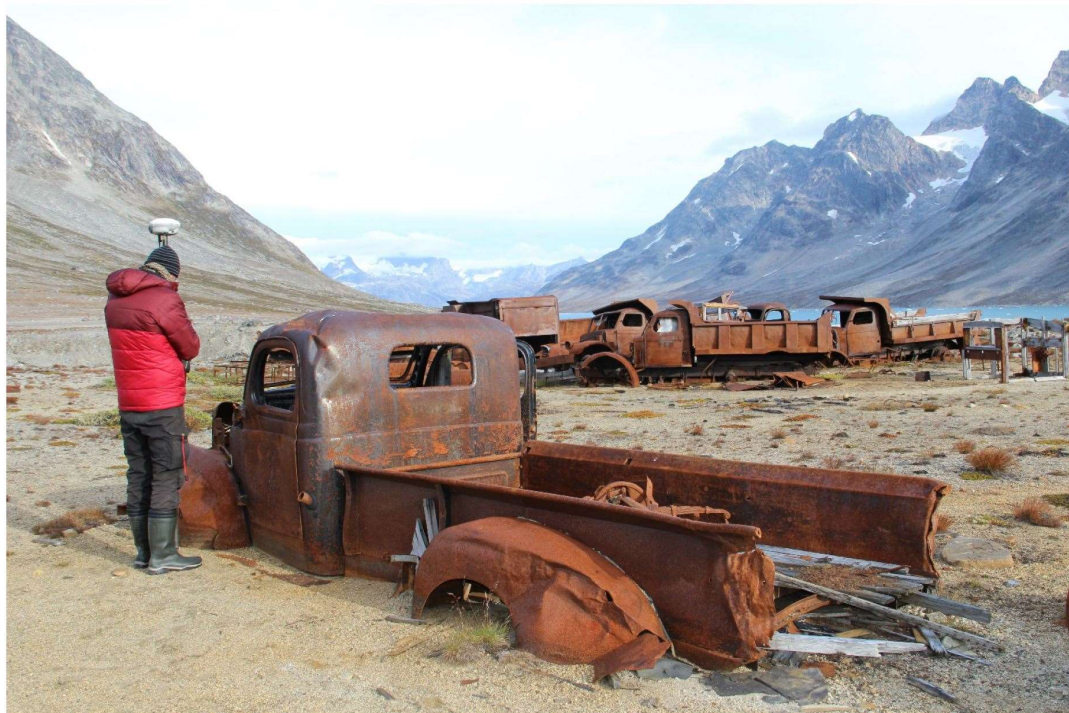
Dodge pickup #1. In the center closest to us is Sterling #9 and to the right of that is Sterling #2. Note that the rear hub assembly appears to still be attached to that truck (Sterling #2) indicating that the entire suspension may still be in place.

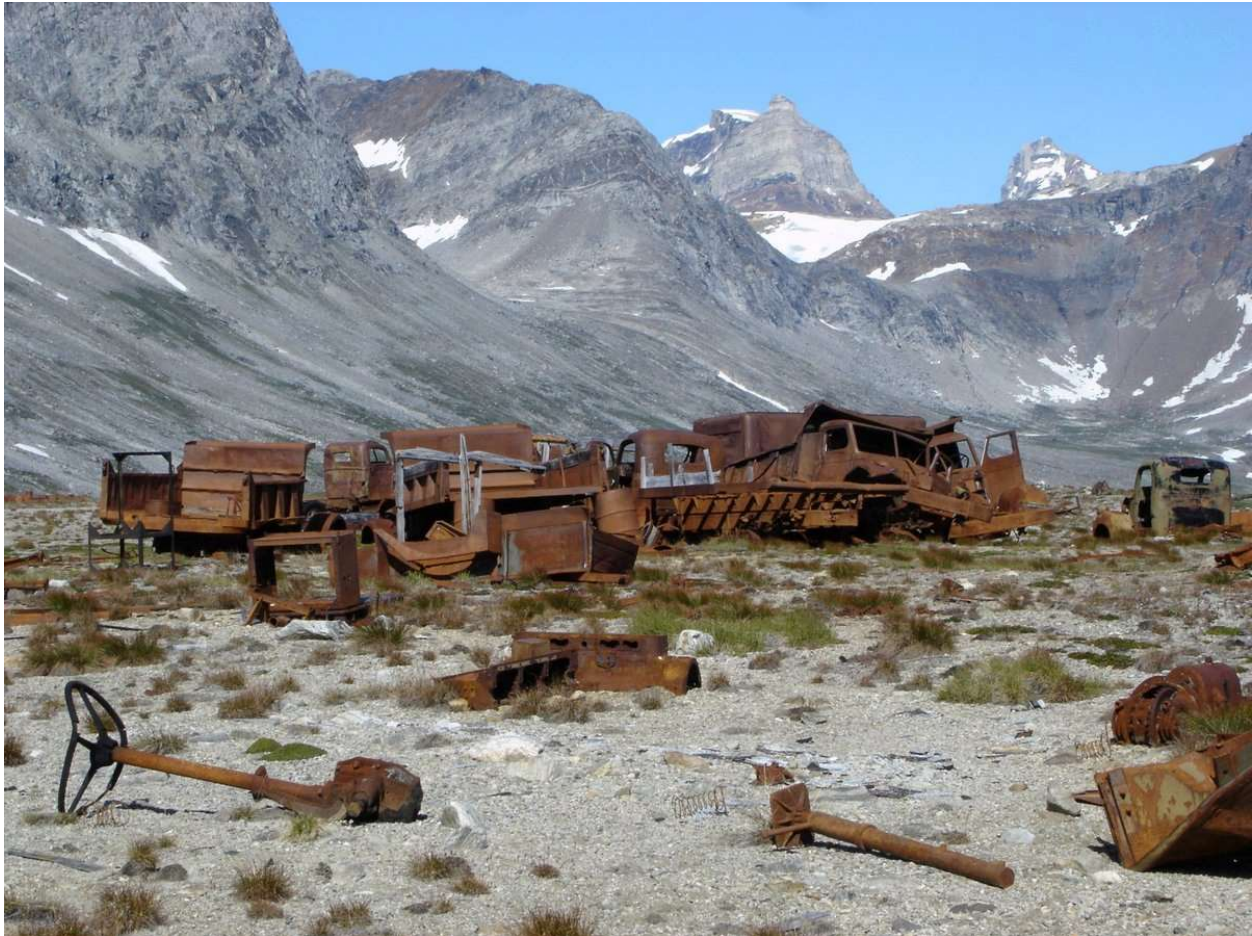
Sterling #9, back of Marmon-Herrington Ford #2, Sterling #2 (MC96), Reo #2, Sterling #3, Sterling #4, Dodge #2 to extreme right. In the left foreground is a Steering column from a Sterling (Distinctive bracket which surrounds the column and mounts the steering box), Waukesha cylinder block in the center foreground which would be typical to a Waukesha 6SRKR such as was used in the Sterling HC145 (and HC144) in the early 1940s. In the right foreground is a differential gear and auxiliary transmission (upside down) from a Sterling like used in the HC145 (and HC144). Not sure what the jack post or the item to the right extreme foreground is.

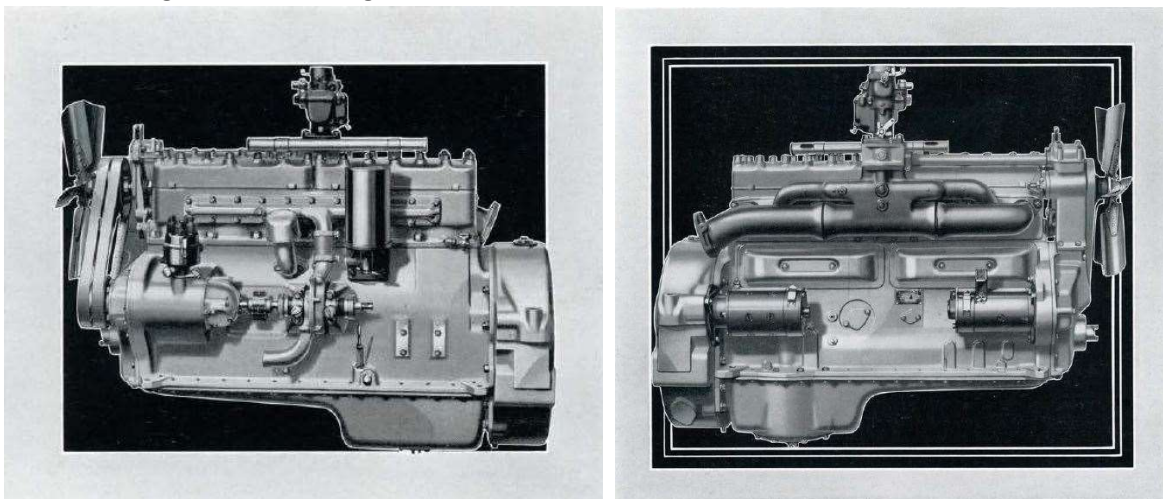
Waukesha 6SRKR 517 cubic inch displacement engine as used in the Sterling model HC145 (and HC144)
