Kapisillit Icefjord Lodge Project Survey Kommuneqarfik Sermersooq 11-13 July 2022

Report prepared by:
Hans Harmsen & Mikkel Myrup
Nunatta Katersugaasivia Allagaateqarfialu // Greenland National Museum and Archives
26 October 2022, Nuuk

1.1. Kapisillit Icefjord Lodge project

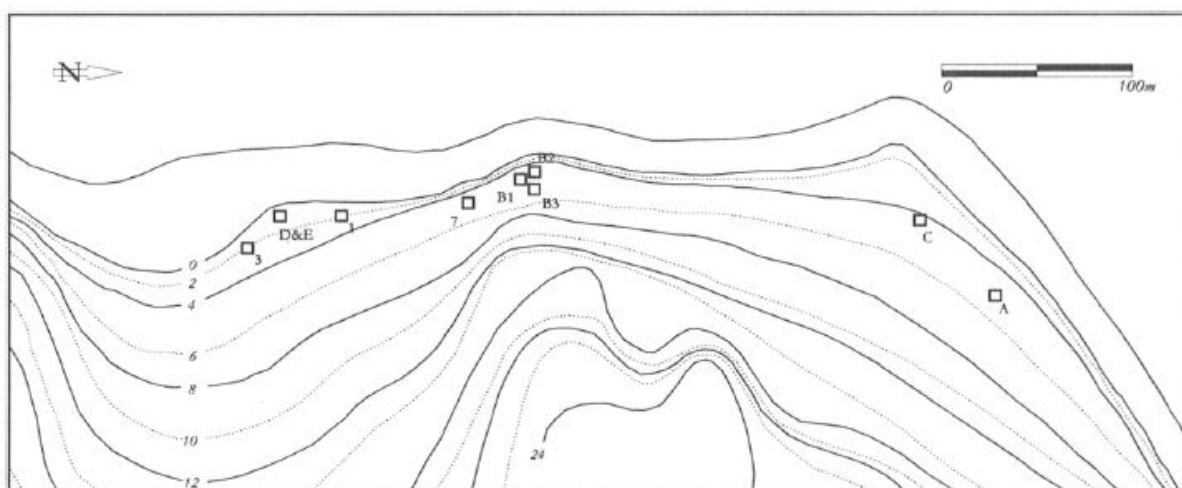
Fig. 4. Nuunnguaq site on the southern coast of Kapisillit Kangerluat. (After Appelt 2003, :214, Figure 2.)

The Nuunnguaq site (NKAH 1520) represents an archaeologically sensitive Paleo-Inuit activity zone found in Survey Area A. Jørgen Meldgaard discovered the site in 1952 during his reconnaissance of the Nuuk fjord. The site is situated at 2-6 m above the present sea level along an approx. 1.2 km x 30 m sloping terrace. The western side of the site is delimited by the Kapisilliit Kuuat. The area extends eastward to a low-lying and swampy area with a small stream that borders a low ridge leading to the Kangiussap Nunaa Peninsula. Excavations were conducted at Nuunnguaq in 1960 and 1963 by Jørgen Meldgaard, Hans Berg, Jens Rosing, James Giddings and Douglas D. Anderson. Eigil Knuth also visited and excavated a small part of the site in 1962, but no record of the excavation currently exists (Appelt 2003). During our visit it was difficult to discern the precise location of the earlier excavations and the area continues to be intensively used by local people for harvesting/smoking salmon. A functioning cold-smoke oven, wooden storage boxes and broken fishing equipment were observed approximately 100 meters east of the river.

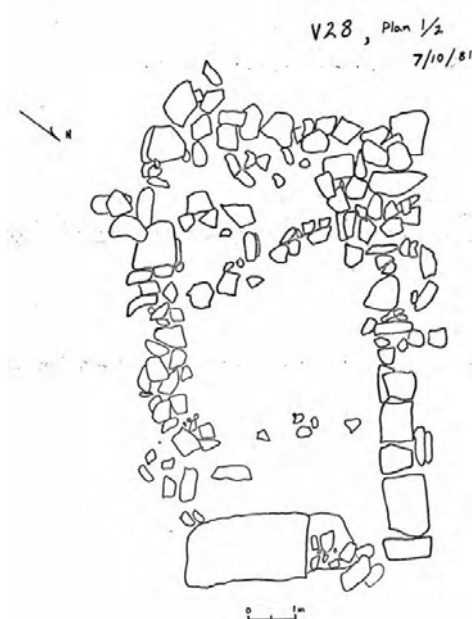
Fig. 5. Norse structure identified by McGovern and Jordan (1982) in their survey of the area in 1981. The Feature was not identified by our team in 2022 and may be a result of the increase in vegetation over the last 40 years.

1446 in Fig. 1) located somewhere in the vicinity north of the small river, however we were unable to identify its location which may be due to the natural growth of dense vegetation in recent decades, as well as the numerous summer cabins in the area that were probably not there at the time of McGovern and Jordan's visit in the early 1980s. McGovern describes the feature as: "...[t]his structure stands alone above an active erosion face. No additional structures located around it. Constructed of very large stones and boulders now much collapsed. Function hard to interpret, but probably a byre or barn." No other information provided. This may or not be the same site listed as NKAH 1447 (Illorsuaasakasiit).

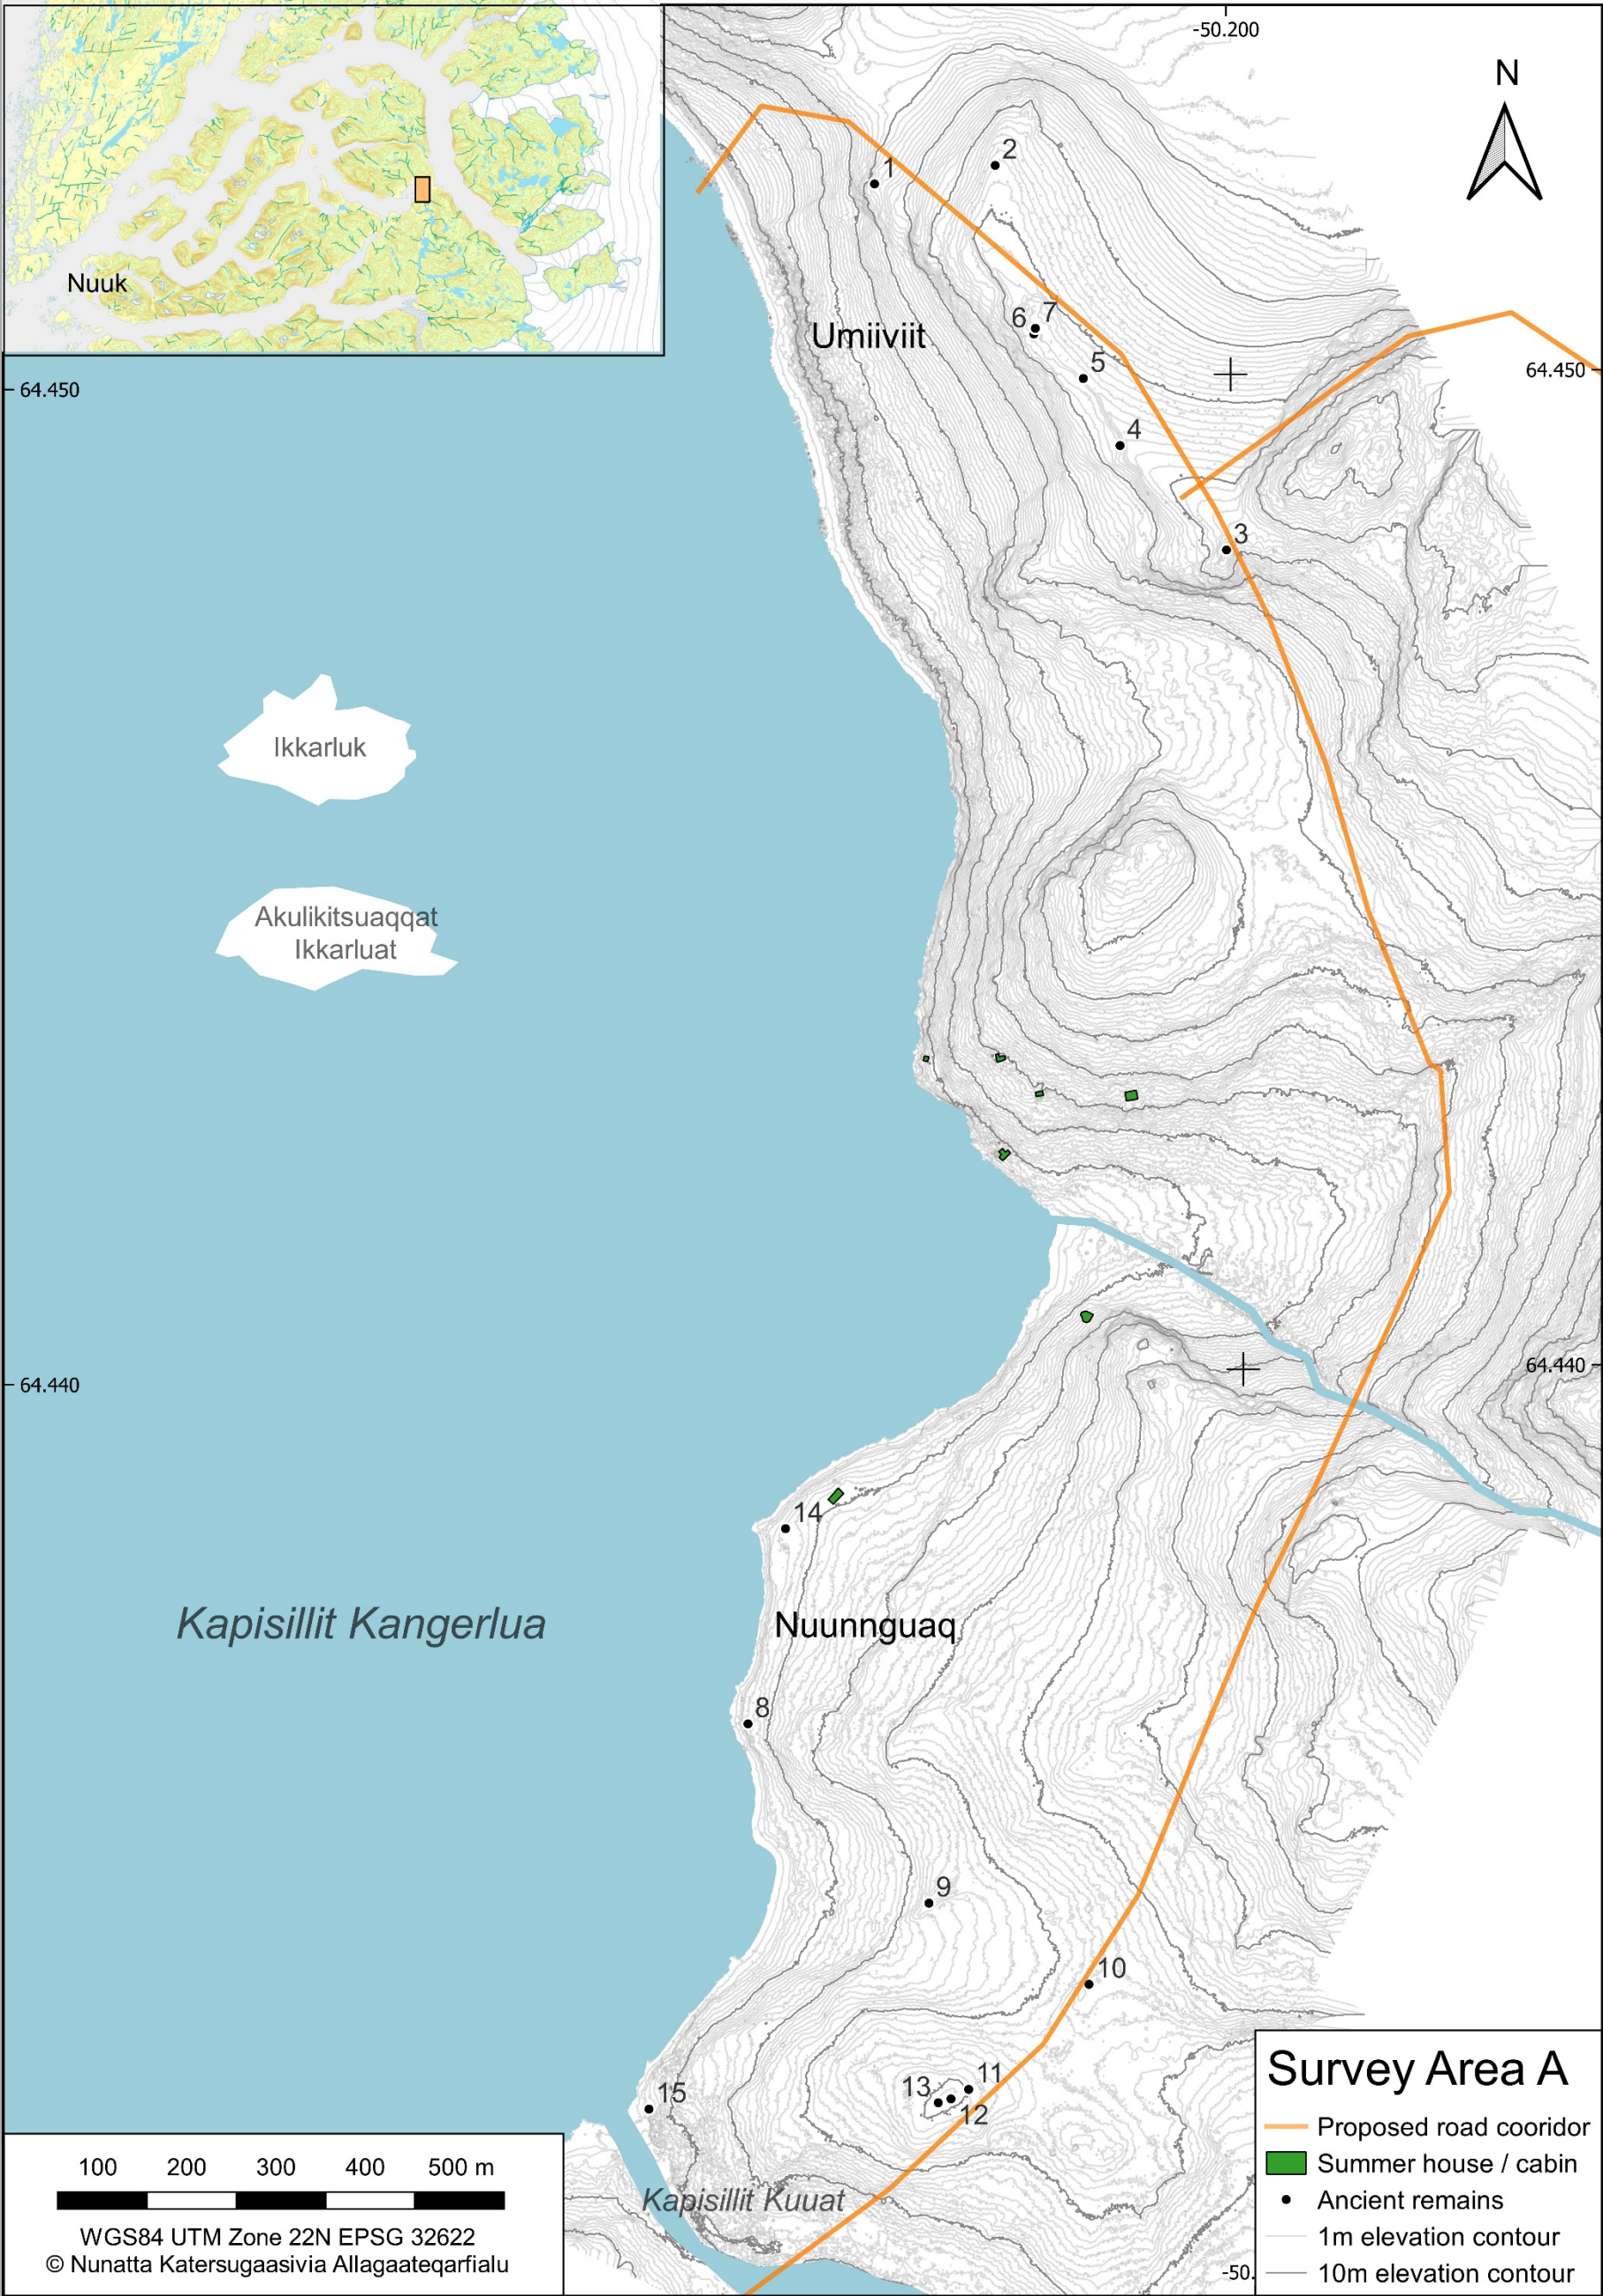
Fig. 7. Survey Area A with significant ancient remains (1-15) identified between 11-13 July 2022.

Fig. 6 provides a map of all archaeological remains identified in July 2022 stretching between Kapisillit Kuuat and Umiiviit along the south and eastern shores of the Kapisillit Kangerlua along with corresponding descriptions for each archaeological feature.

- No road construction should take place on the lower terraces located directly above the shoreline and along the coast (e.g., Nuunnguaq) and by the mouth of the Kapisillit Kuaat due to the high frequency of sensitive archaeological remains in the area.
- When choosing a corridor for the road in Survey Area A, we recommend avoiding areas with naturally occurring exposed rock surfaces to prevent potentially disturbing any undocumented ancient remains.

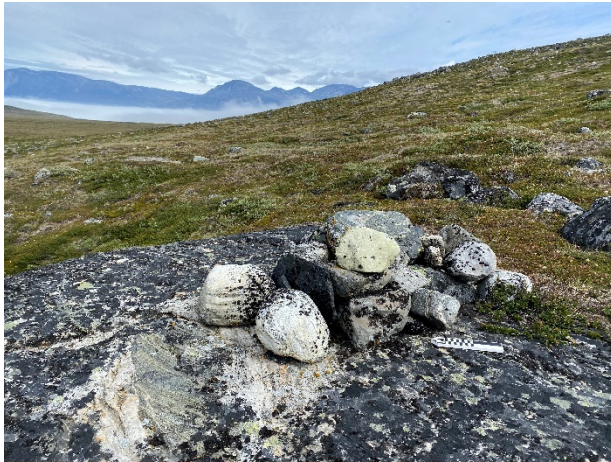
1. Fox trap, 64.45195922, -50.20822994

Northwest to northeast orientation; approximately 30 round cobbles.

Length: 130 cm

Width: ca. 90 cm

Height: ca. 45 cm

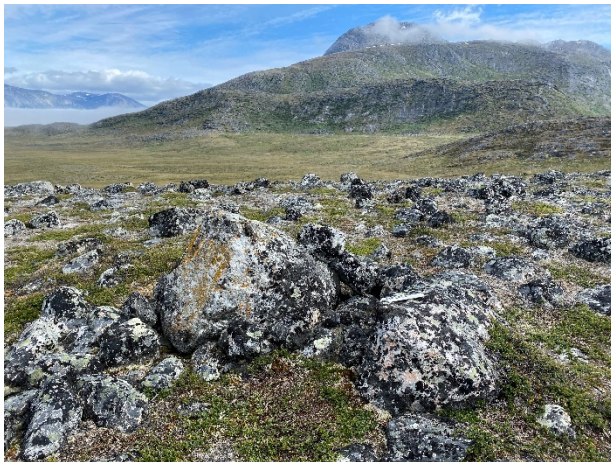
2. Meat cache, 64.45213012, -50.20541804

20+ stones arranged against natural boulder features in the landscape. The meat cache and its components cover an area of about 4 m².

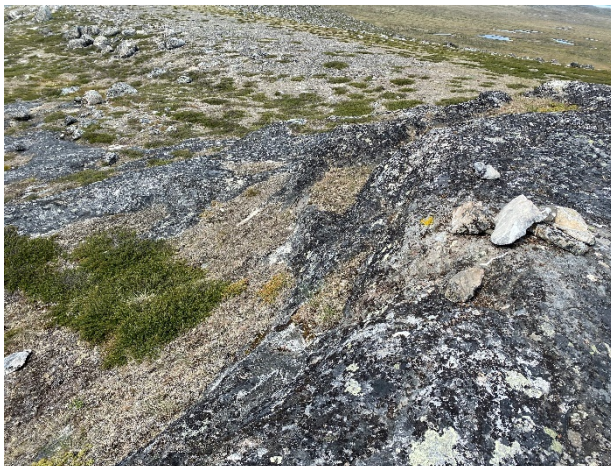
3. Collapsed inussuk, 64.44823594, -50.20014661

An inussuk / cairn marker of undetermined age on exposed bedrock; possibly recent. Approximately 8 large, flat stones and 2 stones that have migrated to the slope below.

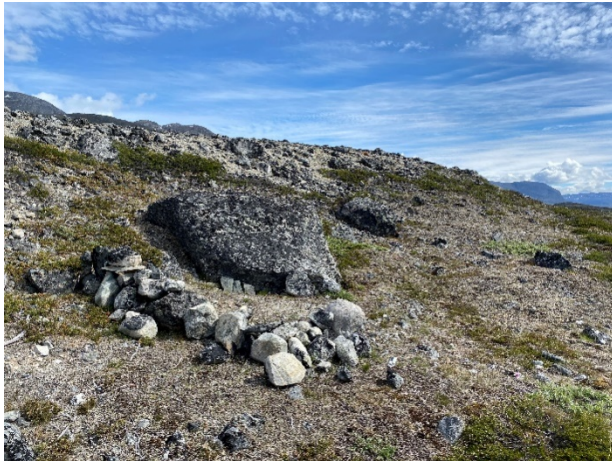
4. Windbreak / hunter's bed, 64.44929904, -50.20259269

A typical 'hunter's bed' or windbreak, most likely of recent construction or re-construction overlooking the fjord to the west. The feature is defined by an 'L' shaped wall constructed of several large round cobbles creating an average height of about 30-40 cm. The northern wall measures 285 cm, and the smaller southwest extension 120 cm. A large boulder with a shallow overhang creates a natural lee against the wind to the south. The feature covers a total area of about 5-6 m². The absence of natural lichen growth on the stones and several rusty nails observed on the ground inside the feature suggesting recent use.

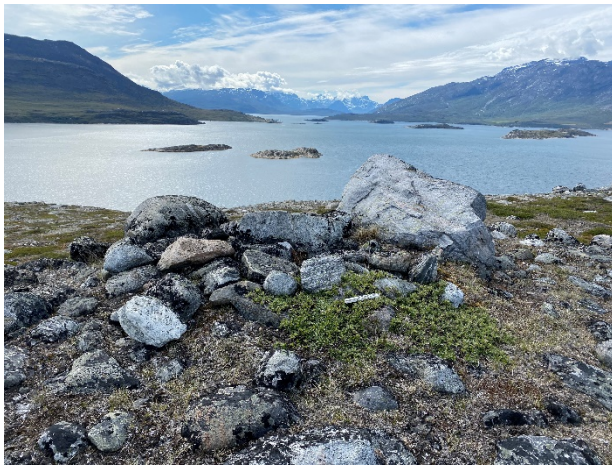
5. Meat cache / possible grave? 64.44997739, -50.20342837

An undetermined stone feature (25+ stones) that could possibly be a former meat cache or depot or a collapsed/emptied grave. No bones were observed, however its orientation on the landscape, with a clear view of the fjord to the west suggests it could have originally could have functioned as a grave.

Length: 90 cm

With: 90 cm

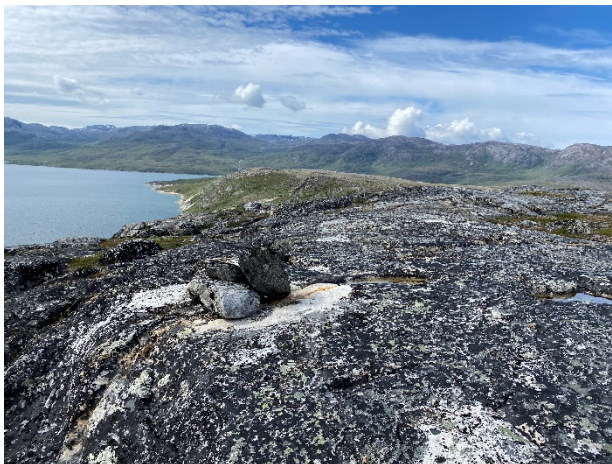
6. Inussuk, 64.45043103, -50.20456688

6 cobble stones arranged as a marker on exposed rock overlooking the fjord to the west.

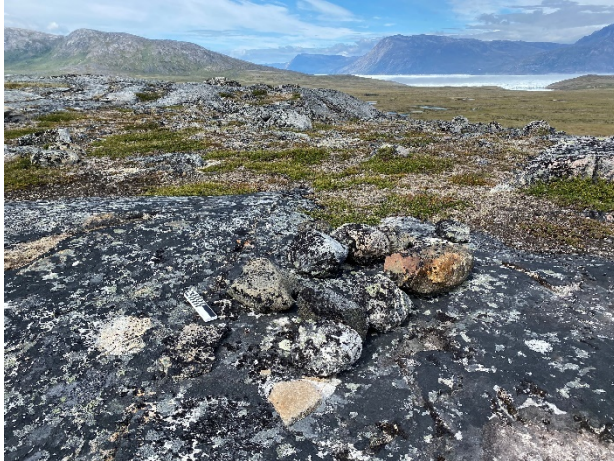
7. Fox trap, 64.45048744, -50.20452970

Remnant of a fox trap placed on bare rock outcrop; some of the stones have been removed and most likely used in construction of the nearby inussuk (#6, 64.45043103, -50.20456688). 13 round, head sized cobbles form the outline of the trap.

Length: 115 cm

Width: 75 cm.

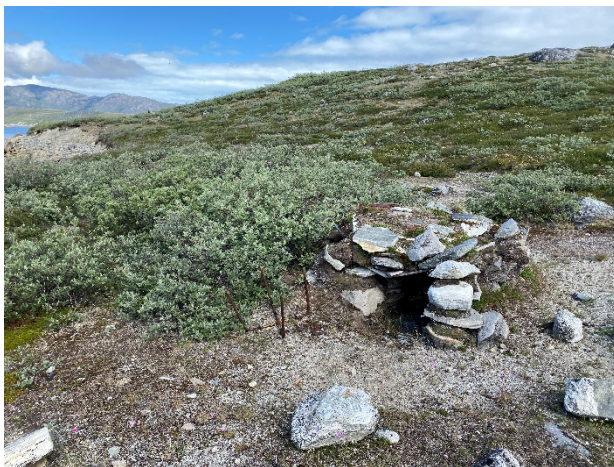
8. Nuunnguaq, 64.43650052, -50.21162021

The Nuunnguaq site (NKAH 1520) is situated 2-6 m above the present sea level along an approx. 1.2 km x 30 m plane along the present-day shoreline. The area covers a distance of approximately 1.2 km with the western side of the site delimited by the Kapisilliit Kuuat. The eastern edge is defined by a low-lying and swampy area. Evidence of modern fishing equipment (including a 'coldsmoker', shown in the photo to the left) suggests intensive use of the area by local people.

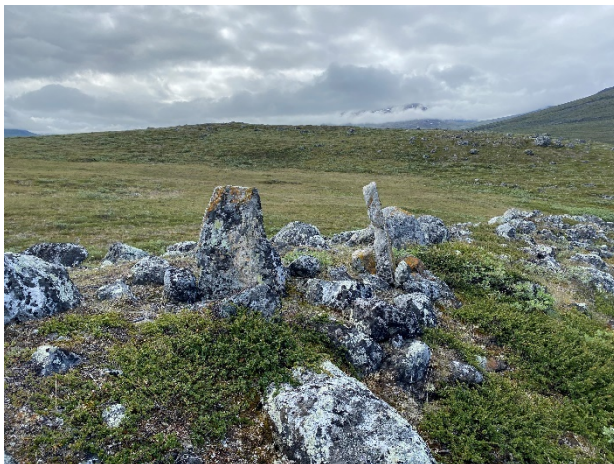
9. Vertical flagstones, 64.43467598, -50.20746203

Two large flat flagstones placed in a vertical position on the landscape, most likely as a visual marker. Undetermined age and otherwise untypical for Inuit. The eastern flagstone measures approximately 100 cm in height and the western flagstone 90 cm in height.

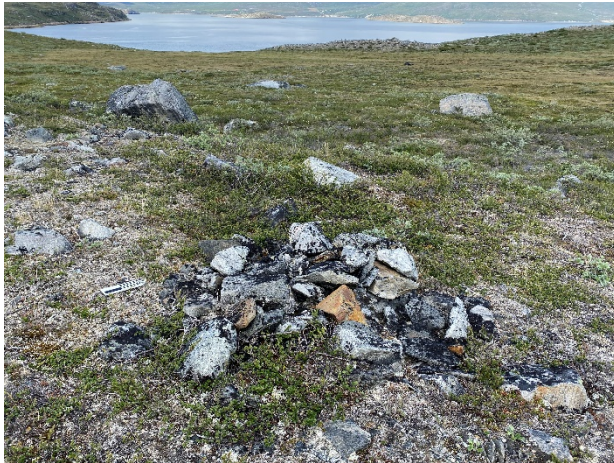
10. Collapsed fox trap, 64.43384016, -50.20376491

Remains of a fox trap located on a hillock with sparse vegetation. Comprised of 50+ round, head sized cobbles.

Length: 130 cm

Width: 90 cm

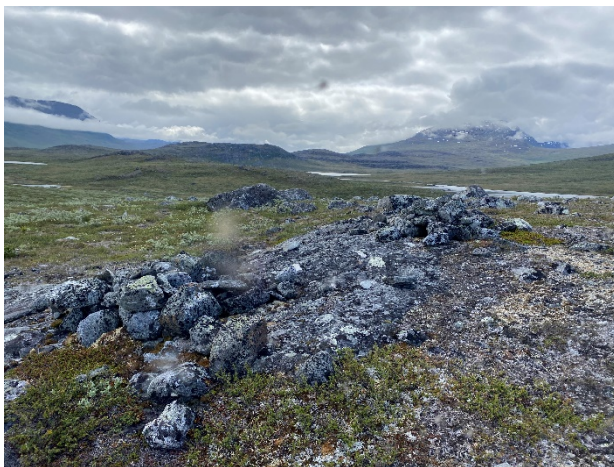
11. Twin Fox Traps (234), 64.43279973, -50.20659303

Two fox traps laid along a northeast-southwest orientation on an exposed bedrock surface. Each fox trap comprises approximately 50+ stones with majority being round, head-sized cobbles.

Southwest fox trap:

Length: 180 cm

Width: 130 cm

Height: approximately 50 cm at highest point

Northeast fox trap:

Length: 150 cm

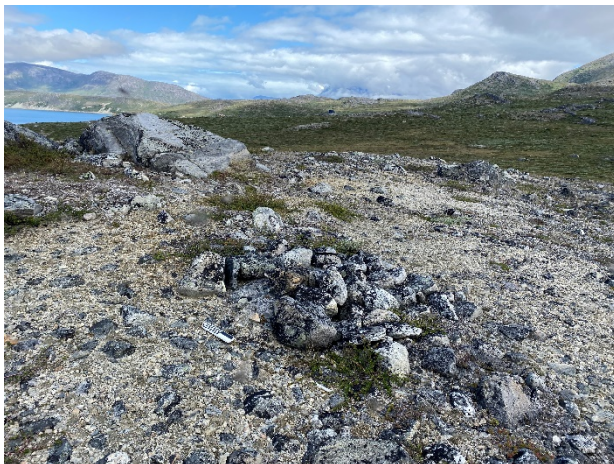
12. Collapsed Fox trap, 64.43270686, -50.20700775

A collapsed fox trap found on an exposed bedrock outcrop to the southwest of twin fox traps (#11, 64.43279973, -50.20659303). North to south orientation. Difficult to determine original dimensions. 40-50 round head-sized cobbles.

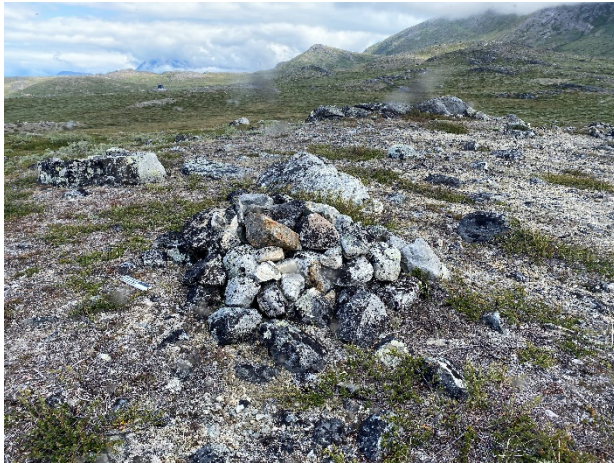
13. Cairn/meat cache, 64.43266902, -50.20730457

Stone feature of undetermined function – possible meat cache or cairn. Comprised of 50+ round, head-sized cobbles.

Length: 150 cm

Width: 120 cm

Height: approximately 50 cm at highest point

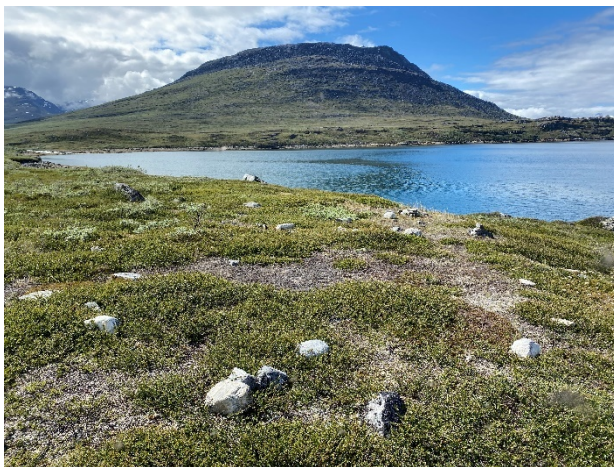
14. Recent tent ring, 64.43845743, -50.21069073

Remains of a recent tent ring located inside the general area of Nuunnguaq. The ring measures 7 meters in diameter, approximately 50 meters to the southwest of a summer cabin and 13 meters from the shoreline. The ring is comprised of approximately 20 round, head sized cobbles.

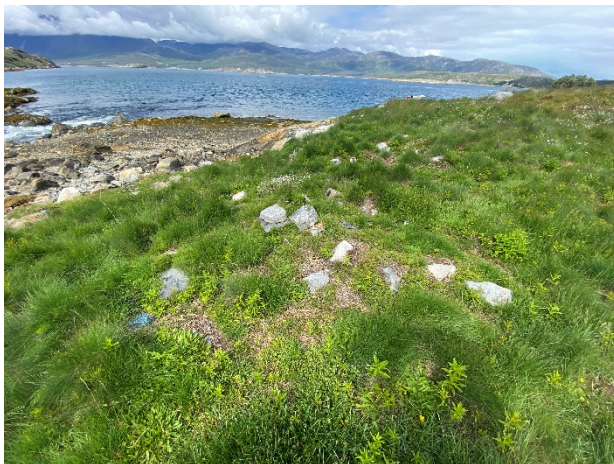
15. River mouth campsite east; midden, 64.43264156, -50.21403351

Another important site is found on the west-facing slope above of Kapisillit Kuuat on the north shore of the river mouth. The site can be tentatively described as a summer campsite (see Fig. 7, point 15) that may have been in use up through the 20th century. Remains of a concrete foundation (Fig. 6.) were observed at the top of the hill a few meters to the north, which may have been a small hunter's cabin. Several well-constrained thick midden layers were identified at the time of our visit on the beachline above the river mouth. No sub-surface testing was performed but exposed erosion fronts revealed a high degree of preservation of organic remains as well as historic material (whiteware ceramic), suggesting the site has a long

life-history. The outlying area is blanketed by a dense thicket of willow (2+m high in some areas) which made further examination of the terrain difficult.

Possibly Illorsuaasakasiit (NKAH 1447). This area covers an area of about 1050 m² along the eastern slope of the Kapisillit Kuaat river mouth. Several collapsed, unidentified stone configurations protrude from the modern surface with a well-constrained midden exposed by erosion along the cobble beach. Historic artifacts (whiteware) observed in the midden profile along with well-preserved organics. Site may comprise numerous phases in Greenlandic cultural history. A square 18 m² cement foundation is observed overlooking the site heading up the slope to the east, most likely the remains of an old hunting cabin.

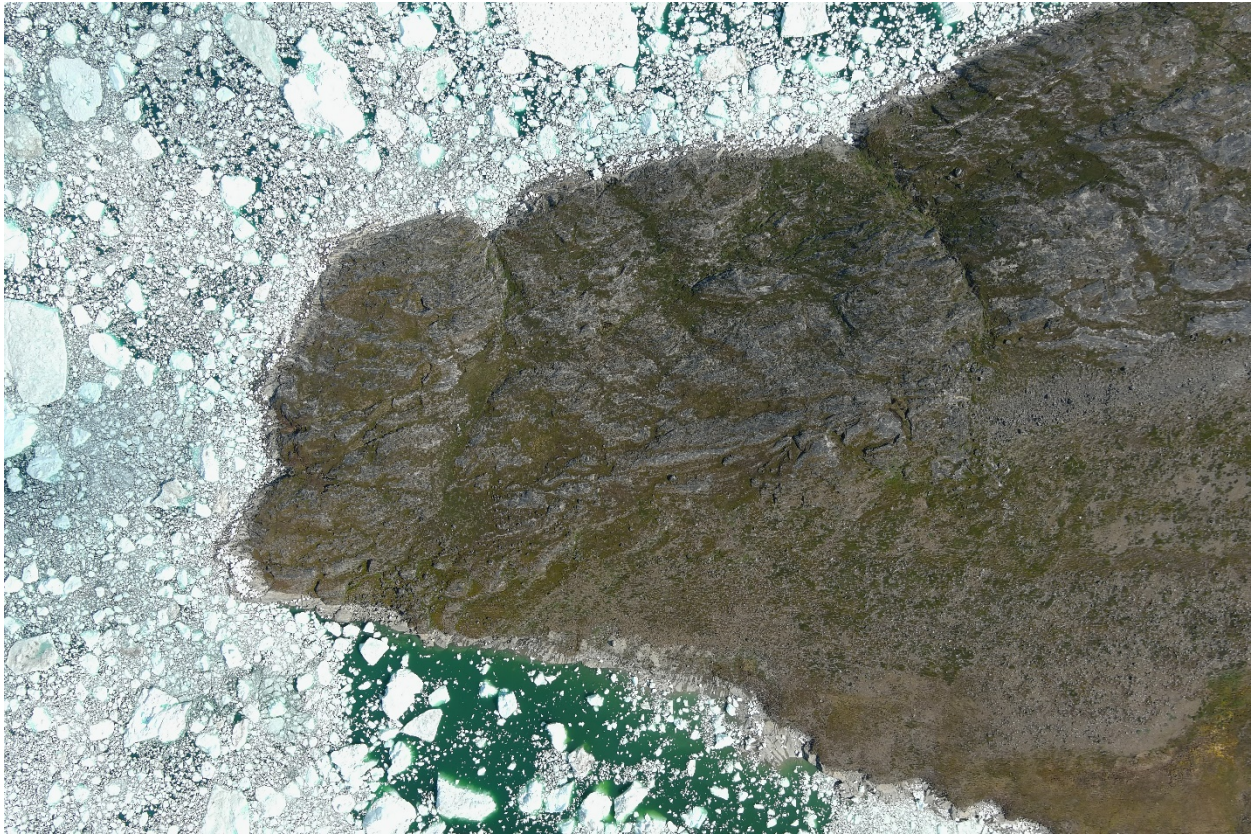
Fig. 8. Areal view of the Issusu peninsula extending into the Kangersuneq.

Fig. 8 provides a map of all archaeological remains identified on the Issusu peninsula in July 2022 along with corresponding descriptions for each feature.

history. **For all ancient remains detailed in the maps in Fig. 6 and Fig. 8 the ancient monument or structure must not be damaged, altered or moved, either in whole or in part and no disturbing activities can place within twenty meters (20 m) from the ancient monuments.** Scheduling must be respected by all parties who use the area where the ancient monument is located—regardless of when this designation was established.

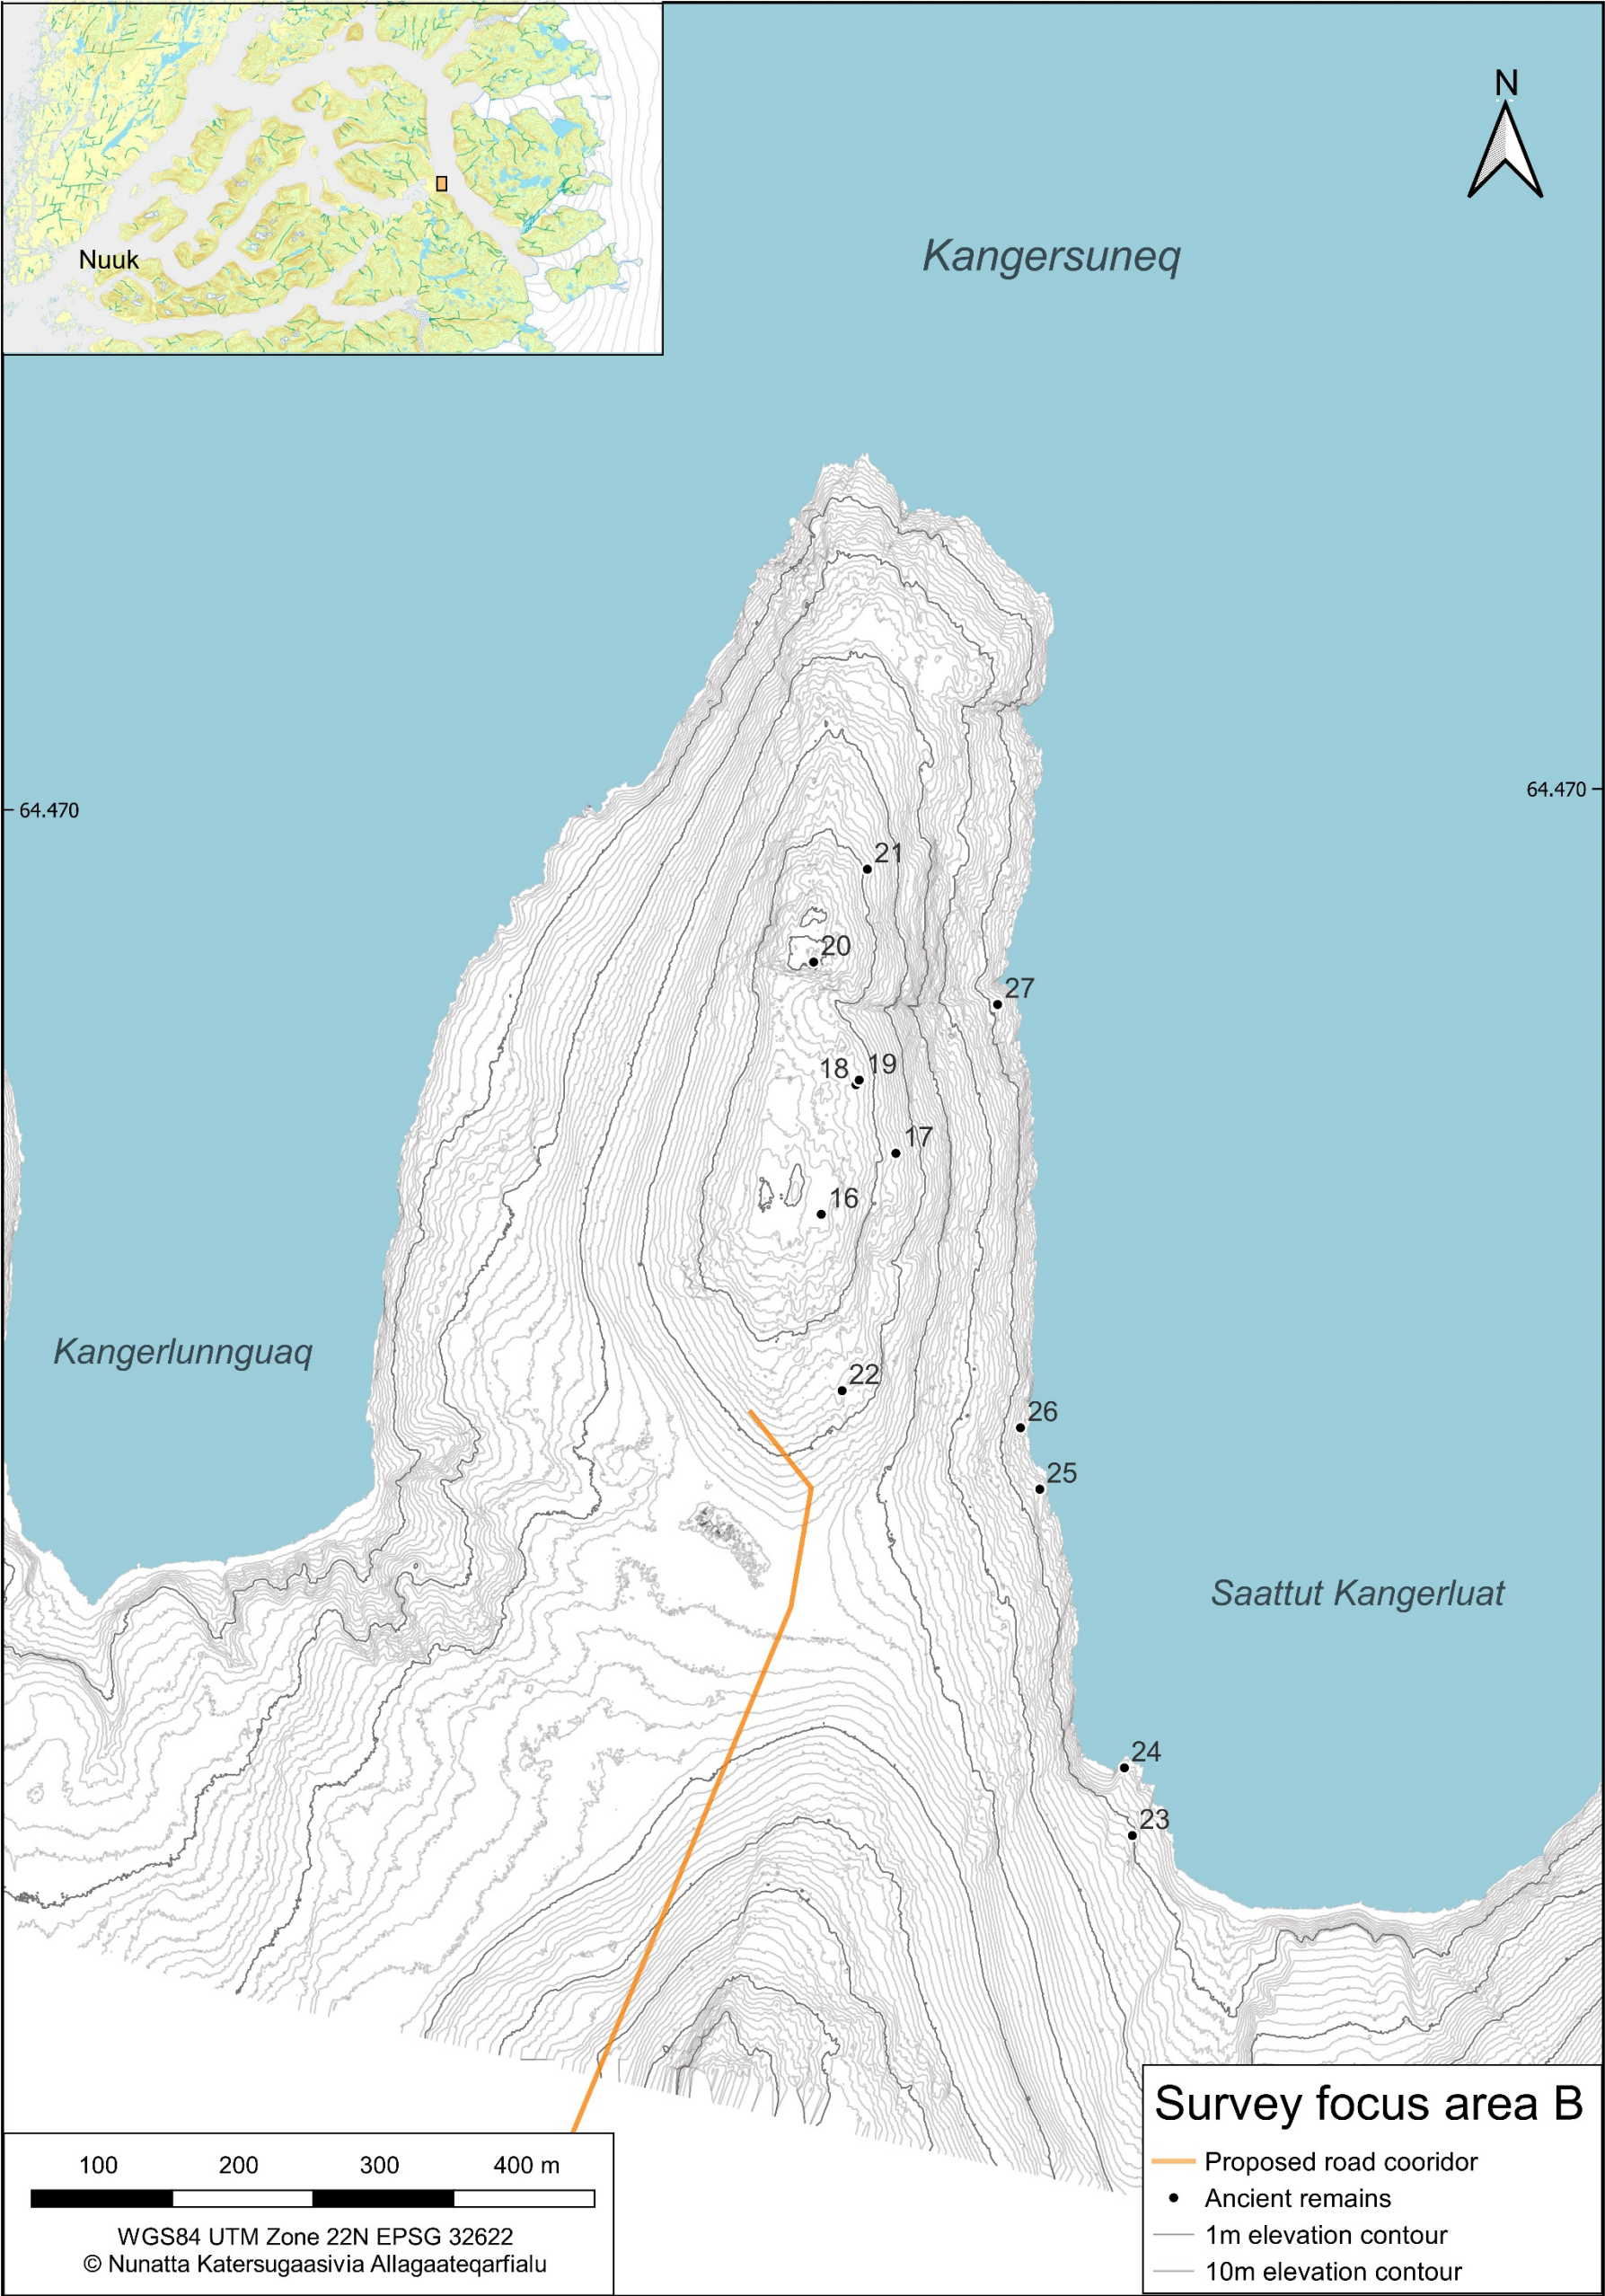
Fig. 9. Survey Area B with significant ancient remains (16-26) identified between 11-13 July 2022. Point 27 marks the location of a recently constructed memorial that should be avoided.

The second survey focus area encompasses the Issusu peninsula, where the Icefjord Lodge complex, restaurant and service buildings will be constructed. The peninsula possesses at least ten ($n=10$) archaeological remains in the form of fox traps and inussuit with several more found in the lower elevation areas. To the east of the peninsula, overlooking the Saattut Kangerluat, the support frame of a former hunting cabin is observed about 10 m above the present-day shoreline (#23). This former structure is likely associated with the fox traps found in the vicinity. These stone-built fox traps are generally delicate, and their stones can be easily manipulated or disturbed. Every effort should be made to avoid disturbing these features, leaving them to remain in place as they are on the landscape.

- A high concentration of fox traps are found on the eastern side of the Issusu peninsula. Within this report, the foxtraps are sufficiently documented to be considered not protected, i.e. they can be removed if they obstruct the development plans. However, we recommend that the current project plan adjust to the placement of cabins to accommodate these features on the landscape so as not to disturb them in their natural setting. These ancient features add value due to their authenticity and provide an opportunity to disseminate information about Greenlandic history and culture to guests who will stay at the Icefjord lodge.
- The memorial located at Point 27, although not protected heritage, should be respected and not disturbed. The memorial marker holds special meaning to the local community at Kapisillit and commemorates the untimely passing of a local community member.

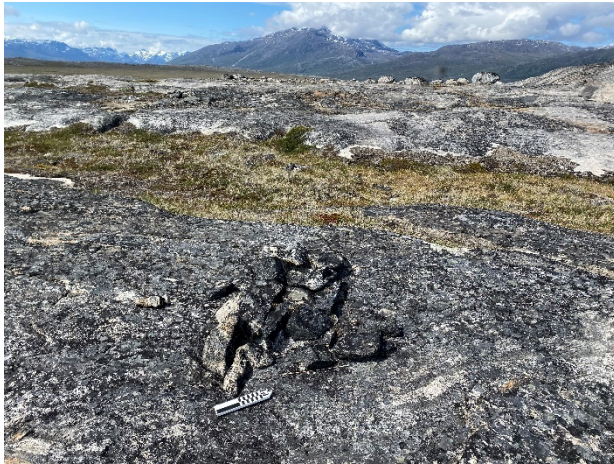
16. Fox trap, 64.46735493, -50.16958551

Collapsed fox trap feature found on exposed rock outcrop. North-south orientation; 19 cobbles. Very disturbed.

Length: 110 cm

Width: ca. 50 cm

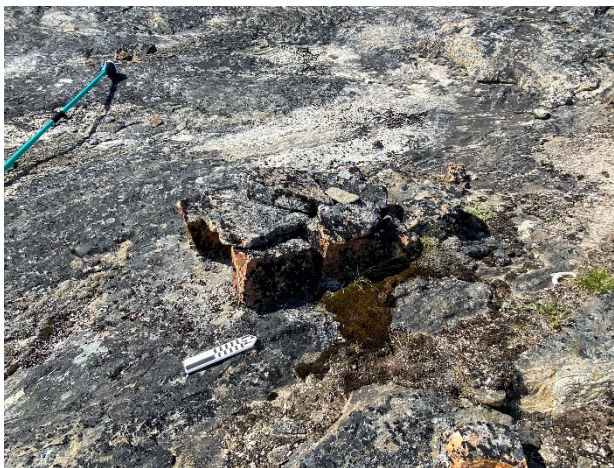
17. Fox trap, 64.46773726, -50.16847172

Extremely well-preserved fox trap located on exposed rock surface on the eastern side of the peninsula. North-south orientation. 13 stones.

Length: 120 cm

Width: 75 cm

Height: 30 cm

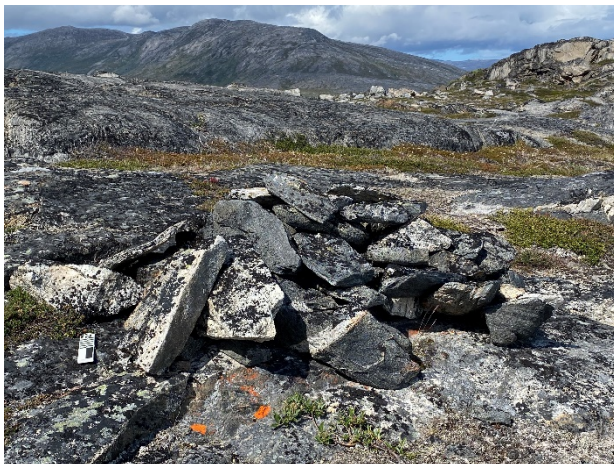
18. Fox trap, 64.46817838, -50.16904786

One of two fox traps located along a northeast-southwest orientation. Comprised of 50+ large, angular stones.

Length: 170 cm

Width: 120 cm

Height: approximately 50 cm

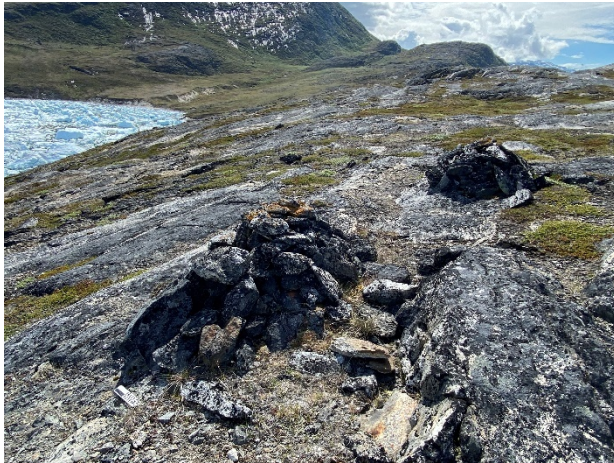
19. Fox trap, 64.46820711, -50.16899950

Second of two fox traps located along a northeast-southwest orientation. Comprised of 50+ large, angular stones.

Length: 200 cm

Width: 120 cm

Height: approximately 75 cm

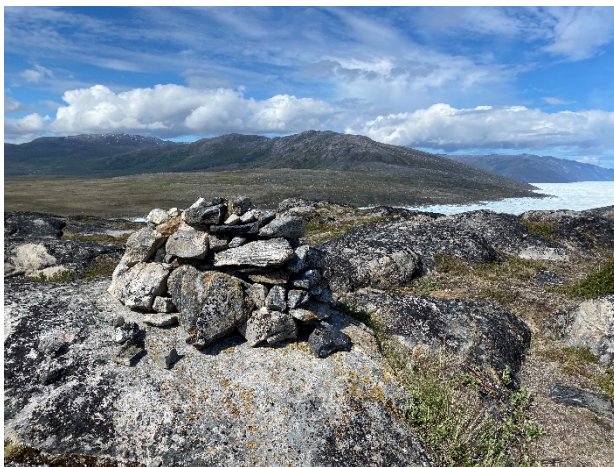
20. Inussuk, 64.46896354, -50.16964976

A circular inussuk placed on the exposed rock face with clear lines of sight in all four cardinal directions on the highest point of the peninsula. The inussuk is comprised of 75-100 large stones of different shapes and dimensions, most being large, angular cobbles and flagstones.

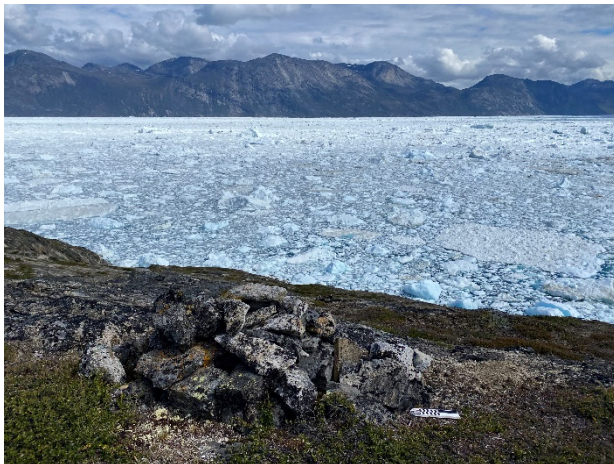
21. Fox trap, 64.46955041, -50.16883769

Fox trap located along a northeast-southwest orientation on bare rock outcrop on east side of peninsula. Comprised of 40-50 large, angular stones.

Length: 150 cm

Width: 100 cm

Height: approximately 50 cm

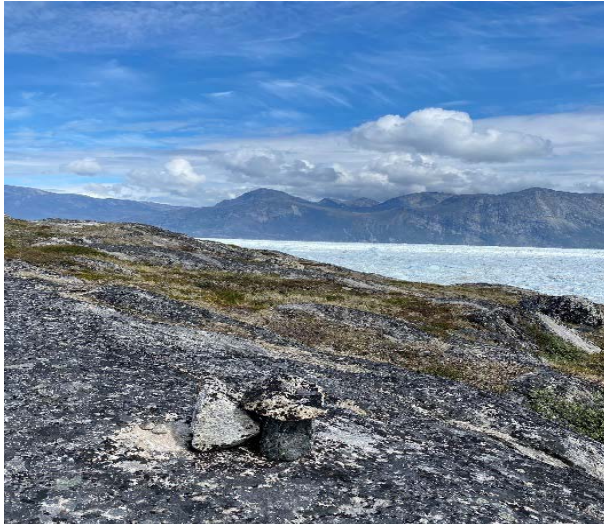
22. Inussuk, 64.46622896, -50.16931156

Landscape marker comprised of 3 large cobbles placed on exposed rock on the east side of the peninsula. Undetermined age.

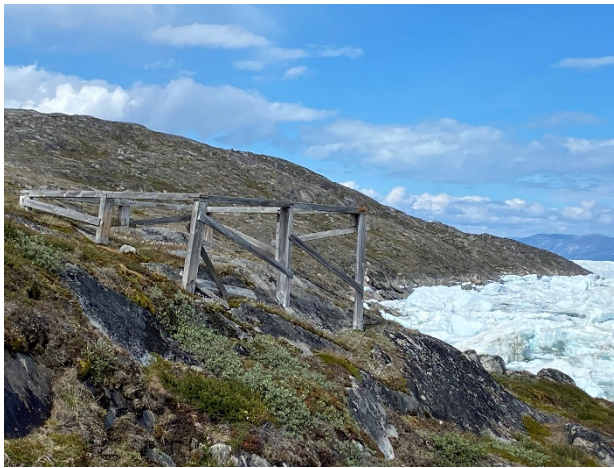
23. Hunter's cabin / hut frame, 64.46336921, -50.16511154

Wooden built frame marking the location of an old hunter's cabin or hut on a slope approximately 10 meters above the shoreline. Most of the original construction appears to have been removed/salvaged and all that remains is the weathered timber from the frame. This structure is likely associated with the many fox traps in the area.

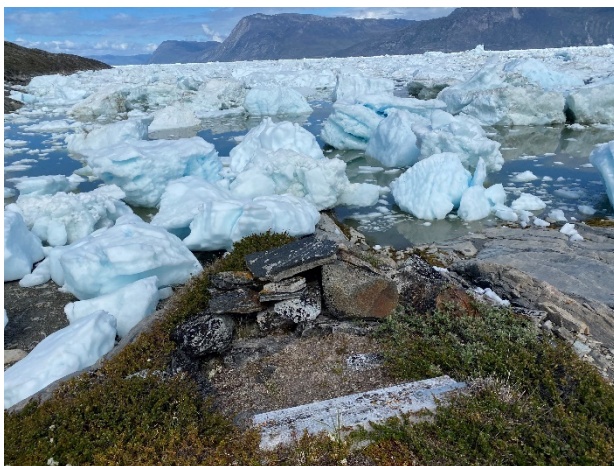
24. Undetermined feature, 64.46380151, -50.16521639

An unknown built feature above the shoreline. The feature comprises ~20 large, angular and rounded head-sized cobbles and flagstones with old, weathered lumber found in situ nearby. It may constitute the remains of a fox trap that was disassembled.

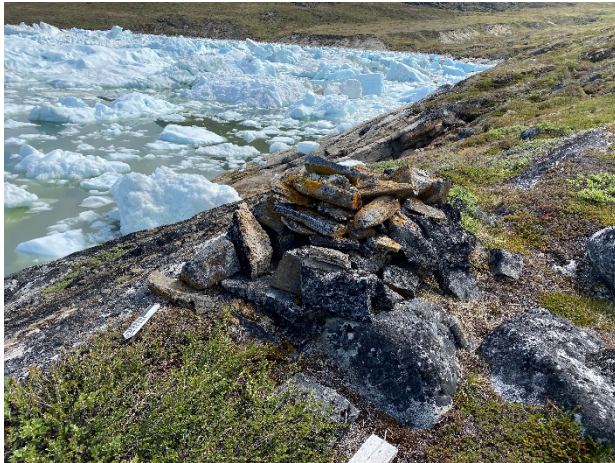
25. Fox trap, 64.46558422, -50.16641156

A very well-preserved fox trap located along a north-south orientation on bare rock outcrop on east side of peninsula, directly above the shoreline. Comprised of 50+ large, angular stones and flagstones.

Length: 180 cm

Width: 120 cm

Height: approximately 80 cm

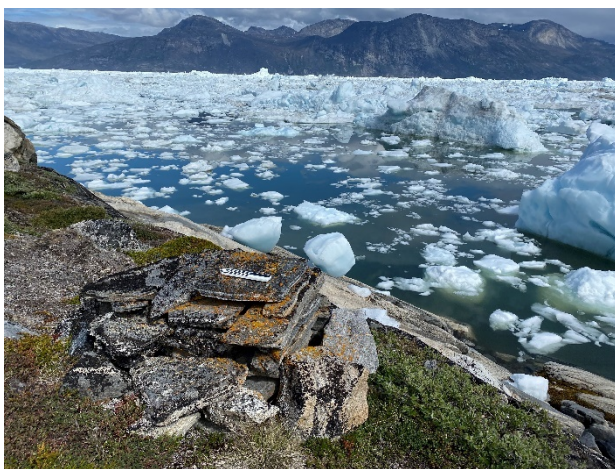
26. Fox trap, 64.46597743, -50.16668426

A very well-preserved fox trap located along a north-south orientation on bare rock outcrop on east side of peninsula, directly above the shoreline. Comprised of 75+ large flagstones.

Length: 160 cm

Width: 110 cm

Height: approximately 80 cm

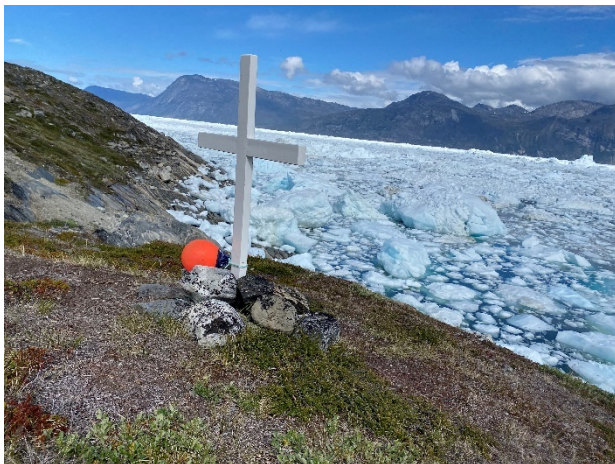
27. Cross memorial, 64.46867772, -50.16694035

A recently constructed memorial (ca. 2020) to commemorate the death of local hunter Jenseeraq Josefsen in 2019. Although the memorial is not protected heritage, it should not be disturbed, and no disruptive activity should take place in the vicinity of the marker.

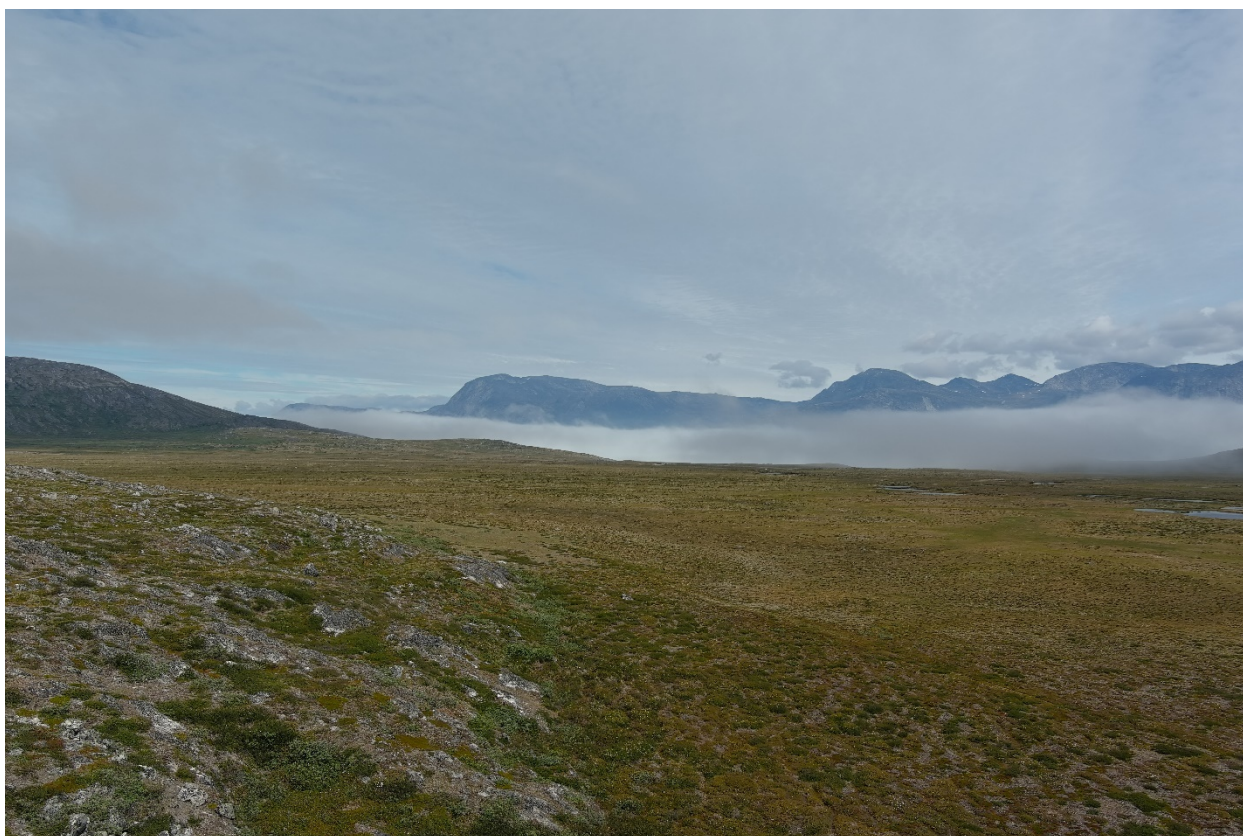
Fig. 10. Survey Area C, facing west.

Survey area C represents a relatively flat, undulating plain formed by the retreat of the ice in the far distant past. The area is a natural water cache for snow melt, making it wet and swampy with several shallow ponds scattered across the plain. No archaeological remains were observed in this area or lower terraces of the Niiggu mountain to the south. Based on the absence of archaeological features, no mitigation efforts are required at this time should a road be placed in this area.

- Although no ancient remains were identified in this area during our investigations, it is possible that some ancient monuments could be discovered in the area in the future. Should any ancient remains be suspected or identified during the course of construction, please contact the NKA and suspend work until a proper assessment of the situation can be made.
