# Investigation of permafrost degradation and coastal erosion at Sermermiut, 2024

Technical Reports of the  
**Greenland National Museum & Archives**  
No. 202501\_1

# Investigations of permafrost degradation and coastal erosion at Sermermiut, Ilulissat Icefjord UNESCO World Heritage site, Avannaata Kommunia 15–19 July 2024

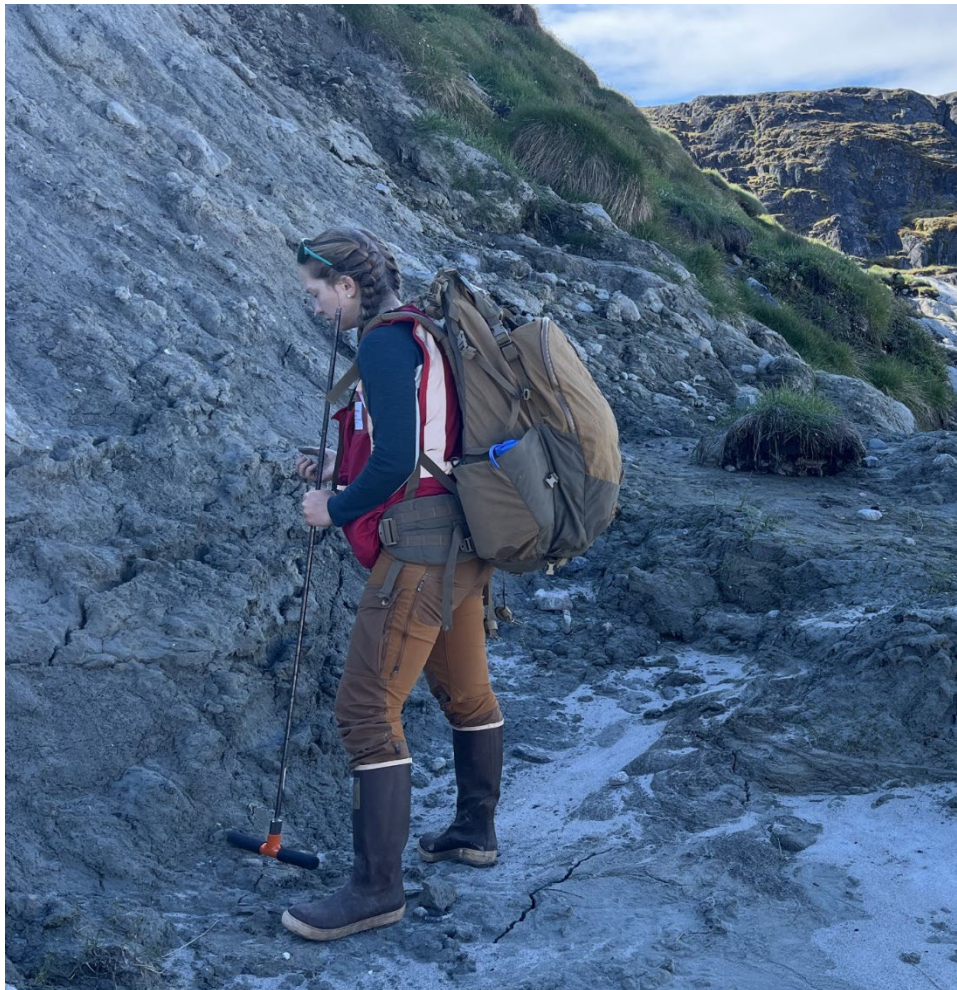
Figure 6. Claire Benton inspecting an exposed slope along the beach at Sermermiut. Photo: C. Shields, 2024.

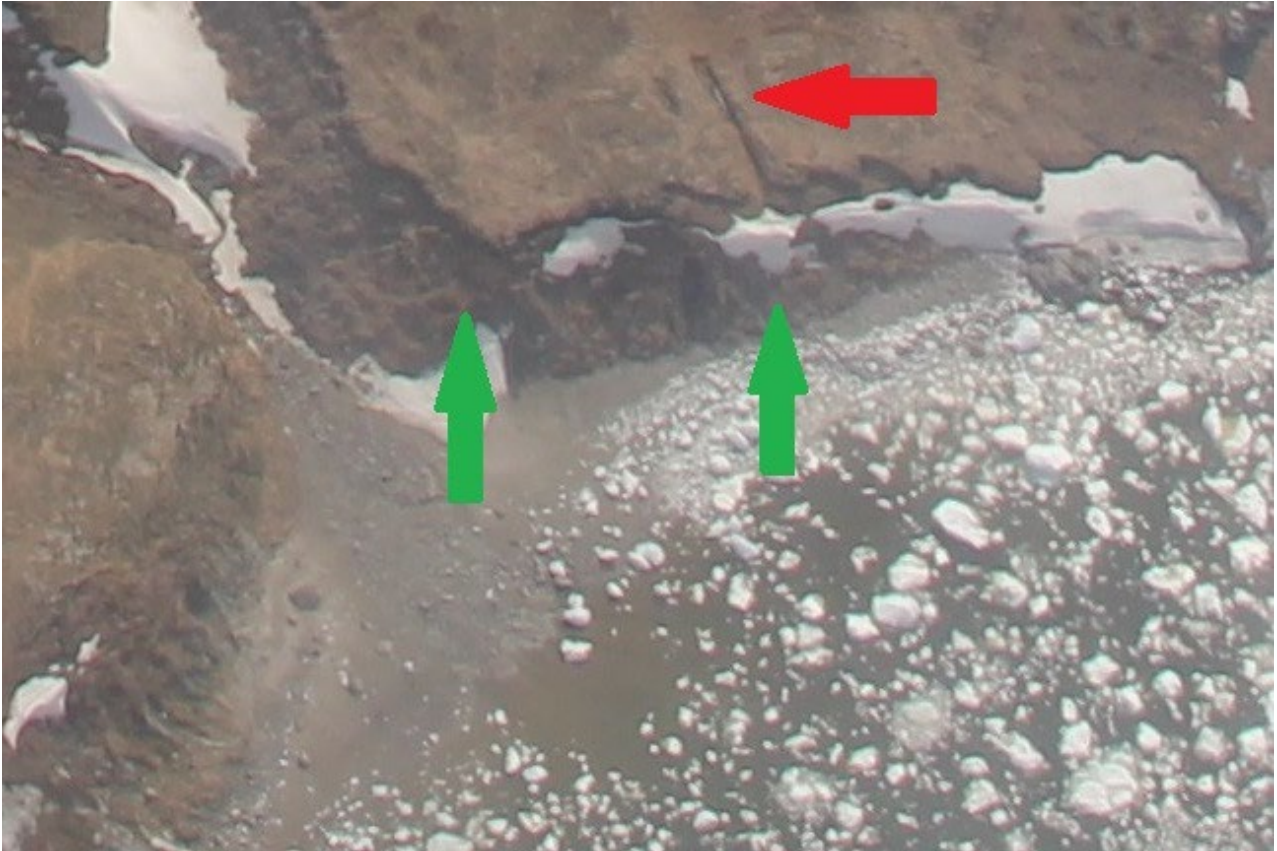
Around this same time, an in-depth report of the erosion at Sermermiut was provided by David Barry in 2004. Although the reporting consisted primarily of photo documentation, it was one of the first comprehensive attempts to establish a baseline for the progression of the erosion along the terrace slopes (Figs. 9 and 10). Barry concluded by proposing that the erosion at Sermermiut was the result of freshwater runoff and snowmelt. Erosion due to marine mechanics was assumed to be minimal, with only 3–5 meters of coastline retreat since 1995.

Figure 10. Erosion of the coastal slope visible from the air (green arrows), as well as the trench excavated by Meldgaard in 1953 and Mathiassen in 1955 (red arrow). D. Barry (2004).

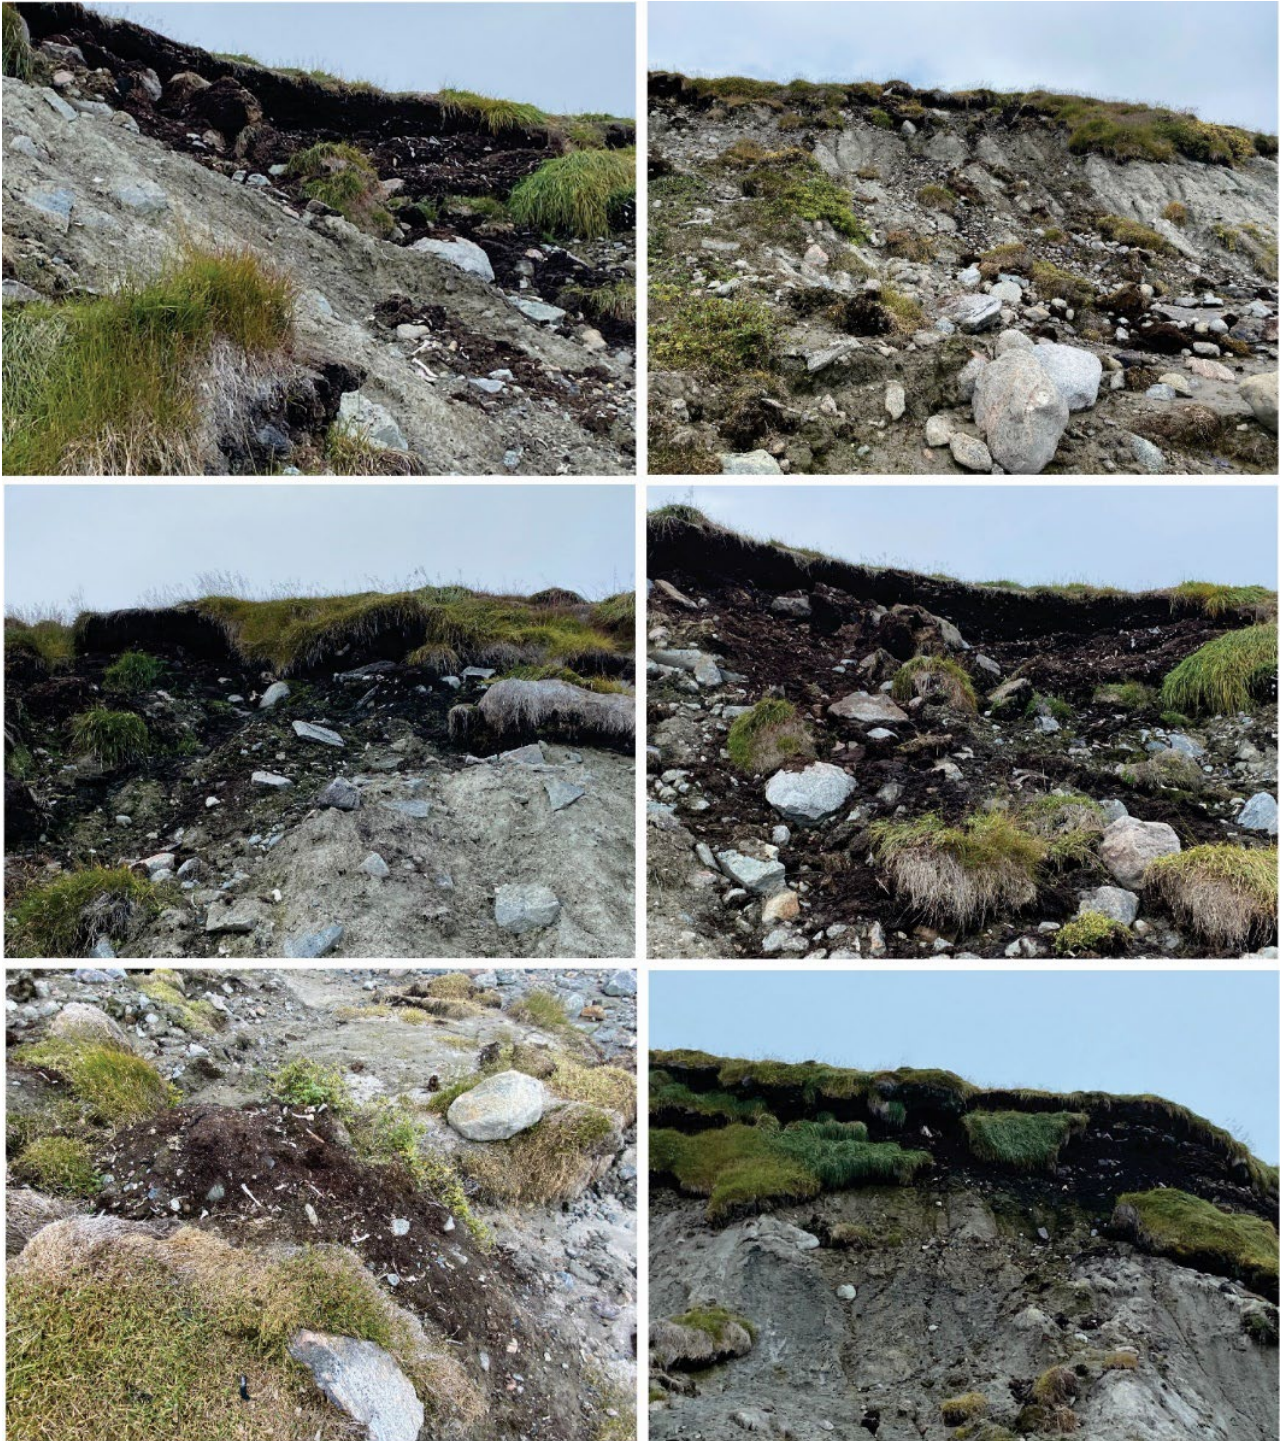
During an ITAP visit to Sermermiut in September 2023, the effects of rapid environmental change were starkly apparent. During the tour, the UNESCO Site Manager highlighted the accelerating erosion occurring at several areas along the bluff face, a concerning trend that appeared to be increasing due to the particularly heavy precipitation that summer. The ongoing detachment of turf along the upper bluffs and subsequent erosion resulted in the exposure of substantial amounts of faunal material that migrated down the slope towards the beach (Fig. 11). The loss of these materials not only diminishes the historical integrity of Sermermiut but also represents a loss of critical information about past human habitation in this region. This situation underscores the vulnerability of archaeological sites to the effects of climate change and the urgent need for measures to consider future scenarios for site conservation or mitigation of the erosion along the slopes.

Figure 11. Erosion documented at Sermermiut in September 2024. Photos: H. Harmsen, 2024.

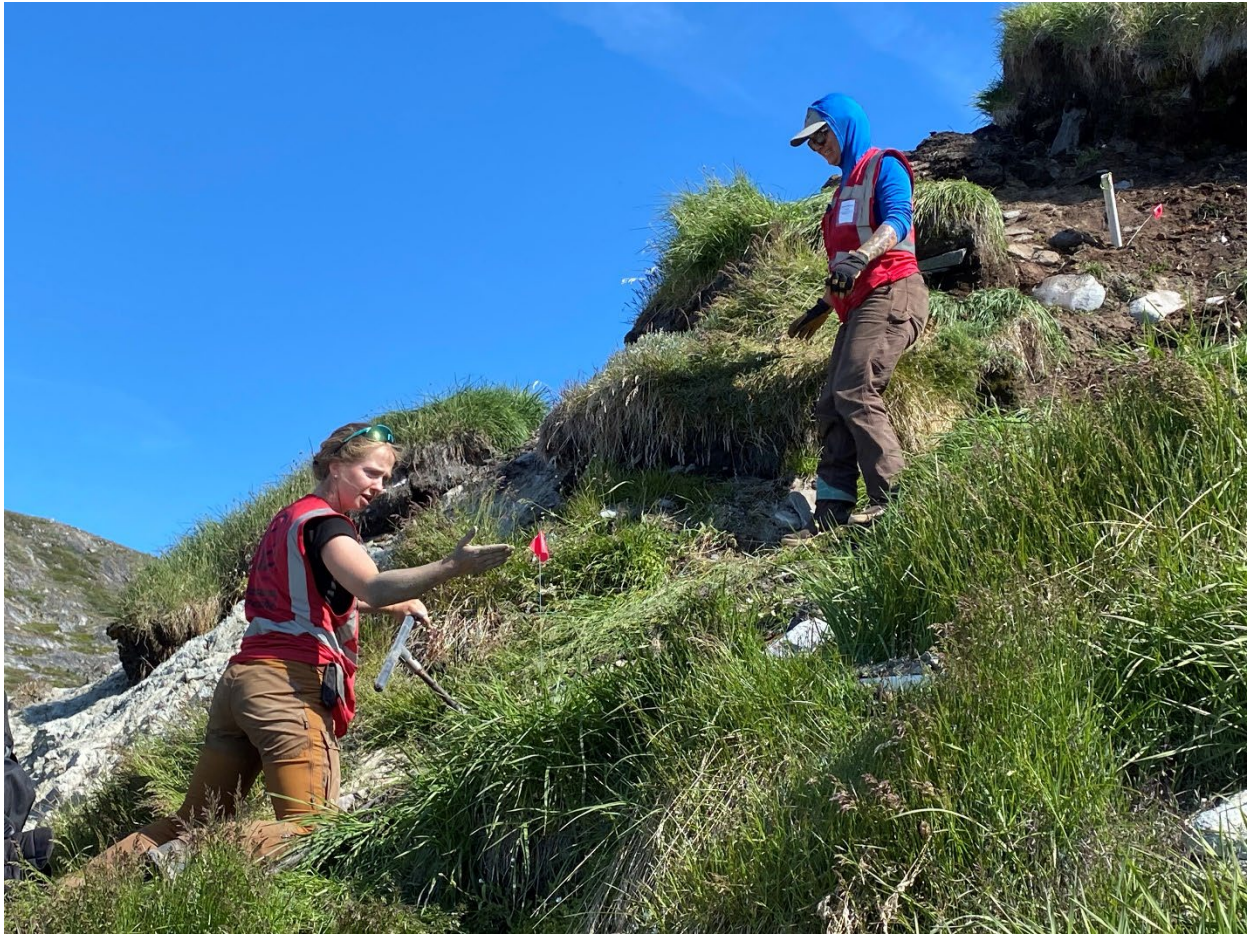
Figure 12. Claire Benton and Christina Bonsell profiling one of the eroding slopes at Sermermiut. Photo: H. Harmsen, 2024.

Over the course of our visit, we recorded careful observations, notes, and photos of the site (Fig. 12). Our focuses included: vegetation, soil surfaces, areas of active and past erosion, morphology of the beach and bluff system, and evidence of wave activity and coastal processes. Discussions with Park Ranger Aron Petersen provided valuable information, including insight on environmental conditions that helped determine the placement of monitoring instruments and understand local oceanography.

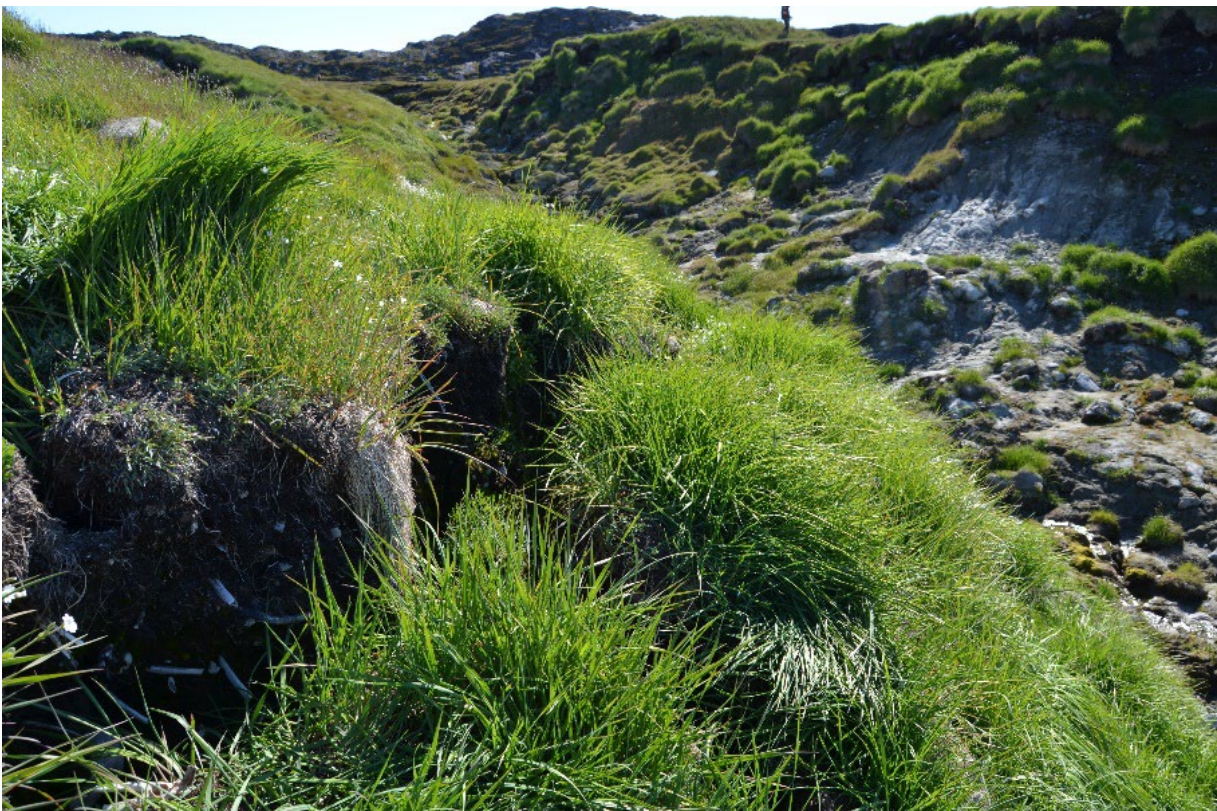
At areas of steep slope gradient around Sermermiut, the ground is visibly failing in large volumes within the cultural layer (former structures and middens) of the soil by an erosion process called thermal denudation (Aré 1988). A high volume of coarse fragments, such as rocks and faunal bones, exists within the top 1 to 2 meters of soil; these coarse fragments are highly susceptible to thermal and gravitational erosion. The mineral subsoil below consists largely of fine-grained marine sediments and appears to seep out from underneath the cultural layer. While the fine-grained subsoil erodes out from underneath the cultural layer, the ground surface at Sermermiut responds to the weight of the unsupported cultural layer in expanding cracks that precede slumping or toppling erosion events (Fig. 13).

Figure 13. Cracks in the tundra at Sermermiut expose faunal bones in the middens as the ground begins to slump away. Photo: C. Benton, 2024.

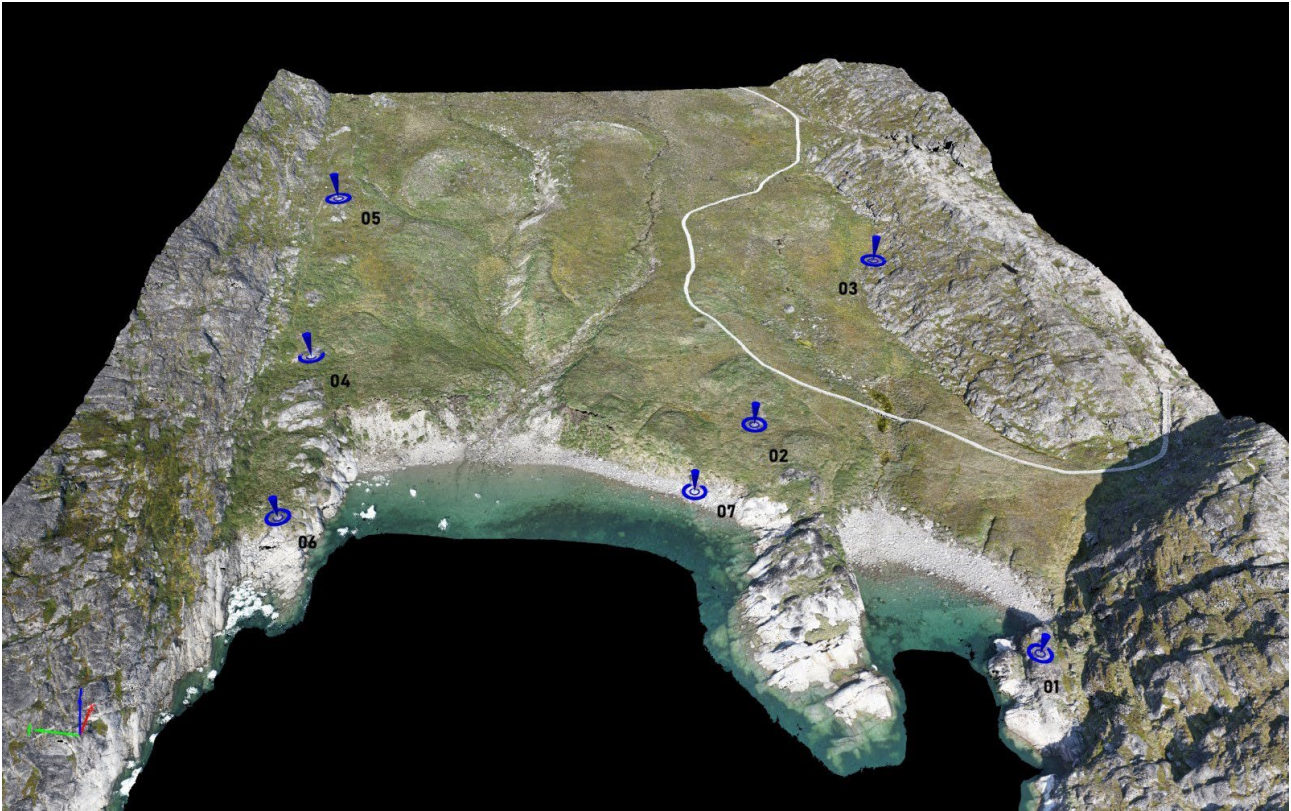
Figure 16. 2024 Sermermiut point cloud showing the newly established GCPs. Data source: Greenland National Museum and Archives, 2024.

Prior to the arrival of the team on-site, Inuplan A/S was contracted by Avannaata Kommunia (Isfjordskontoret) and the NKA to establish seven ground control points (GCPs) at Sermermiut (Fig. 16). The GCPs will be used for future unmanned aerial vehicle (UAV) surveys of the area. The GCPs were surveyed using real-time kinematic global navigation satellite system (RTK-GNSS) equipment with an anticipated 3D accuracy of 20–30 mm relative to selected reference network (i.e., geodetic benchmarks). The coordinates are provided in GR96 UTM zone 22 (horizontally) and local MSL (vertically). These are the same reference systems used for most official technical and

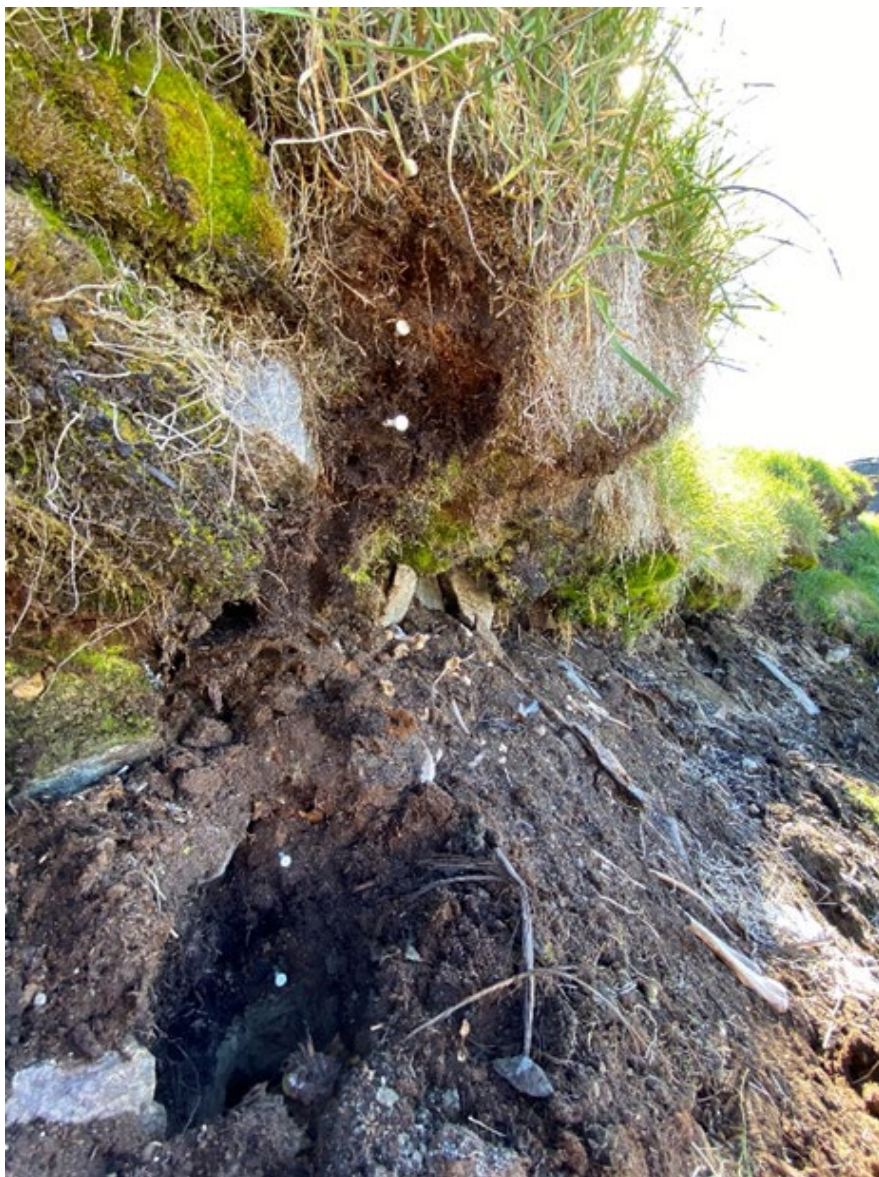
Five soil profiles were surveyed to document physical, chemical, and thermal aspects of the soil, which can be correlated with and supplement historic descriptions of the soil (Fredskild 1961; Larsen and Meldgaard 1958). A modified Pedon Description Form from the USDA Natural Resources Conservation Service (NRCS) was used to document soil (pedon) and site data (Soil Survey Staff 2024). Soil profiles were prepared and extracted using minimally invasive shovel slices, knife cuts, and hand-operated augers on the bluffs (Fig. 21) and using hand-operated augers in the thawed active layer and a Shaw Backpack Drill in frozen layers. Soils were described following NRCS standards (Soil Survey Staff 2024), with additional data collected for depths greater than two meters, ice volume, and cryostructures.

Figure 21. A soil profile exposed along the bluff face, with white markers indicating transition zones. Photo: C. Benton, 2024.

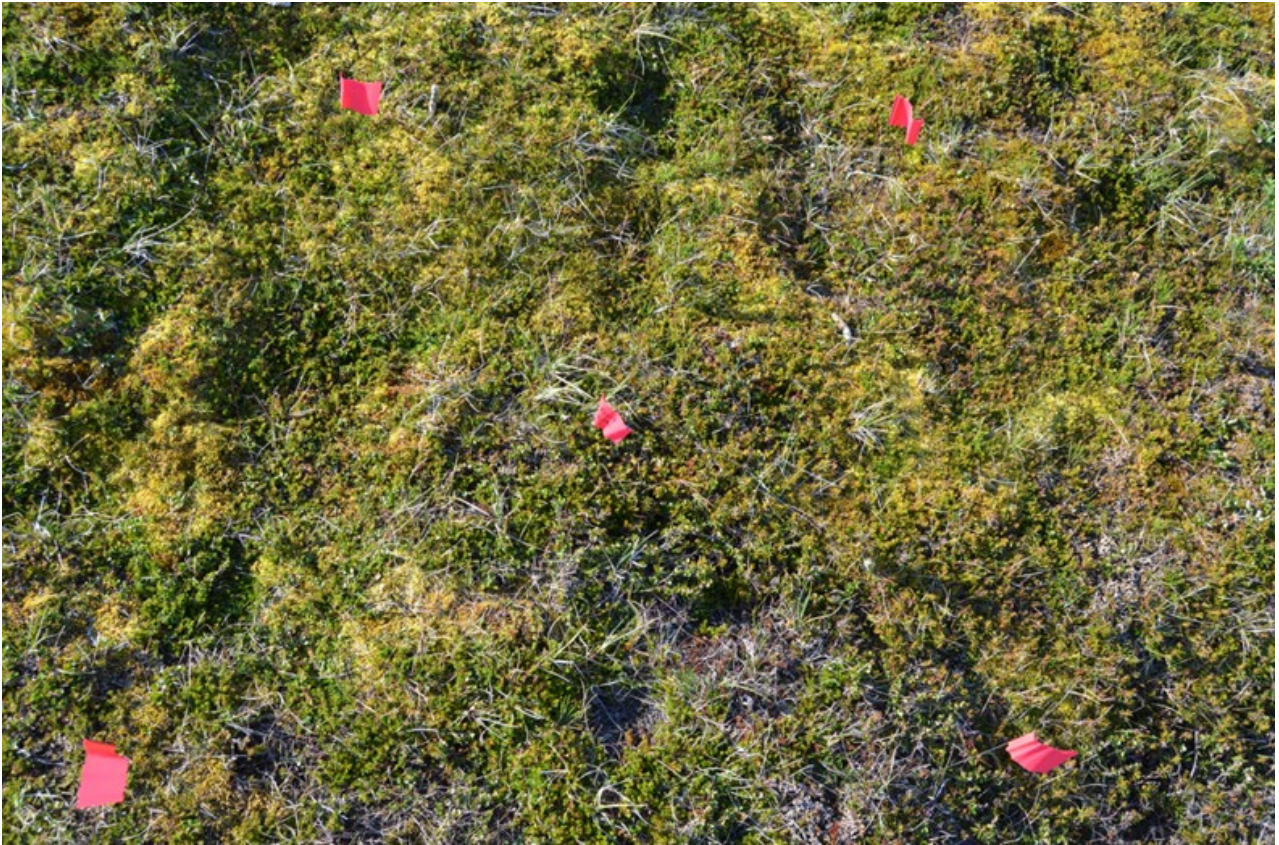
Figure 22. Pin flags marking the corners and center of a 1 m<sup>2</sup> vegetation quadrat. Photo: C. Benton, 2024.

Site, pedon, and vegetation plot data (Fig. 22) is stored in the USDA's National Soils Information System database. PDF copies of all datasheets will be stored on the team's DOI Sharepoint web page.

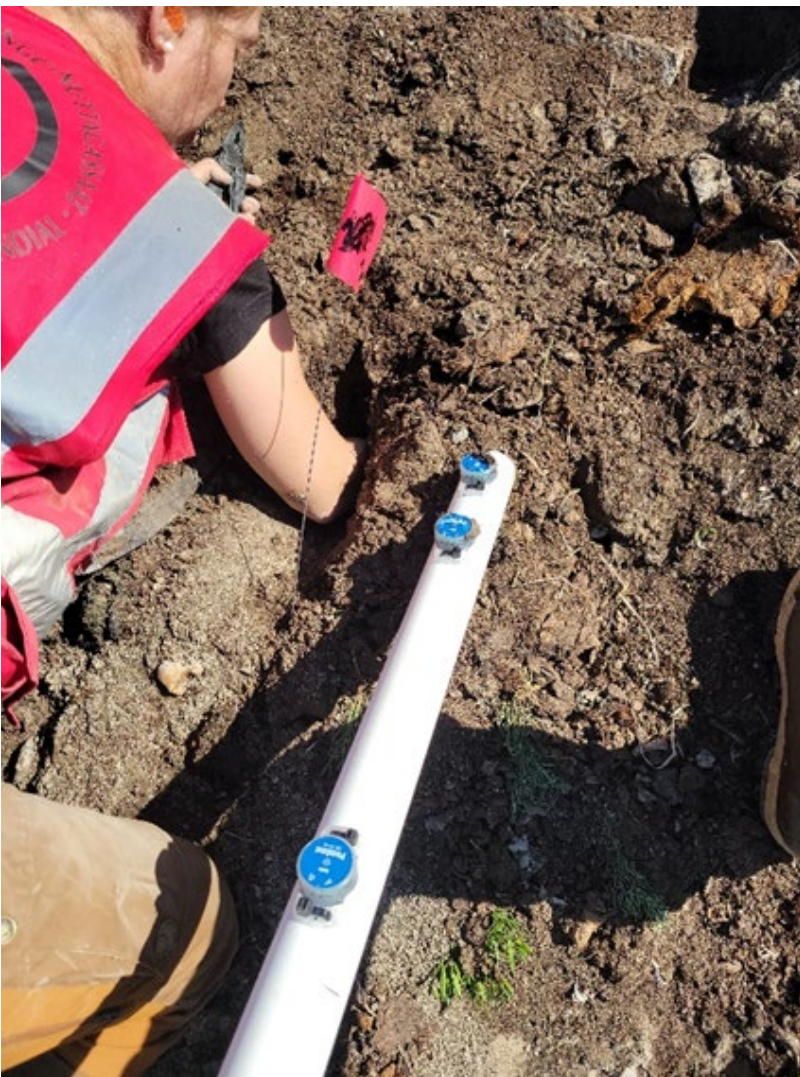
Figure 23. Soil temperature datalogger array showing three different dataloggers set to be installed at different depths. Photo: C. Bonsell, 2024.

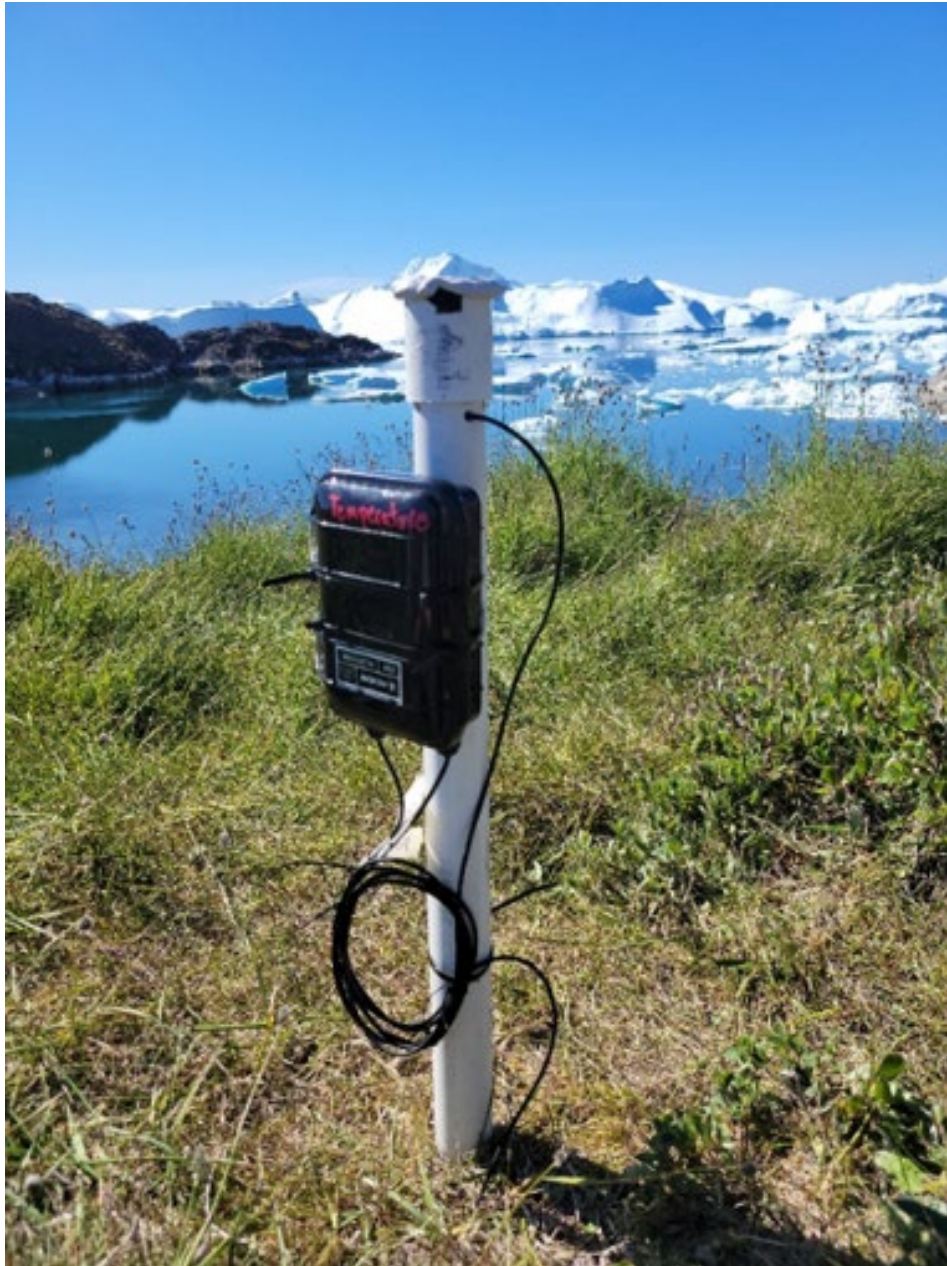
An additional temperature datalogger (HOBO MX2301A) was installed at frost tube site 1-03 to collect air (approximately 60 cm above surface within the mounting tube) and surface soil (approximately 2 cm depth) temperature over the year (Fig. 24). The data from this datalogger can be downloaded any time using the HOBOLink cell phone application.

Figure 24. Air and surface soil temperature datalogger at site 1-03. Photo: C. Bonsell, 2024

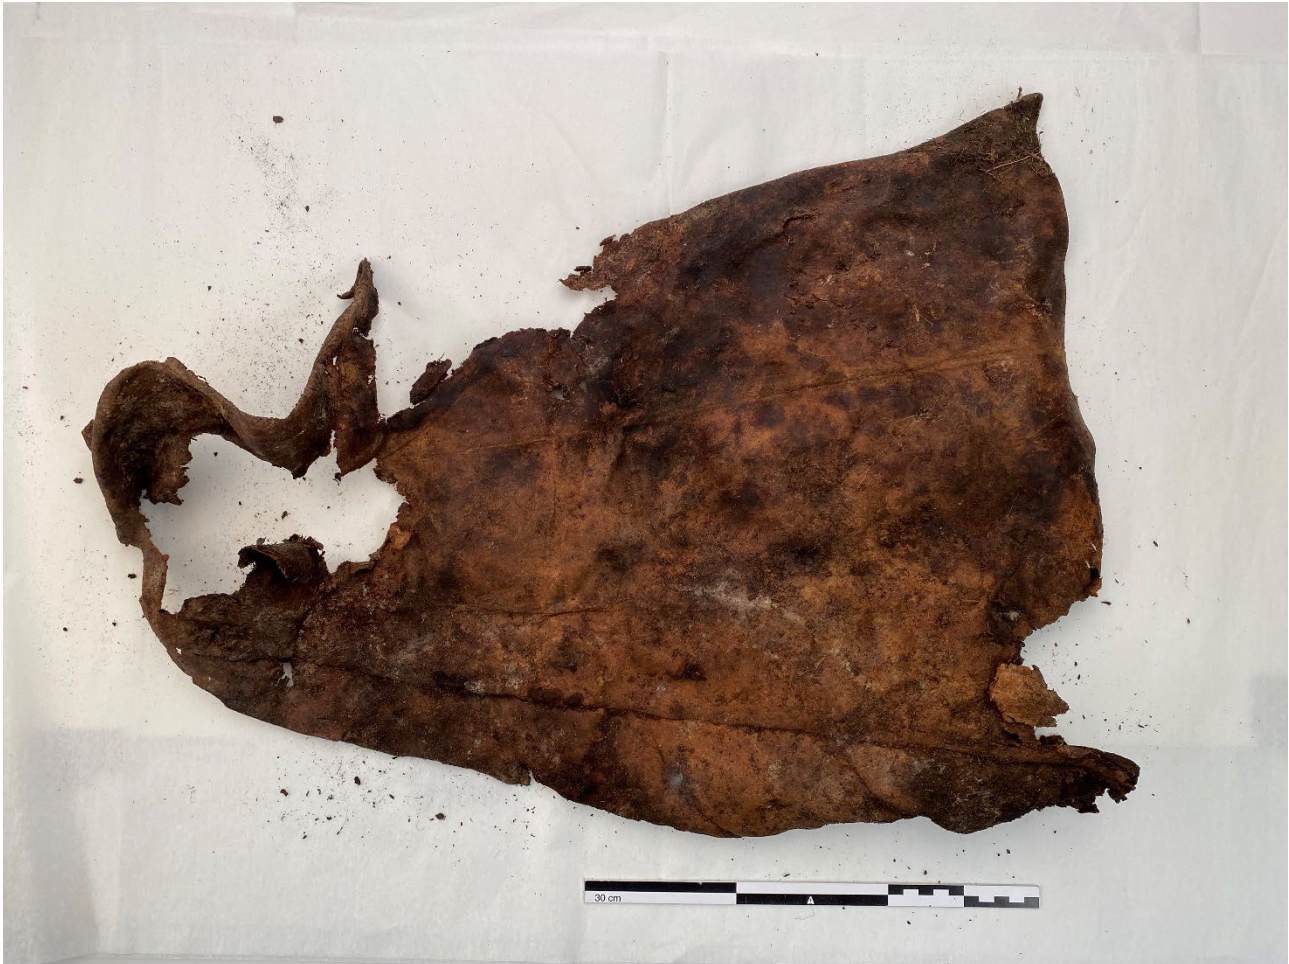
Figure 26. Seal skin recovered from eroding slope at Sermermiut. Most likely from a kayak. Photo: H. Harmsen, 2024.

A significant portion of our fieldwork in July was dedicated to documenting the substantial amount of archaeological material eroding from the middens along the bluff edges and cascading down the slope to the beach. This material comprised a mixture of midden waste and structural remnants from submerged house features, including turf walls, cobbles, and flagstones that would have formed dwelling floors. The non-structural component primarily consisted of processed and discarded faunal remains, many of which exhibited remarkable preservation. However, the sheer volume of these remains scattered across the newly eroded slopes and beach necessitated a selective approach to artifact collection. We limited our retrieval to three objects: (1) a large section of seal skin, most likely part of a kayak (Fig. 26); (2) a small piece of worked wood (Fig. 27); and (3) an ivory fragment, likely once part of a harpoon shaft (Fig. 28). These artifacts are now securely stored at the Greenland National Museum in Nuuk.

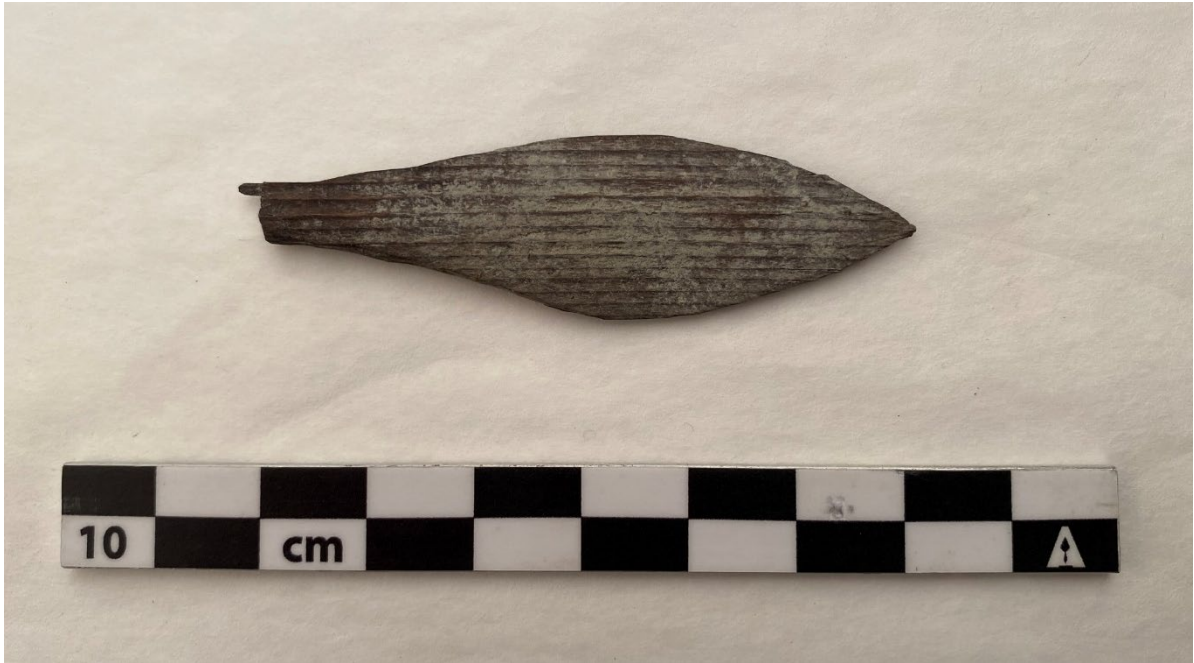
Figure 27. Worked wood fragment from Sermermiut. Possibly part of a toy paddle or oar. Photo: H. Harmsen, 2024.

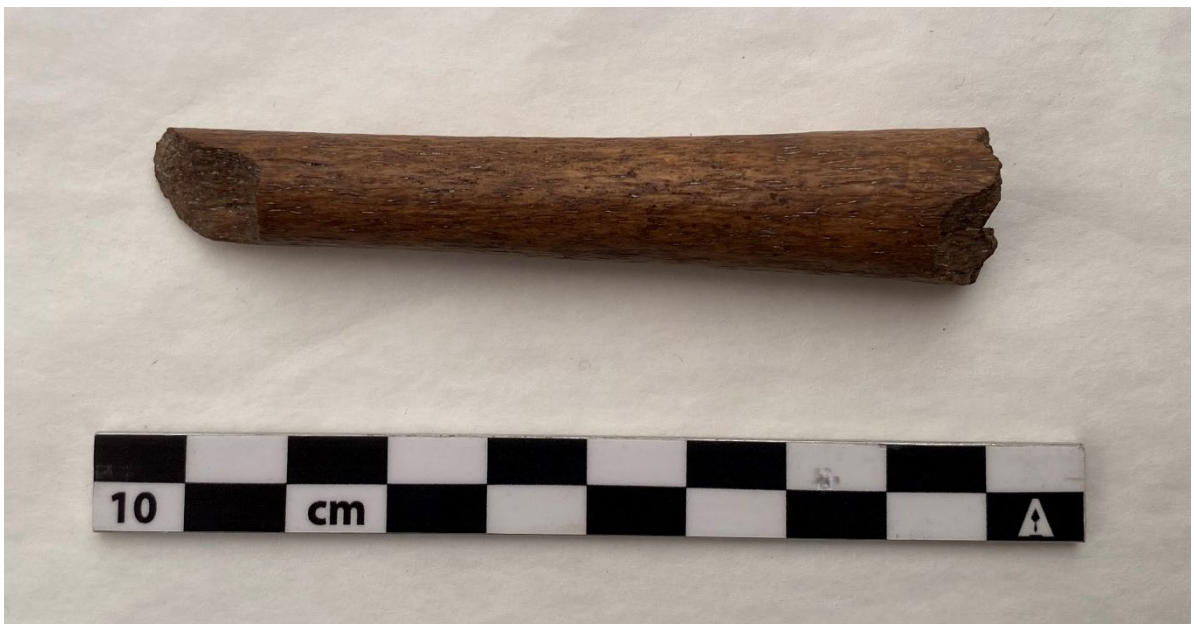
Figure 28. Ivory fragment from Sermermiut. Most likely part of a harpoon shaft. Photo: H. Harmsen, 2024.

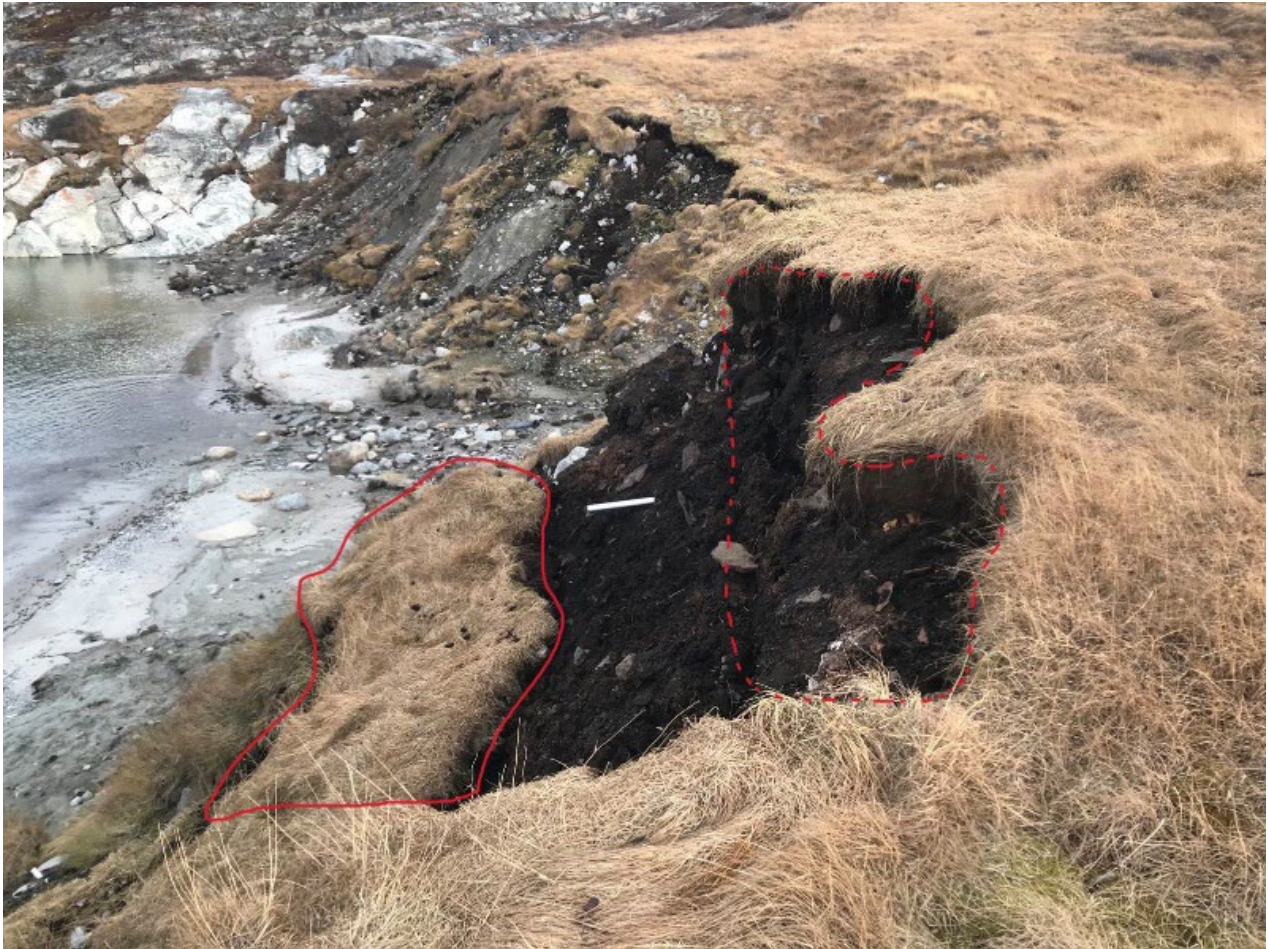
Figure 29. Erosion event recorded in October 2024. Photo: B. Albrechtsen, 2024.

On 3 October 2024, a recent erosion event was noted during a visit for repeat photography. This event occurred between the 30 August and 3 October site visits. A block of soil with an approximate surface area of  $13 \text{ m}^2$  and volume of  $5.9 \text{ m}^3$  detached from the bluff edge in one cohesive unit (Fig. 29). The detachment occurred above site 001 and buried sensor 001-2 (Figs. 30–32). This block slid partway down the slope, exposing and displacing multiple artifacts from the bluff. No visible ice was present on the newly exposed face.

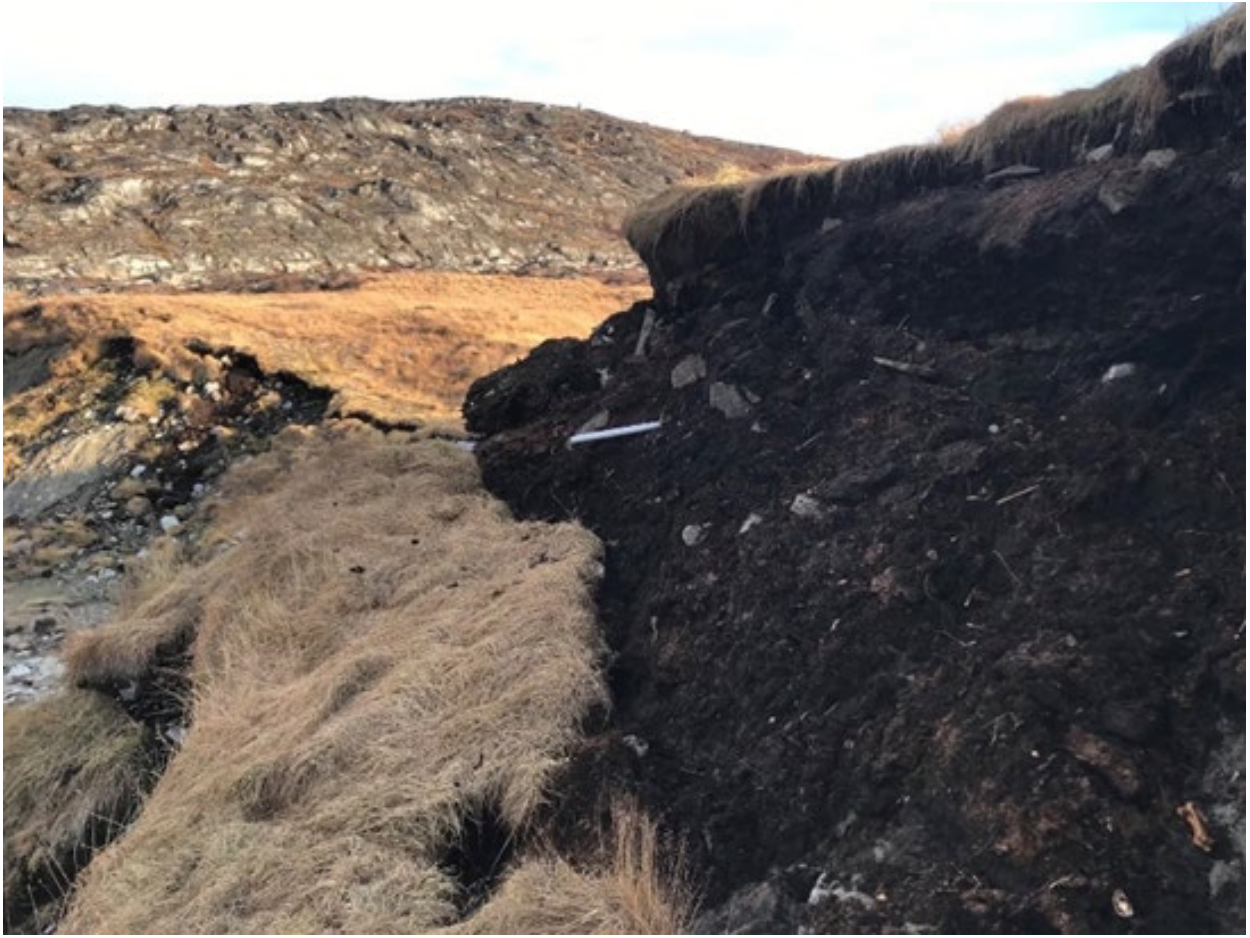
Figure 30. Main failure unit from fall 2024 erosion event. Photo: B. Albrechtsen, 2024.
