SURVEY REPORT OF IKKATTEQ, BLUIE EAST 2 (BE-2)
SEMERSOOQ MUNICIPALITY, EAST GREENLAND

REPORT PREPARED BY:

HANS HARMSSEN
MIKKEL MYRUP
HANS LANGE

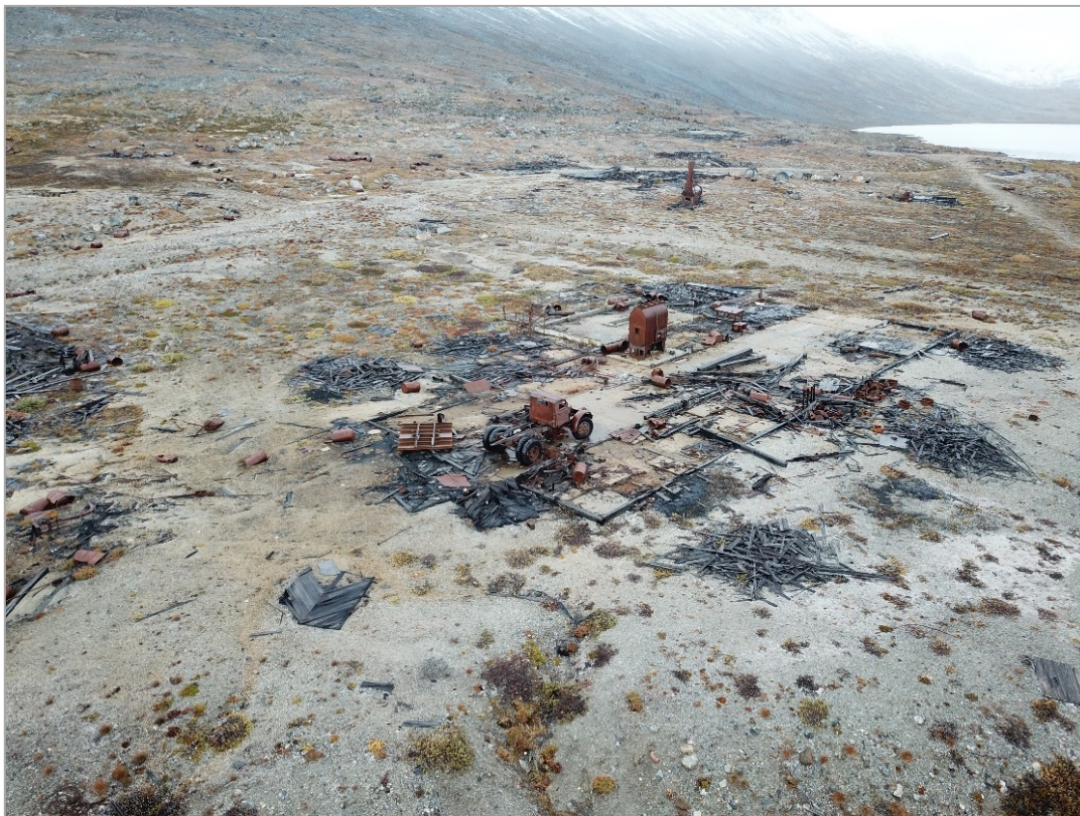
Fig. 6. An areal view of a portion of the main camp area facing north. The remains in the photo may likely be the location of the camp machine shop or maintenance garage (photo: H. Harmsen 2018).

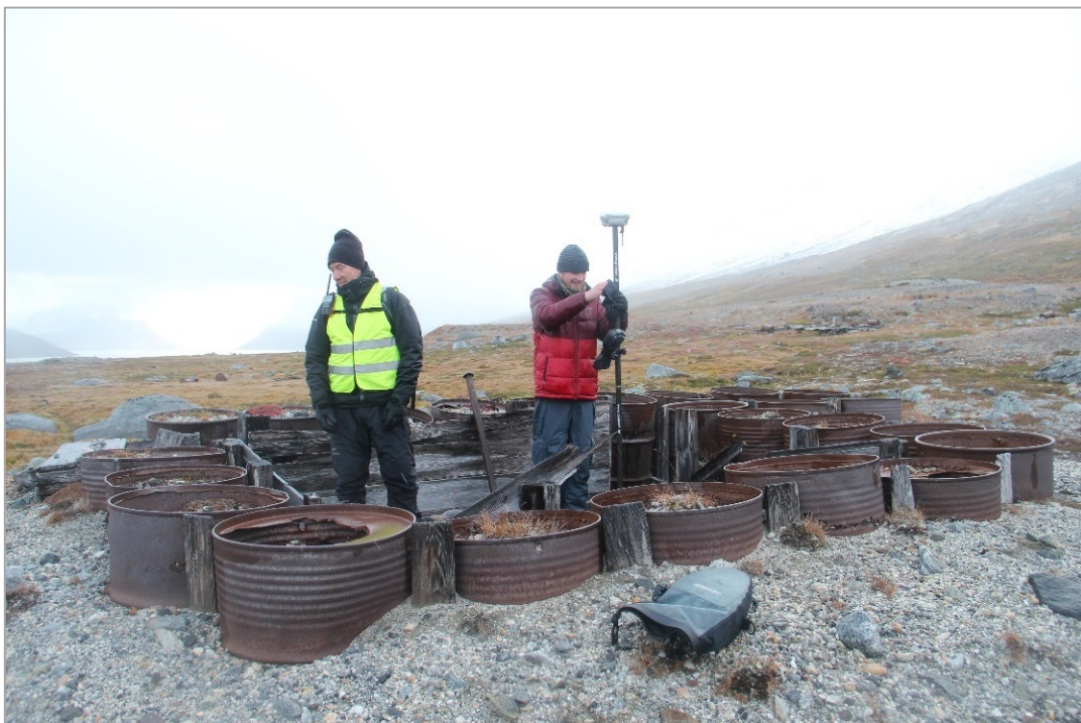
Fig. 9. Sixteen ($n=16$) earthenwork anti-aircraft gun defenses are found scattered around B-E2. Myrup and Harmsen observed inspecting the feature (photo: H. Lange 2018).

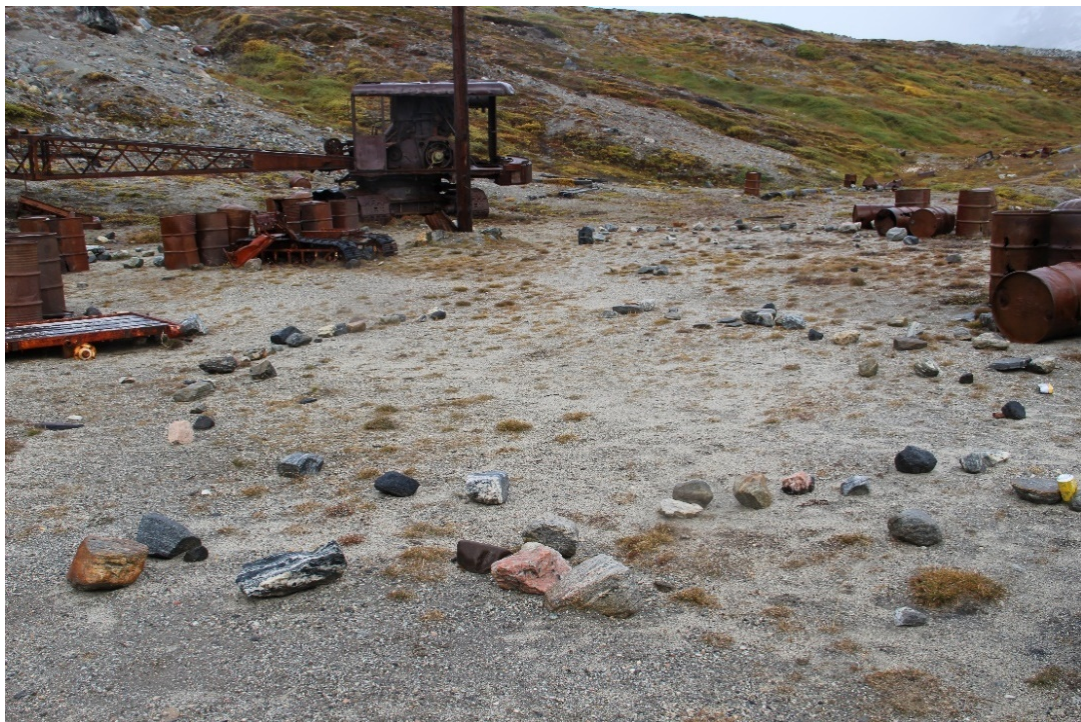
Directly south of the runway on the beach front lies a concentration of discarded vehicles, heavy machinery, building remains and a wooden pier. This area was the harbor area and would have been the used for offloading fuel deliveries, materials and provisions from supply ships. Recent visits by local people to BE-2 were evidenced by a circular stone tent ring, as well as more modern garbage strewn around the harbor area (Fig. 11).

Fig. 11. Evidence of recent visits by locals to BE-2. A stone tent ring and modern trash was observed in the area immediately adjacent to the old wooden pier. The harbor crane can be seen in the background of the photo (photo: H. Lange 2018).

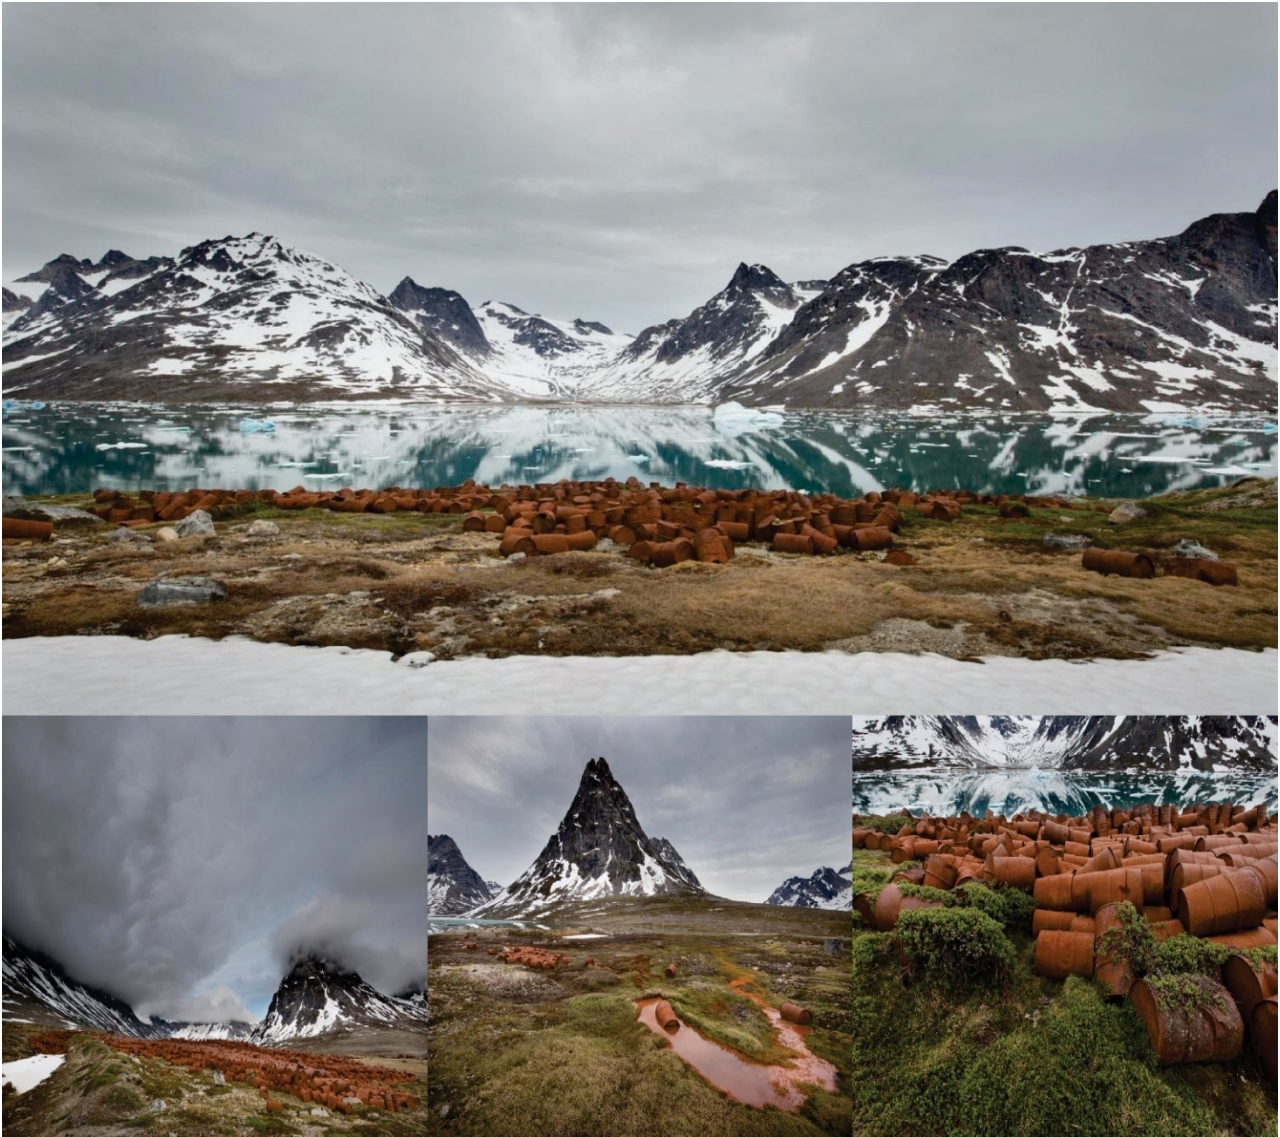
The most overarching feature of BE2 are the extensive fields of empty, rusting 55-gallon aircraft fuel barrels (Fig. 12). Referred to by locals from the area as 'the American flowers' (*Amerikanske blomster*), the discarded barrels cover a collective surface area of approximately three hectares. This figure should be measured against the fact that in many individual locations, barrels may be piled as much as two to three layers deep—making it difficult to statistically approximate the total number of barrels currently present at the site.

Fig. 12. Dramatic images of the barrel fields at BE-2 (photos: Ken Bower, 2016, from <http://www.ken-bower.com/> (reproduced here without permission).

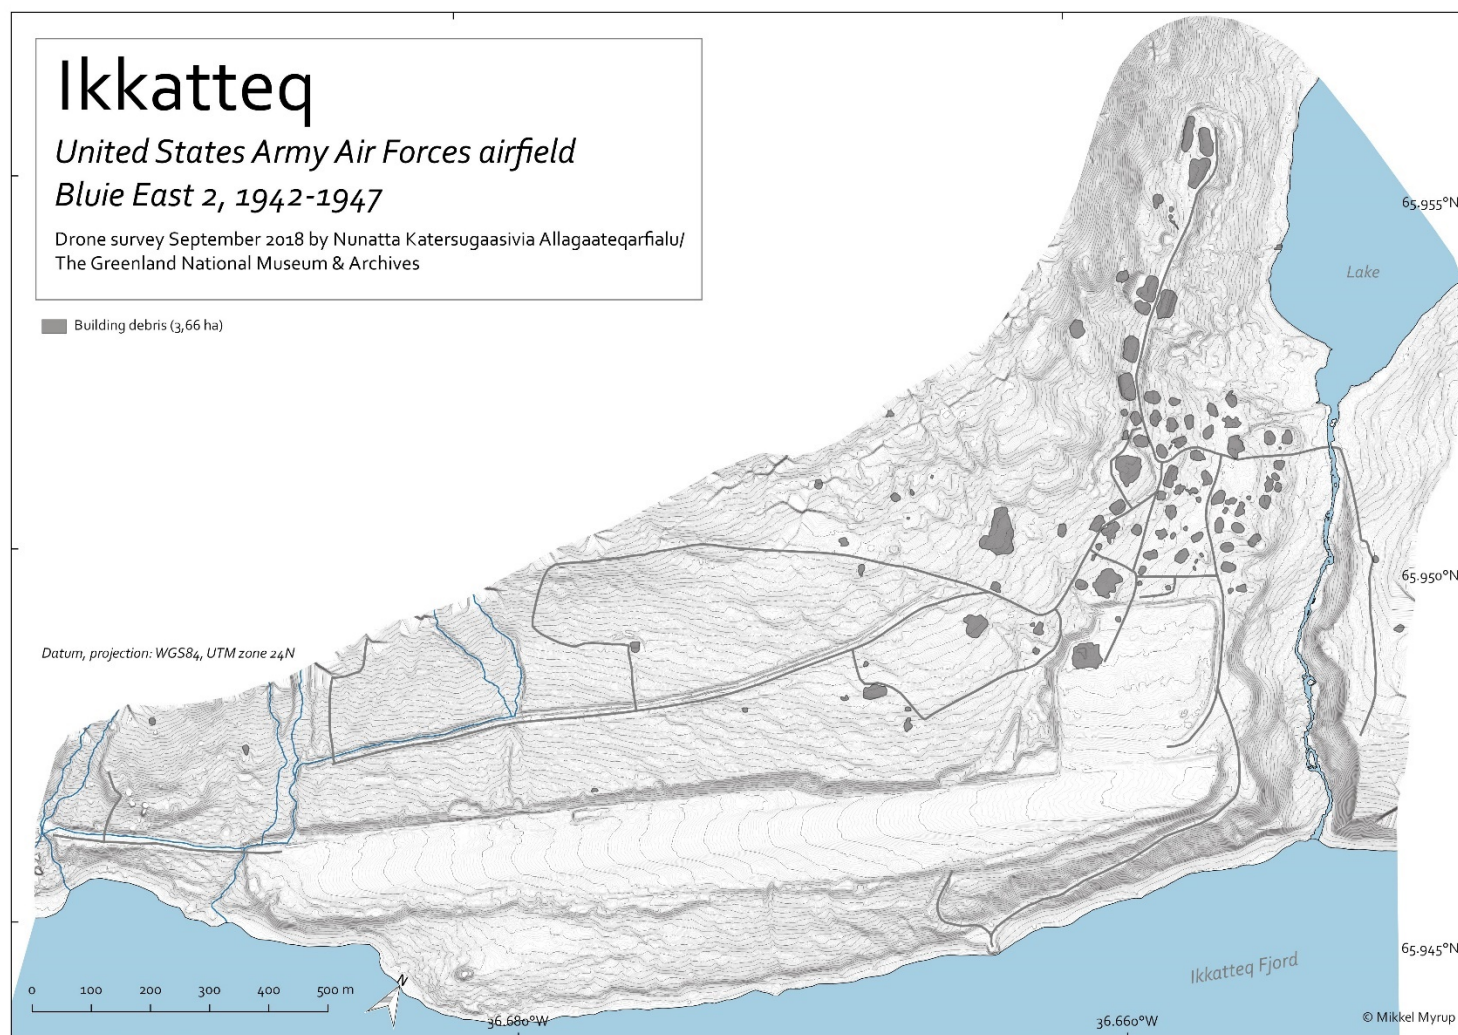
Fig. 14. Map showing building wooden building debris observed at BE-2 in September 2018. Debris cover a combined surface area of 3.66 hectares (36,600 m²). Much of this debris has been heavily disturbed through salvage, strong winds and the breakdown of the base during the decommission at the end of 1947 making it difficult to estimate the total number of building structures at BE-2. Map courtesy of M. Myrup, Greenland National Museum and Archives 2018.

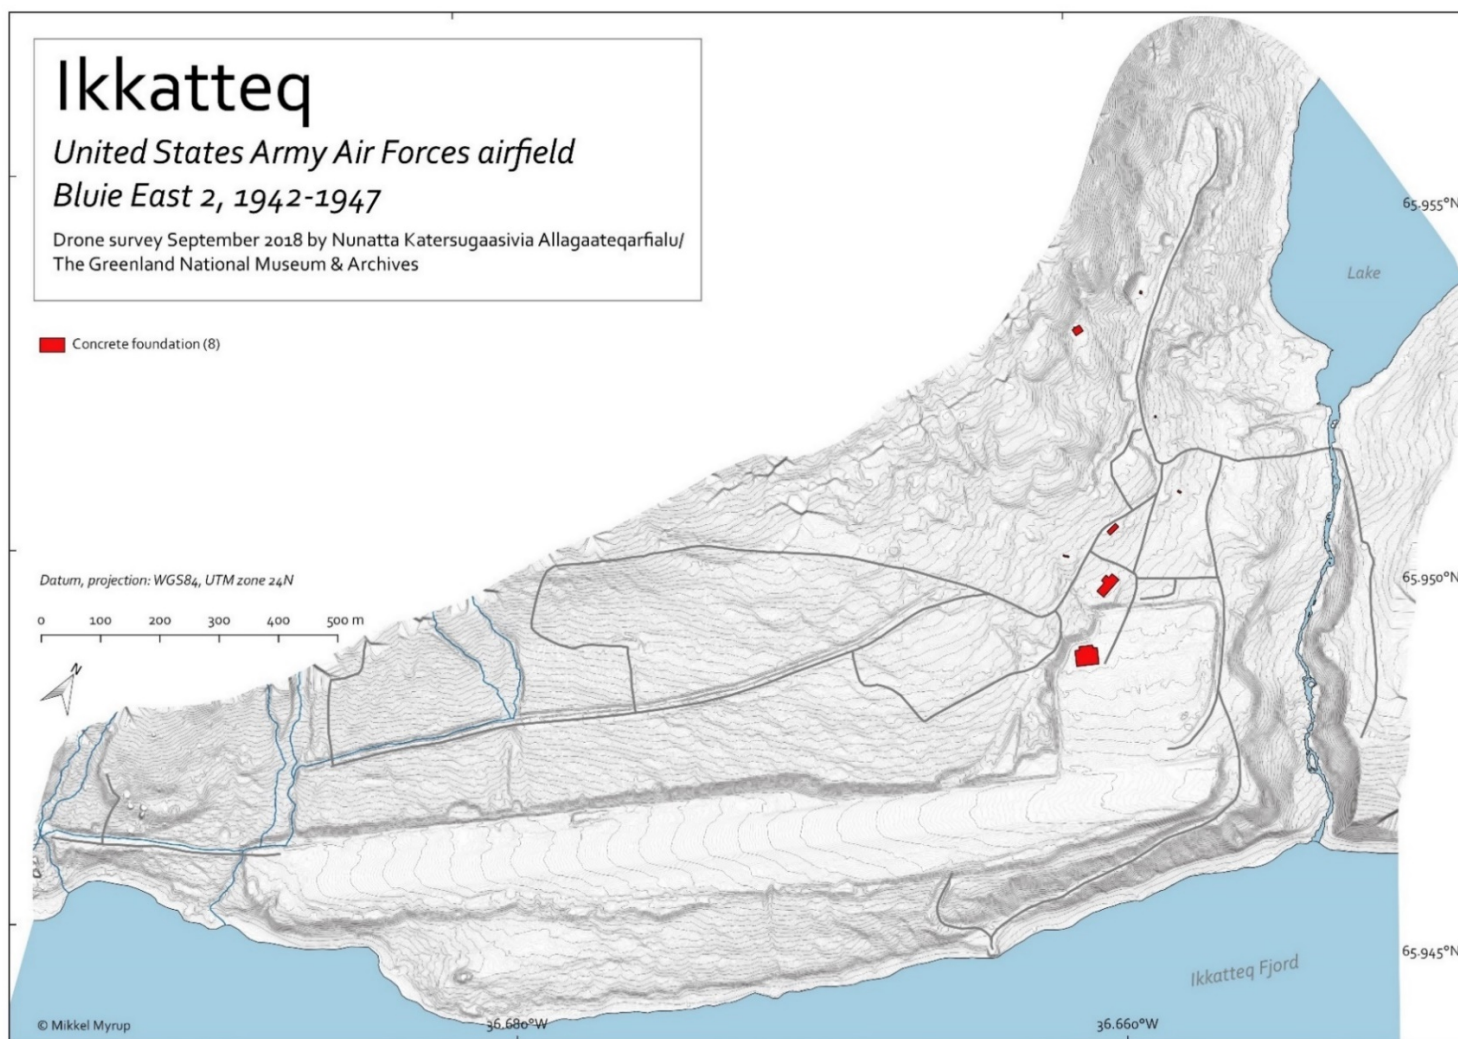
Several buildings also possessed concrete foundations ($n=8$) (Fig. 15). These foundations are distinguished separately from the anti-aircraft gun emplacements that also possessed concrete foundations.

Fig. 15 Map showing eight ($n=8$) concrete foundations observed at BE-2 in September 2018. Locations of concrete foundations shown in red. Map courtesy of M. Myrup, Greenland National Museum and Archives 2018.

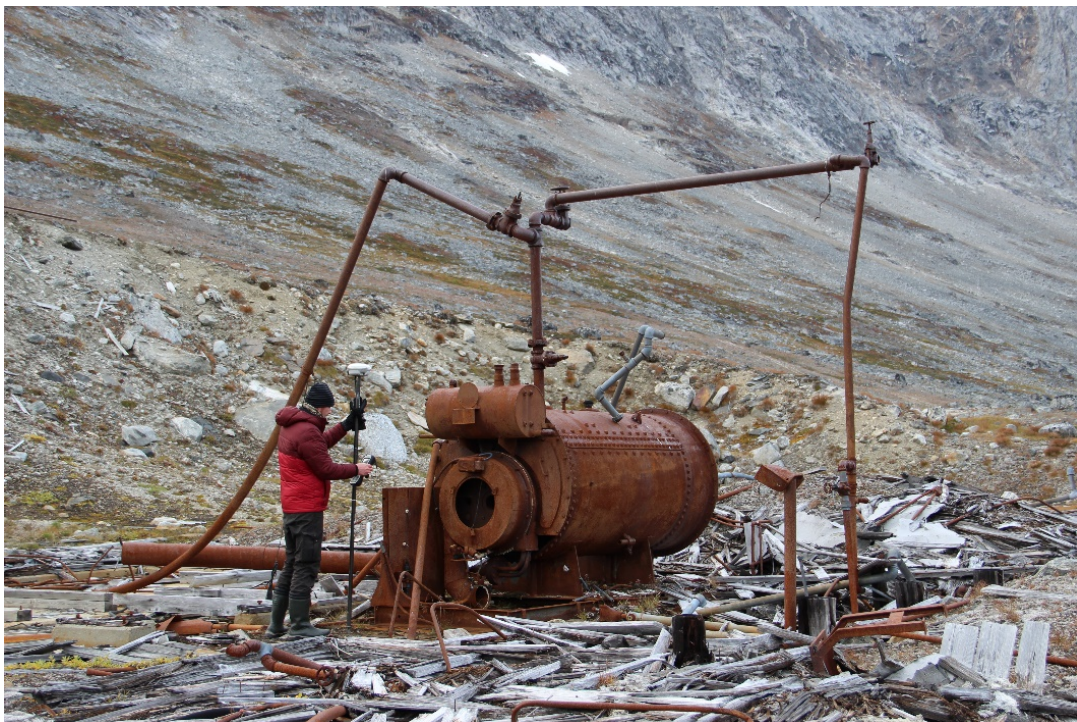
Fig. 17. A large pump was observed near the well in the northwest part of the camp of BE-2. This large industrial pump would have transported water throughout the base (photo: H. Lange 2018).

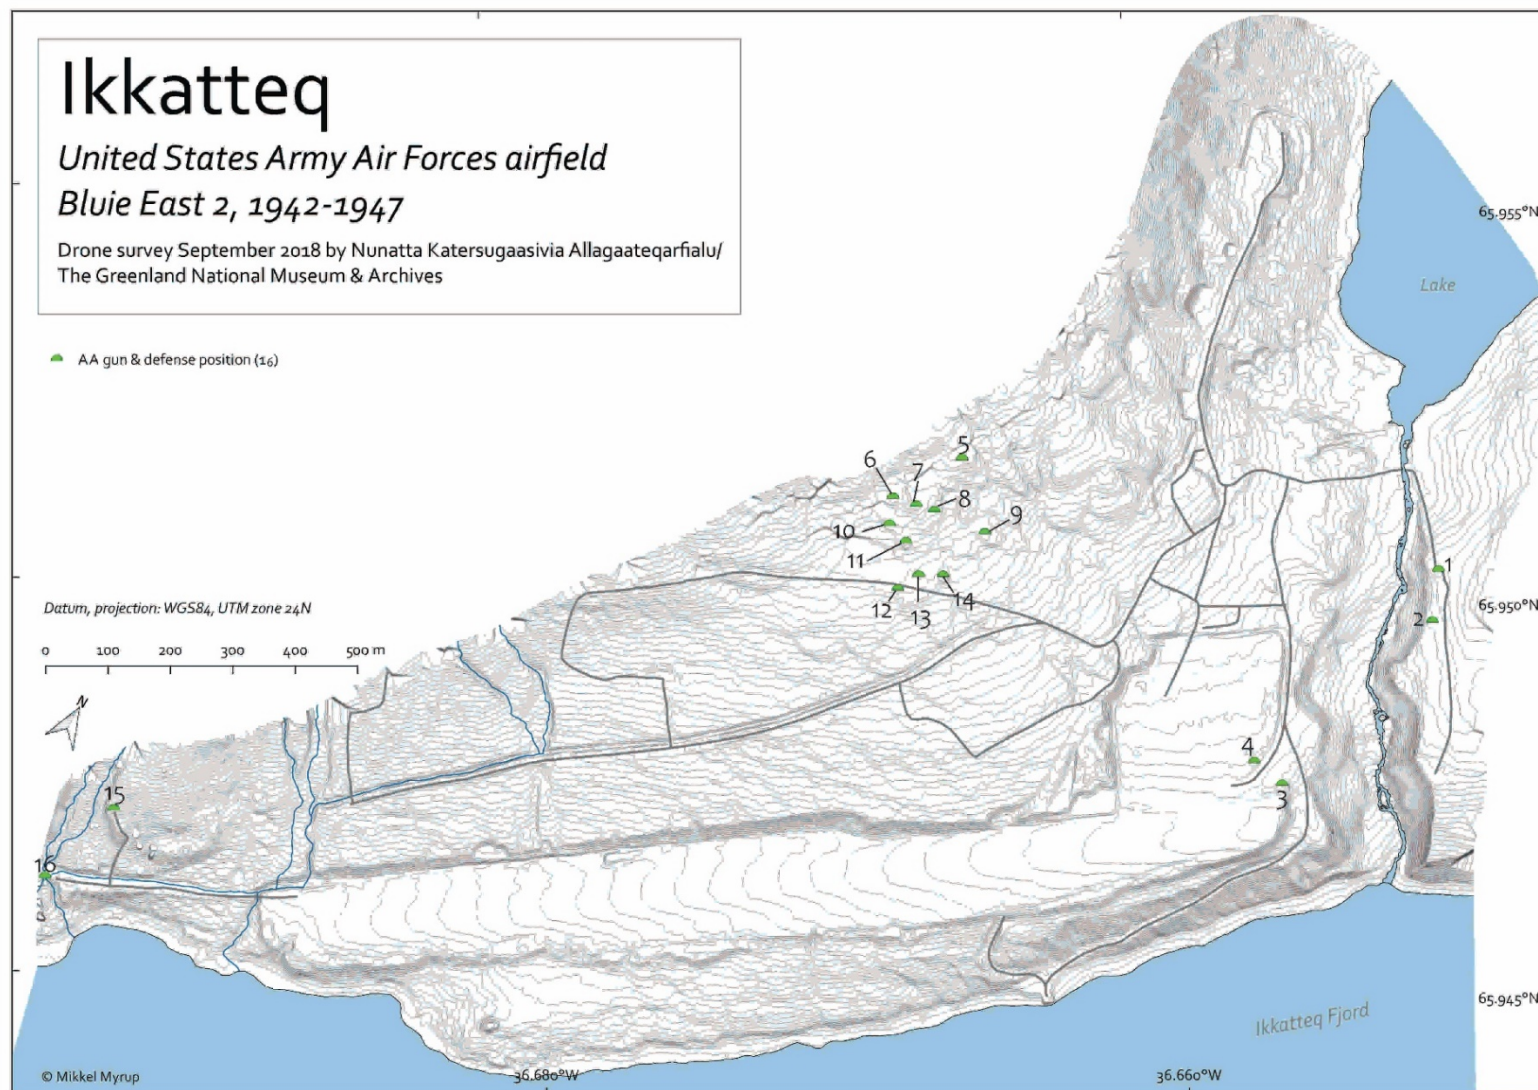
Several Heavy Anti-aircraft (HAA) earthwork defense systems ($n=16$) were observed at BE-2 (Table 2, Fig. 23). Most of these features were dugouts with short earthen walls (~.5 m deep) reinforced by empty 55-gal. fuel barrels filled with soil. Four constructions possessed concrete-poured foundations, assumed to be necessary for positioning and securing of large artillery weapons. Fig. 24 provides illustrations of a few selected examples of earthwork defense features observed at BE-2. Figs. 25-26 show the condition of two of the features observed at the time of the survey.

Fig. 23. Map showing locations of earthwork defense ($n=16$) features observed at BE-2 in September 2018. Map courtesy of M. Myrup, Greenland National Museum and Archives 2018.

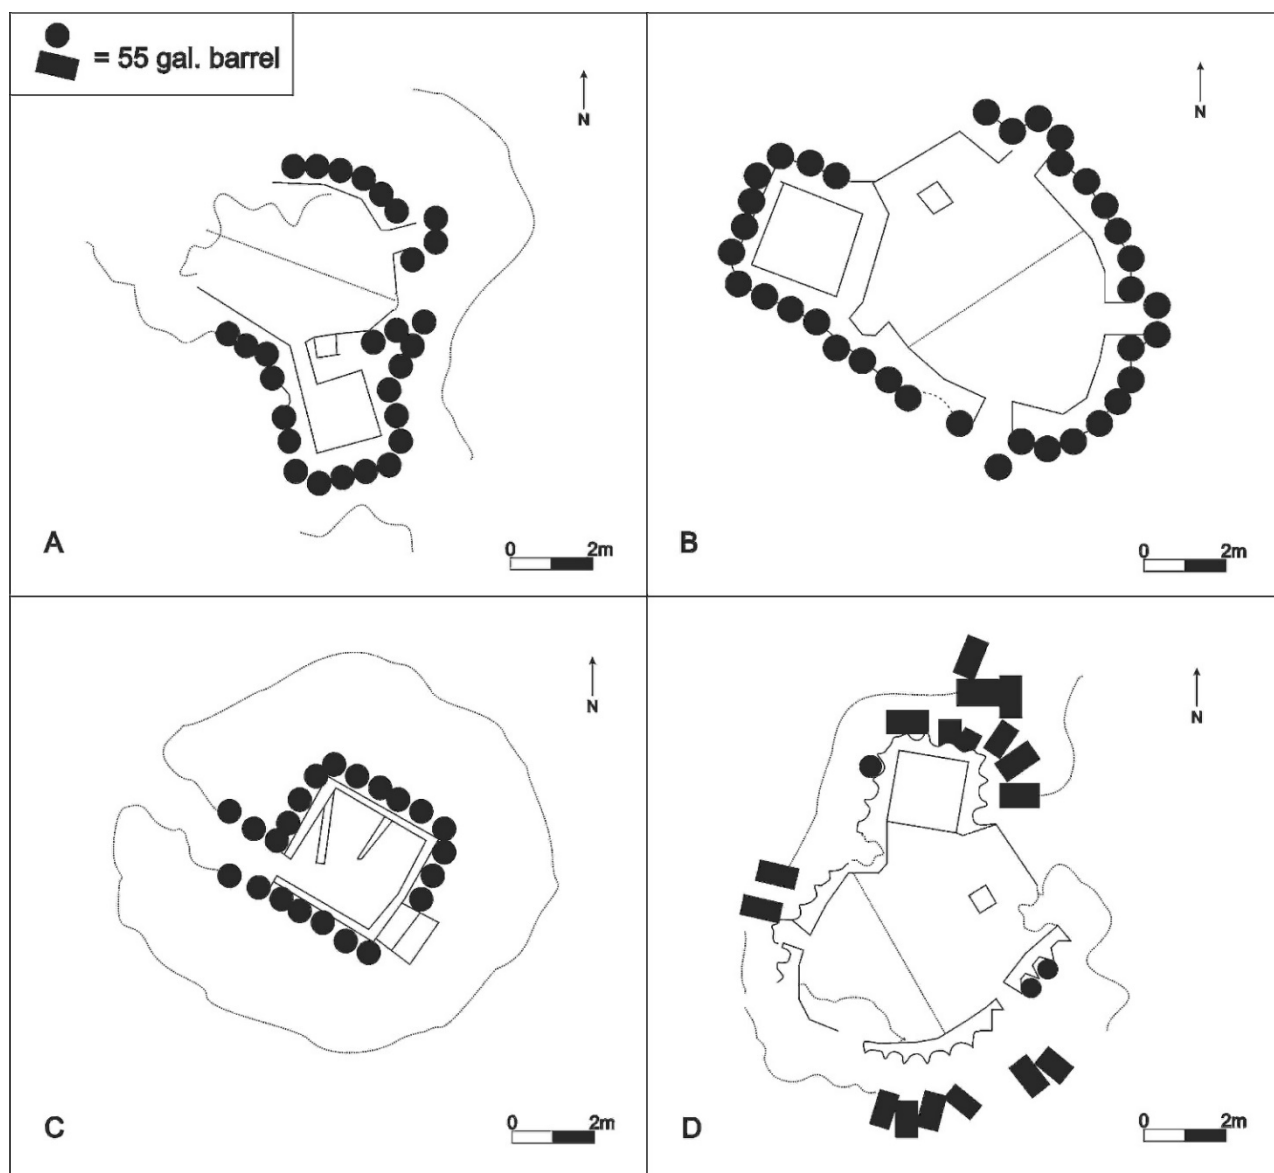
Fig. 24. Sketches showing selected examples of earthwork defense features at BE-2. (A) Feature 1; (B) Feature 3; (C) Feature 9; (D) Feature 15.

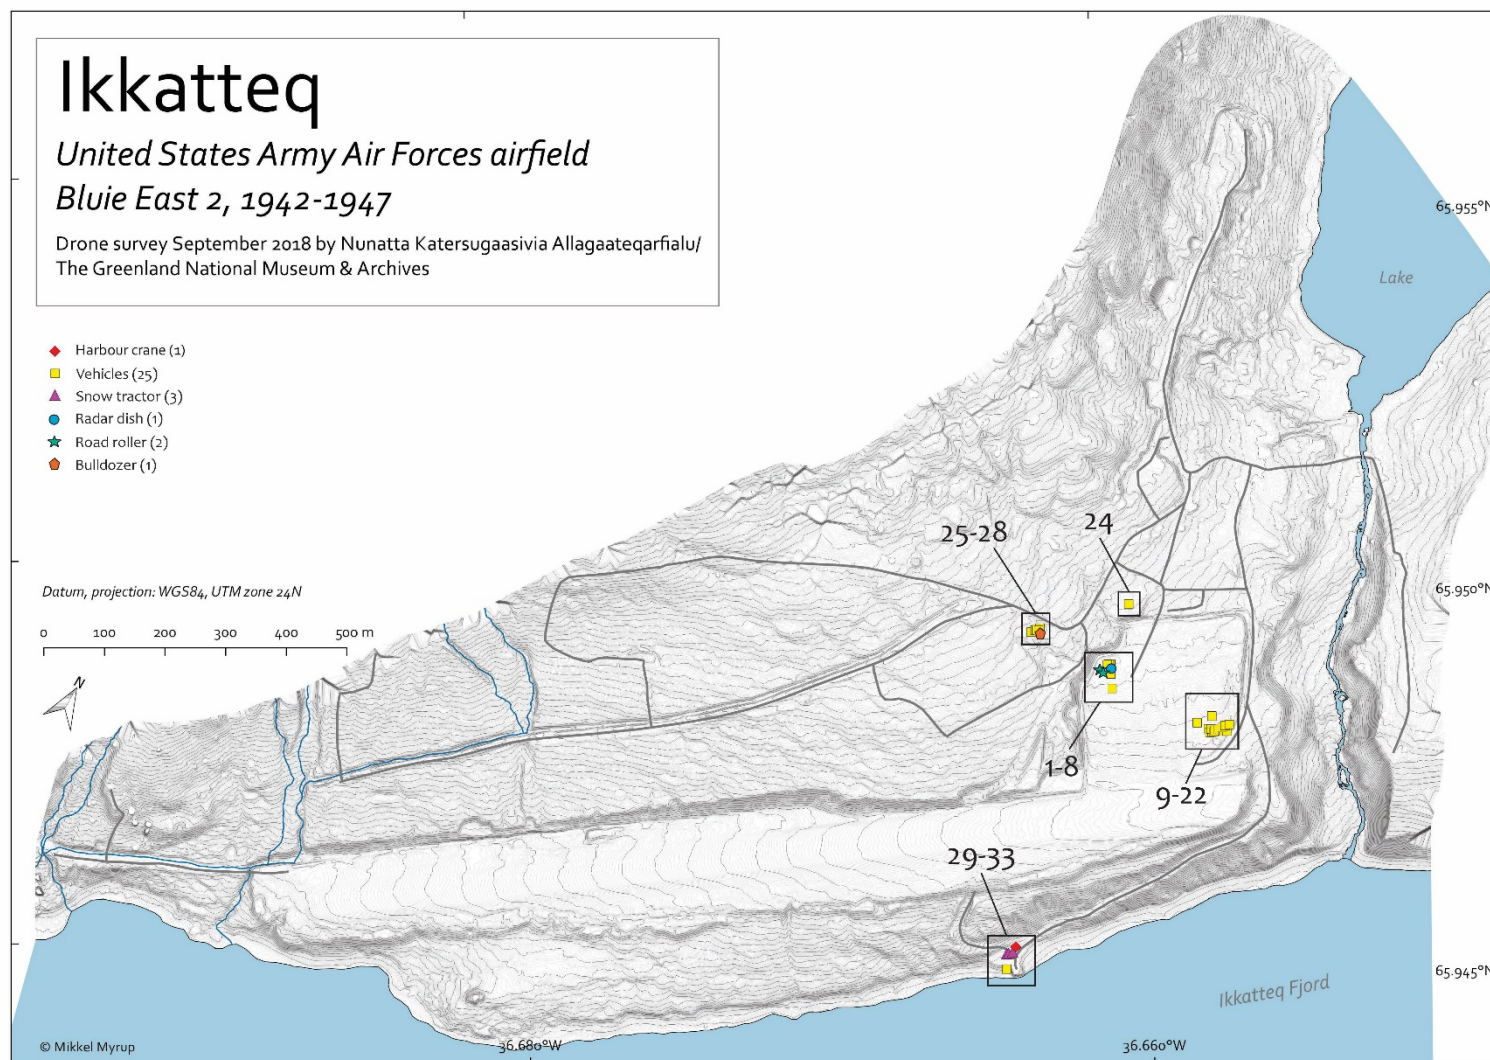
The remains of thirty-three ($n=33$) vehicles and pieces of heavy equipment were observed at BE-2 (Table 3, Figs. 32-36). The fleet at BE-2 comprised a wide variety of different trucks and tracked vehicles that ranged from light duty $\frac{1}{2}$ -1 $\frac{1}{2}$ -ton light duty trucks to heavy duty 9 to 10-ton trucks, as well as a rare type of snow tractor (M-7). One mobile radio dish was identified in the collapsed remains of the hangar, but close inspection was impeded due to the fragility of the structure (Fig. 31). Several other types of heavy machinery were also observed that included two road rollers, a small bulldozer, several cold-weather cabs missing engines and chassis as well as the remains of the large tank-treaded crane next to the old pier (Fig. 37 & Fig. 38). Photo identification of the make and model of several vehicles found on-site was aided by the expertise of Jeff Lakaszcyck, Warren Richardson and Taigh Ramey of the Stockton Field Aviation Museum, Stockton, California.

Fig. 31. The remains of thirty-three ($n=33$) vehicles and pieces of heavy equipment were observed at BE-2 in September 2018. Map courtesy of M. Myrup, Greenland National Museum and Archives 2018.

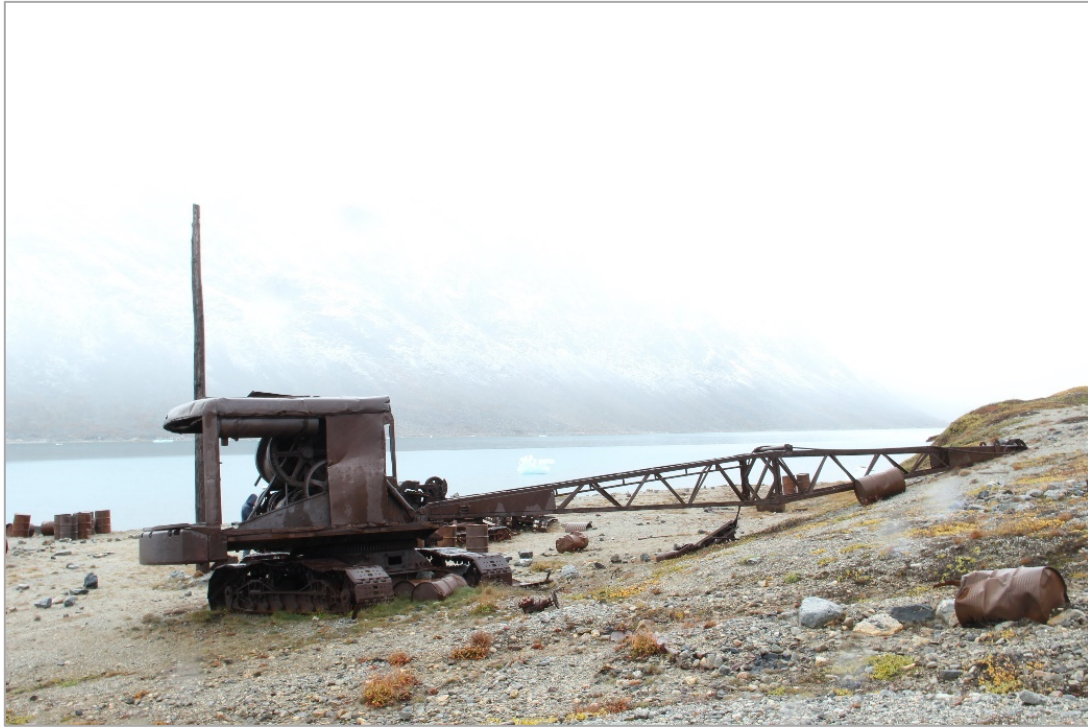
Fig. 37. Harbor crane (Vehicle no. 29) with tank treads found by the old pier at BE-2 (photo: H. Lange 2018). The Thew Shovel Co., Lorain, Ohio.

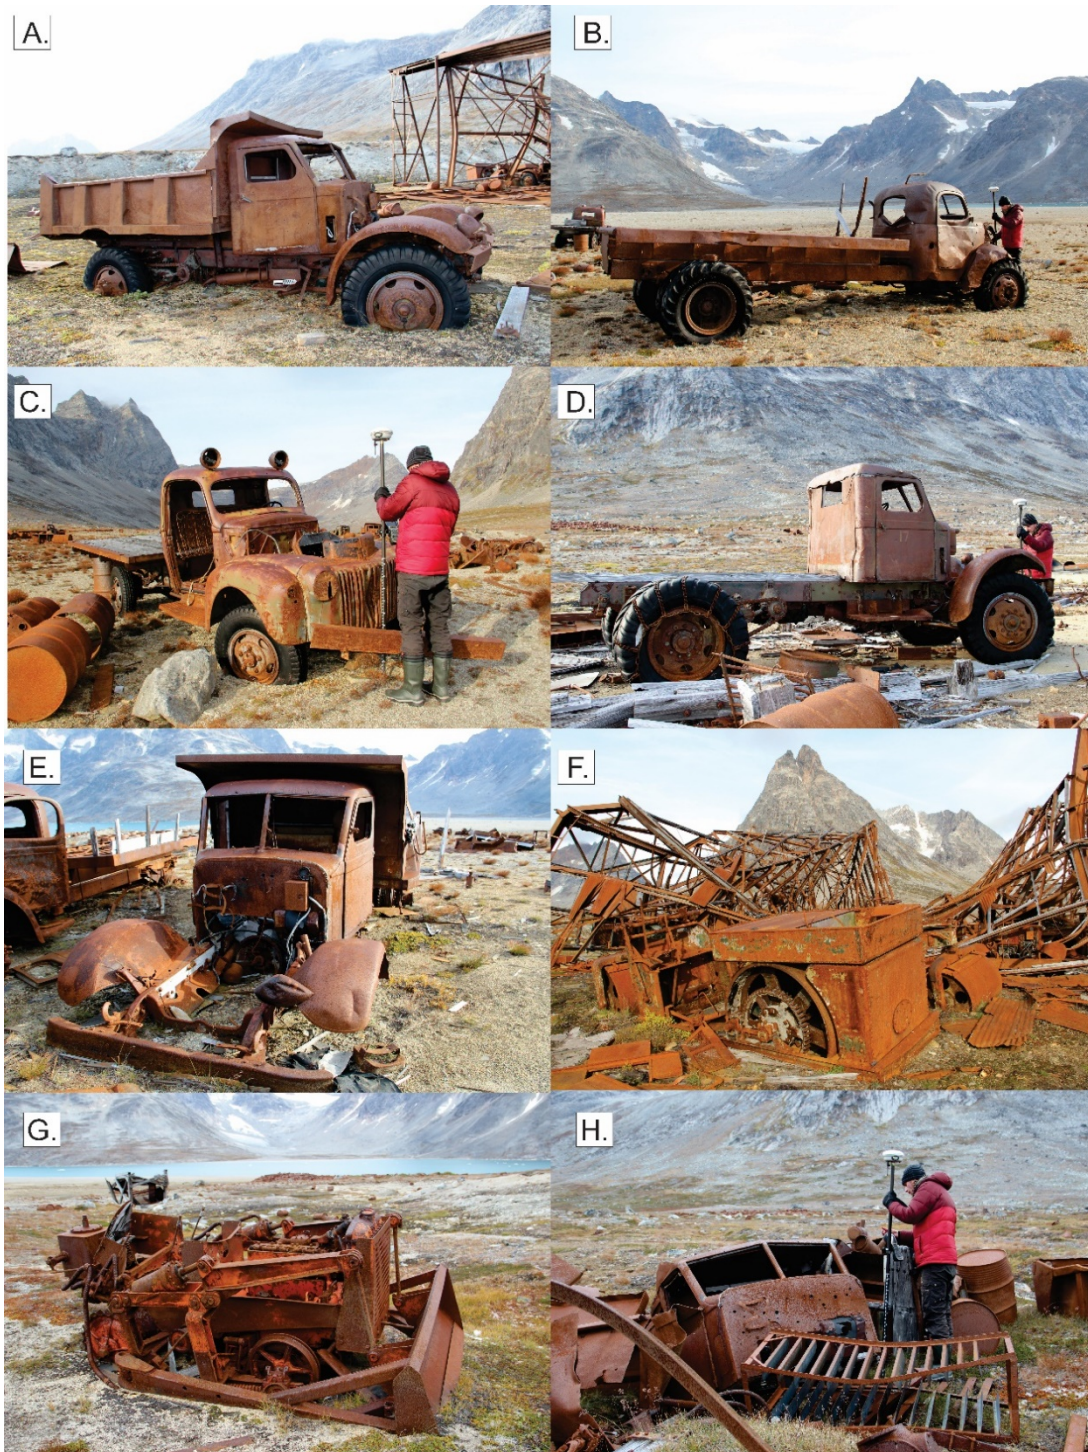
Fig. 39. Examples of derelict vehicles observed at BE-2 in September 2018. (A) Vehicle no. 8, Sterling HC 145 truck, ca.1940-41. 6-cylinder, gasoline SRKR Waukesha engine, 9 to 10-ton payload., (B) Vehicle no. 12, 23. Reo Model 23 or 25. 2 1/2-ton 6x6 truck, also known by the nickname 'deuce and a half', or just 'deuce.' This model was designed as a tactical cargo truck for the US Armed Forces. Load-rated (2,300 kg; 5,000 lb) could operate off-road in all weather; (C) Vehicle no. 23, Reo Model 23 or 25; (D) Vehicle no. 24, Sterling HC 145 truck with snow chains still present on the rear tires.; (E) Vehicle no. 11, Sterling MC 96, similar to HC 145 built with 60-inch wide cabs vs. the HC145 64-inch wide cab; (F) Vehicle no. 1, road roller, unknown make and model; (G) Vehicle no. 25, possibly Catepillar; (H) Vehicle no. 26, unidentified cab, no engine or chassis.

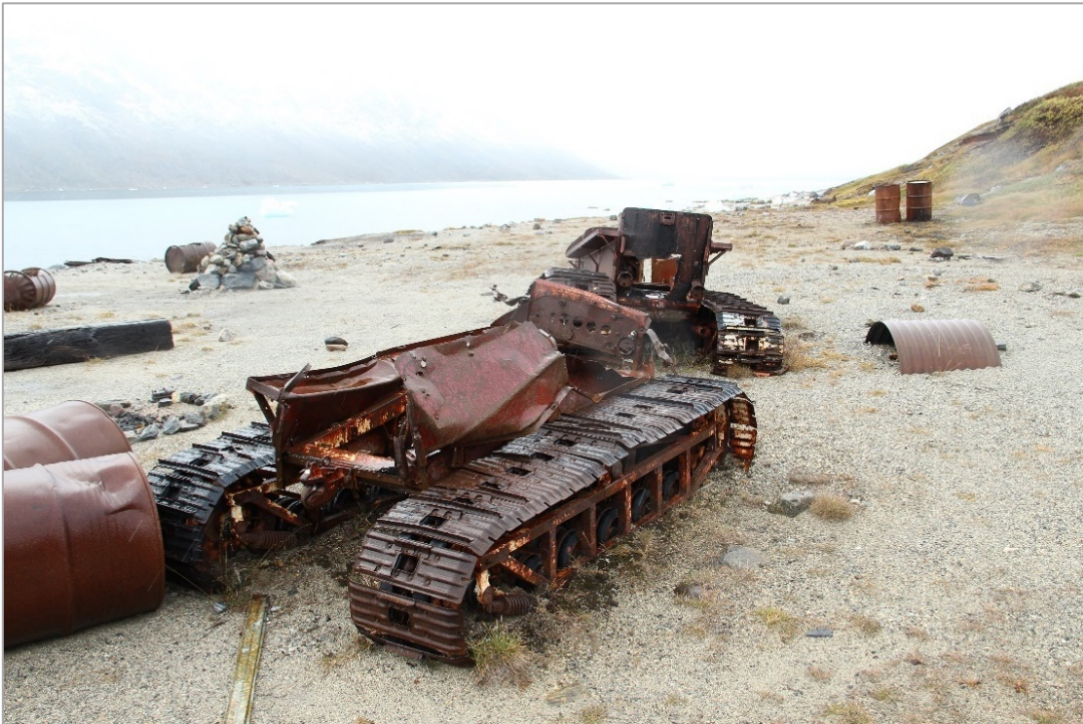
Lastly, one of the most interest discoveries of the survey was the positive identification of the remains of three ($n=3$) Allis-Chalmers M-7 Snow Tractors (Fig. 41 & Fig. 42). These small half-track vehicles were used for transport in remote and snowy terrain and are extremely rare finds today (Raimey 2018, personal communication). The front axle could be equipped with either wheels or skis and these vehicles are noted for their use in search-and-rescue operations in the Second World War.

Fig. 41. Remains of an Allis-Chalmers M-7 Snow Tractors (Vehicle nos. 31-32). These small half-track vehicles were used for rescue operations in remote and snowy terrain and are extremely rare WW2 relics (photo: H. Lange 2018).

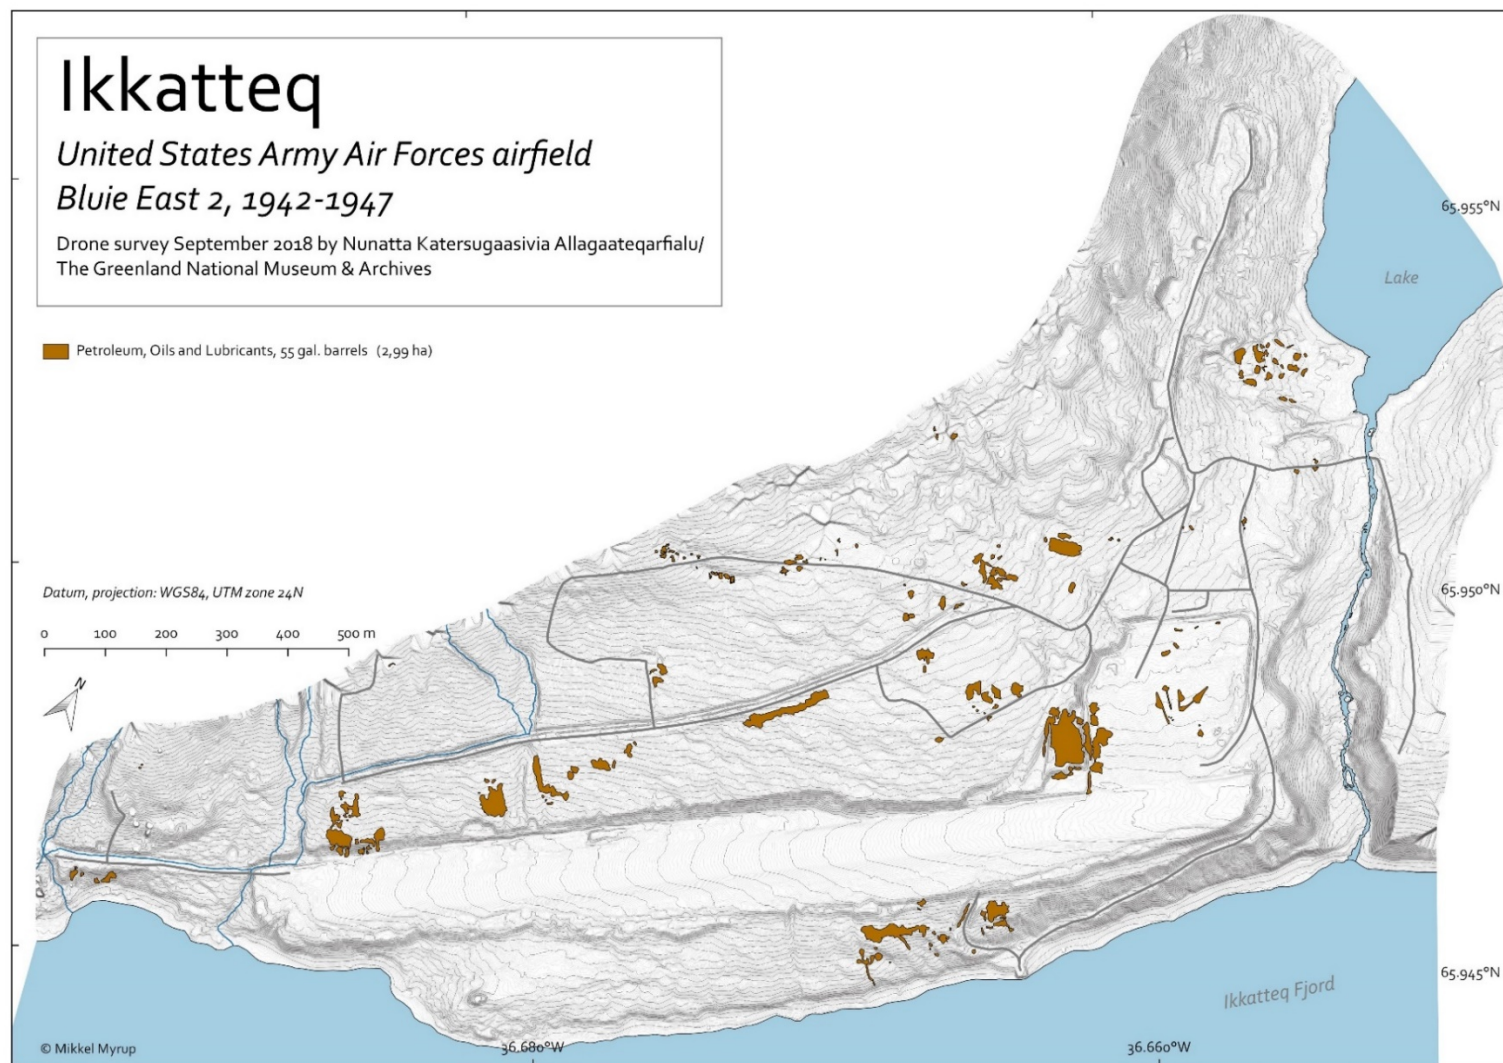
Empty fuel barrels (Fig. 43) cover an approximate surface area of approximately 3 hectares (~28,000 m²) at BE-2 (Fig. 45). The barrels are 55-gallon drums used for the storage of airplane fuel. An average barrel measures 87 cm x 50 cm in diameter. At the moment, there is no clear estimate on how many barrels are present at BE-2, but various news media have placed the number somewhere around 10,000 (e.g. Lang 2018). Actual numbers may be much higher in the range of 20-30,000.

For the most part, no fuel was observed to be still present in the barrels—this is attributed to the fact that the barrels are highly corroded, and the liquid has been gradually transported into the topsoil. As a consequence, large portions of BE-2 may be contaminated with a high level of lead and other toxic chemical residues.

Fig. 45. Map showing major clusters of empty fuel barrels at BE-2 in September 2018. Barrels are observed to cover an approximate surface area of ~3 hectares. Map courtesy of M. Myrup, Greenland National Museum and Archives 2018.

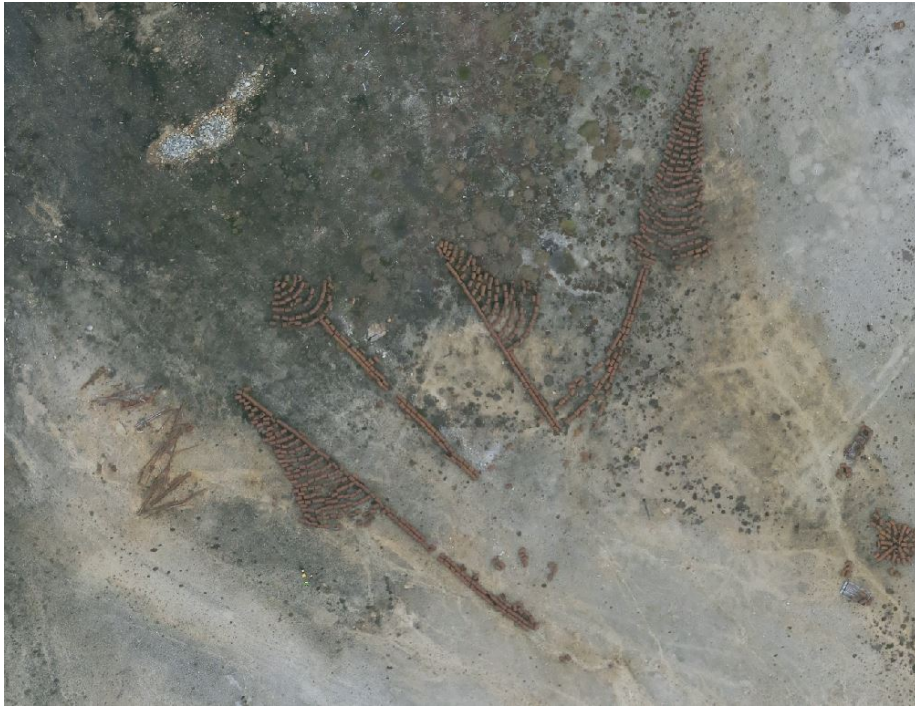
Large concentrations of barrels are found clustered in many areas at BE-2 (for example, see Fig. 44), but individual barrels are also found strewn across the site from the southern tip of the runway to the northern periphery of the camp on the lake shore. In two areas, barrels have been arranged to form designs that form shapes, such as flowers when observed from above (Fig. 46 & Fig. 47).

Fig. 46. Barrels arranged to form a design as seen from above (photo: M. Myrup 2018).

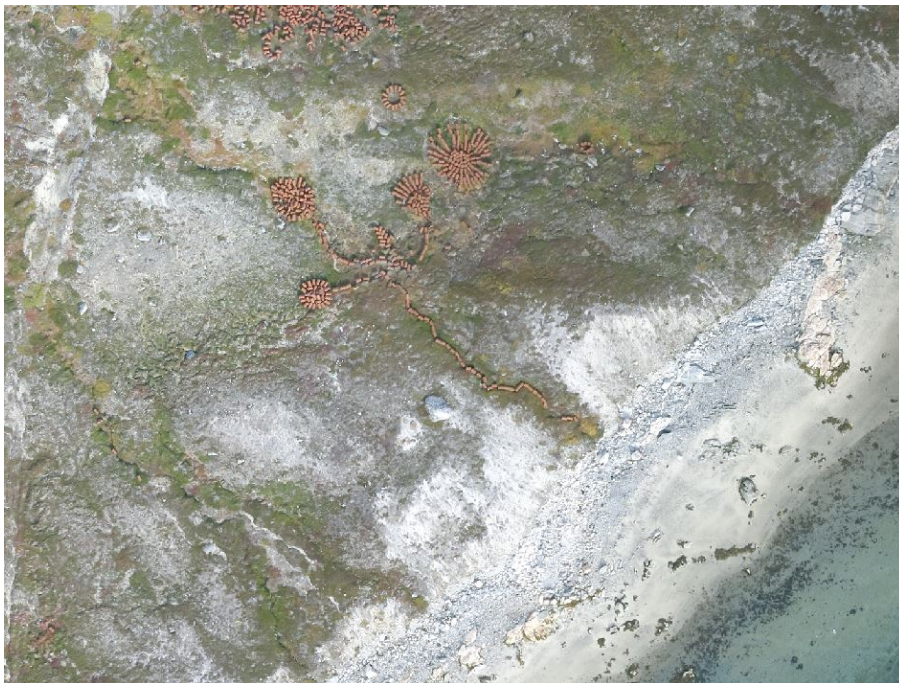
Fig. 47. Barrels arranged to form a flower pattern (photo: M. Myrup 2018).

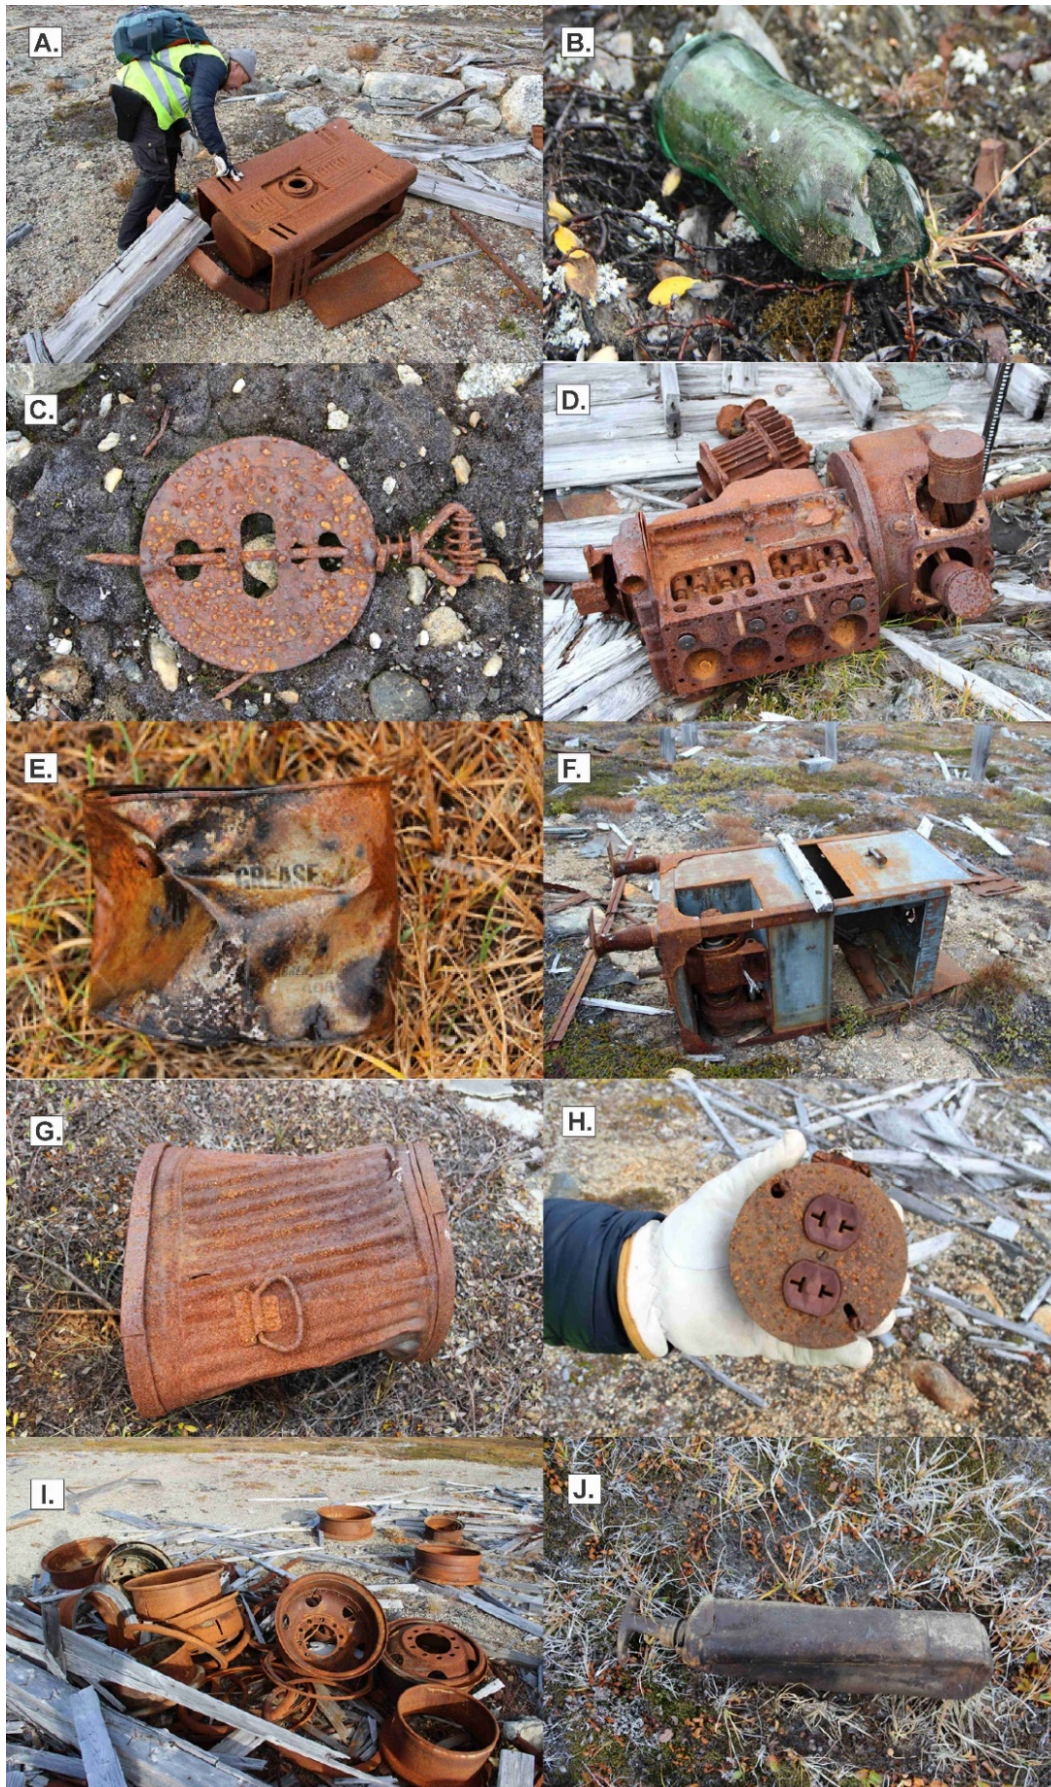
Fig. 48 illustrates several different types of small- to medium-sized artifacts observed at BE-2 in September 2018. All the items appear to have been American production types of both commercial and military design and therefore diagnostically significant. It appears that soldiers stationed at the base were afforded basic amenities such as oil heat and electricity, a luxury that most Greenlanders at the time did not have access to. For example, several medium-sized oil heaters were observed in building footprints that were most likely barracks, private quarters and offices (Fig. 48, A). An electrical dishwasher was observed in an area believed to be the former mess hall. Of special interest was also the item shown in (Fig. 48, H), a T-slot duplex electrical socket and housing. The electrical grid at the base would have run at 110-120 Volts, the North American standard for supply voltage.

Fig. 48. (Following page) Selected images of World War II era artifacts identified at BE-2 in September 2018. (A) H. Lange inspecting an oil space heater, unknown model; (B) Broken Coca-cola bottle; (C) Front panel, space heater; (D) Engine bloc, unknown model; (E) Grease used for machine lubrication; (F) Electric dishwasher?; (G) Steel garbage can; (H) T-slot duplex electrical socket with housing; (I) Assorted tire rims; (J) OLD-TIME General S-O-S Fire Guard Model 85 Fire Extinguisher (photos: H. Lange and H. Harmsen 2018).
