SURVEY REPORT OF IKKATTEQ, BLUIE EAST 2 (BE-2)
SEMERSOOQ MUNICIPALITY, EAST GREENLAND

REPORT PREPARED BY:

HANS HARMSSEN
MIKKEL MYRUP
HANS LANGE

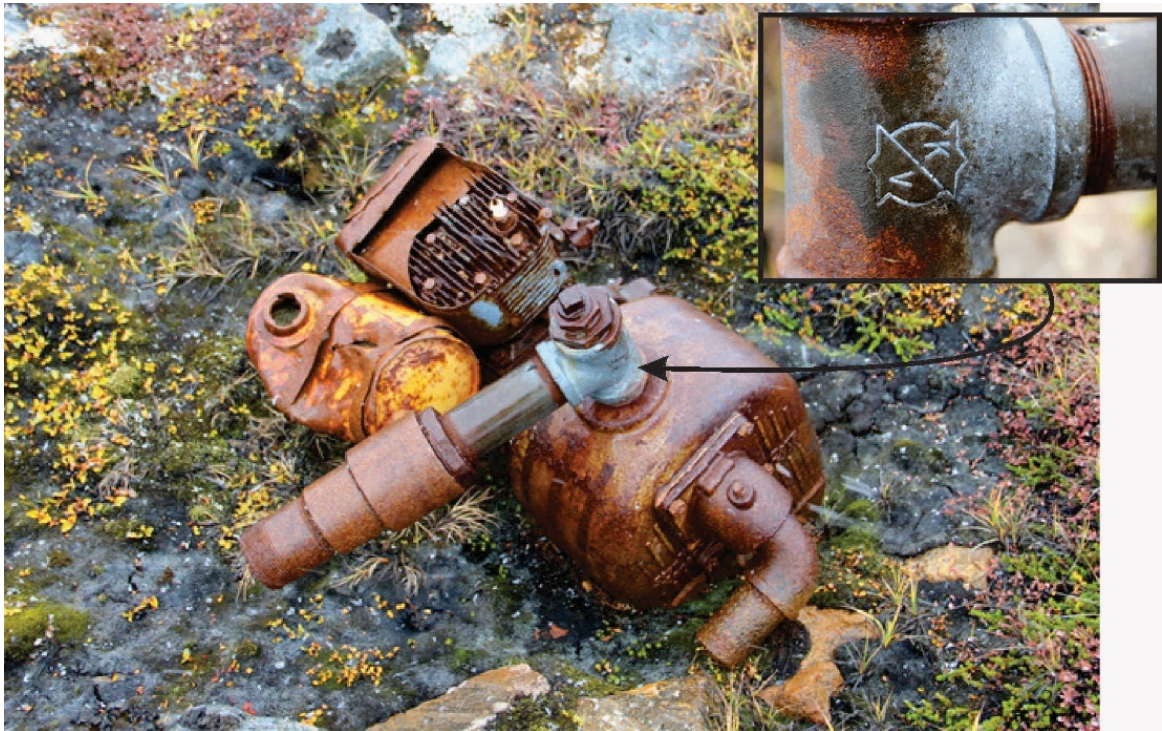
Fig. 49. Discarded hydraulic pump (photo: H. Lange 2018).

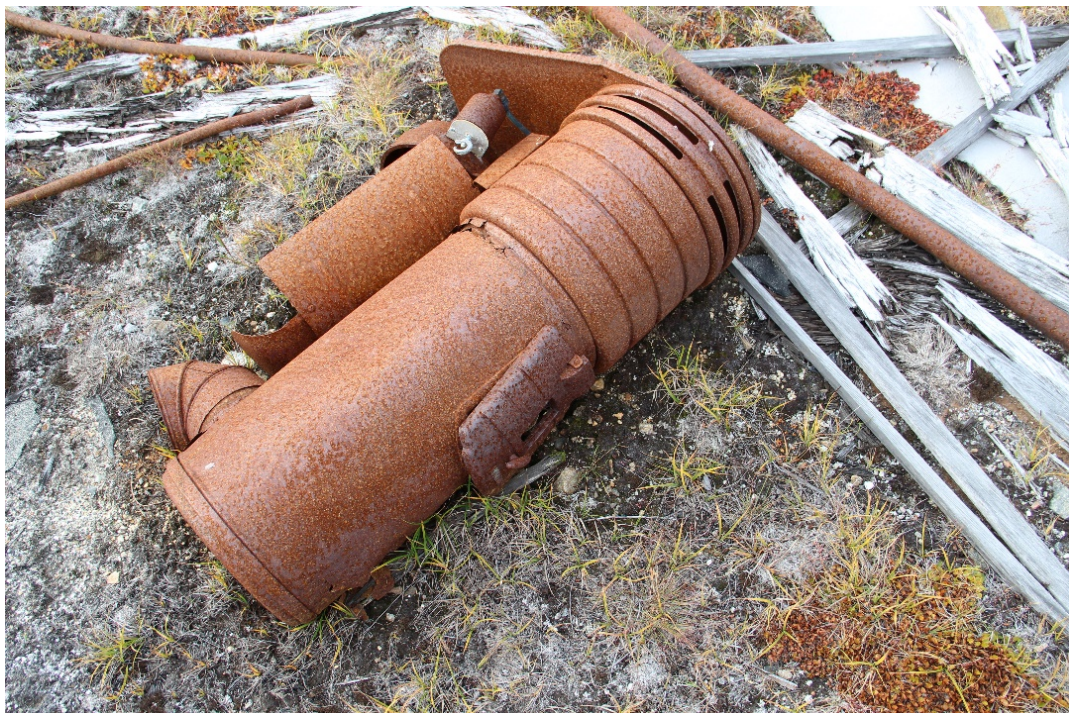
Fig. 50. Remains of a steel fixture, possibly part of a boiler or heating unit (photo: H. Lange 2018).

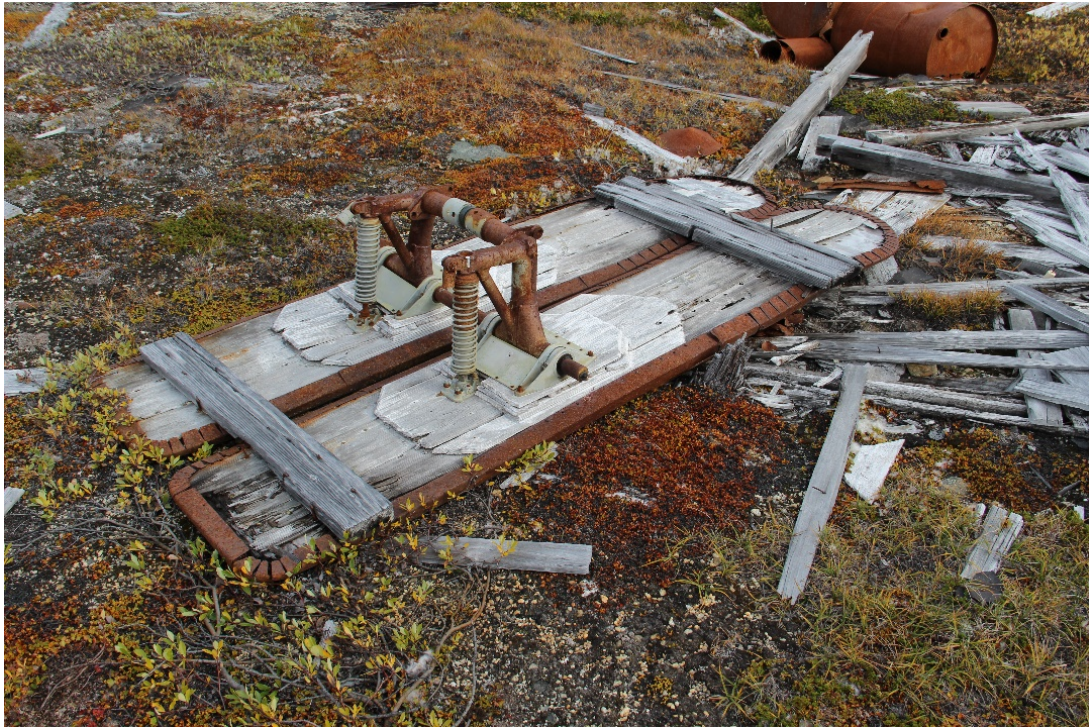
Fig. 51. Modified snow skis, possibly attached to a trailer pulled by the M-7 (photo: H. Lange 2018).

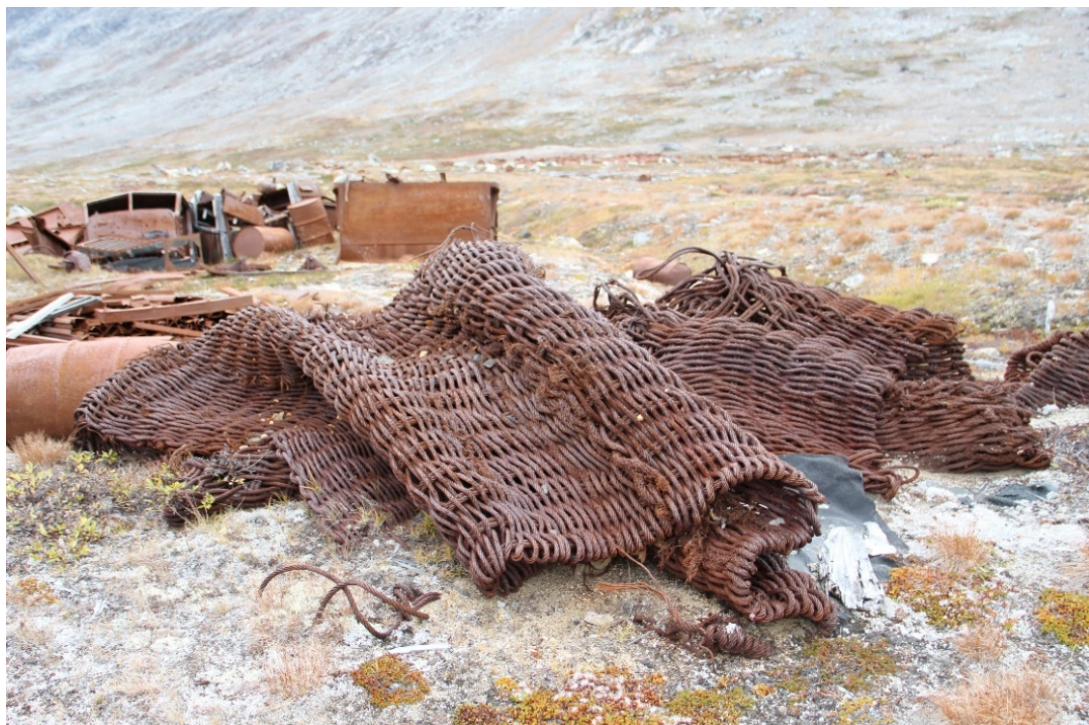
Fig. 52. Braided steel carpet, helpful for traction in slippery or boggy terrain (photo: H. Lange 2018).

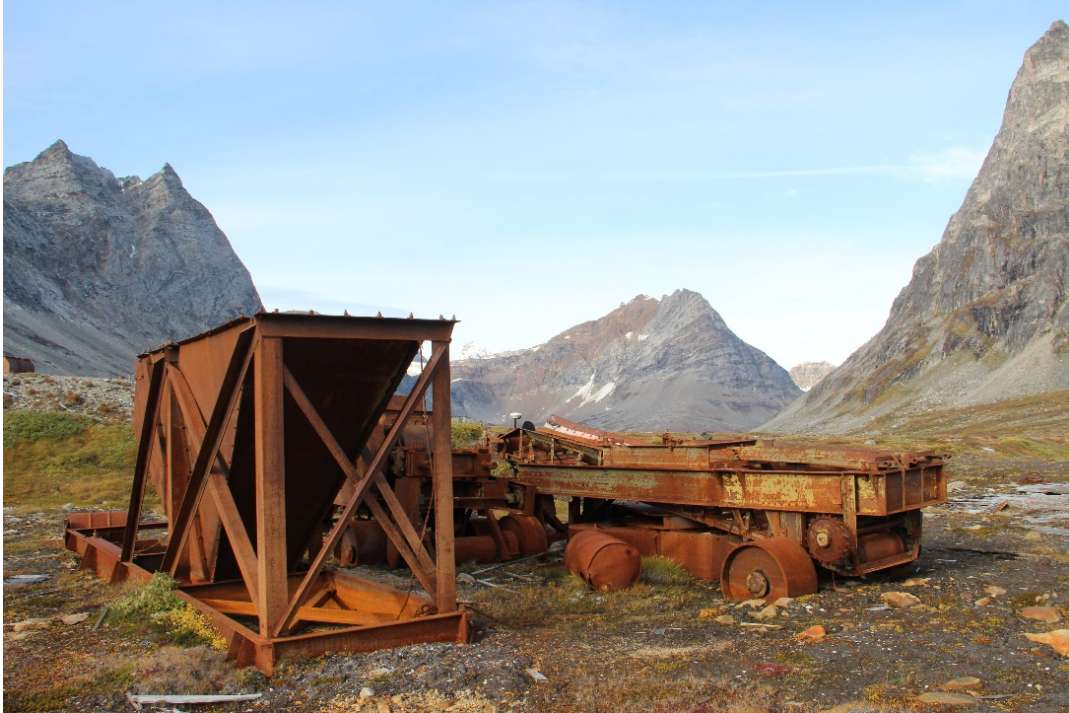
BE-2 possesses several pieces of stationary machinery and equipment such as gravel crushers, furnaces and boilers (Figs. 53-55). Most of these items are made of steel and weigh several tons. In some cases, maker's marks were still visible, such as is seen on the boiler shown in Fig. 55. This industrial boiler can be traced to the FitzGibbons Boiler Company, Inc., Oswego, New York.

Fig. 53. Heavy machinery used for production and loading gravel at BE-2 (photo: H. Lange 2018).

- All heavy and stationary man-made objects (e.g. boilers, furnaces, generators, concrete foundations, etc.) at BE-2 should remain undisturbed. These types of large objects pose no current threat to the environment and possess significant historic value by virtue of their diagnostic character. Present and future generations will benefit from being able to visit and observe these objects in their original setting.

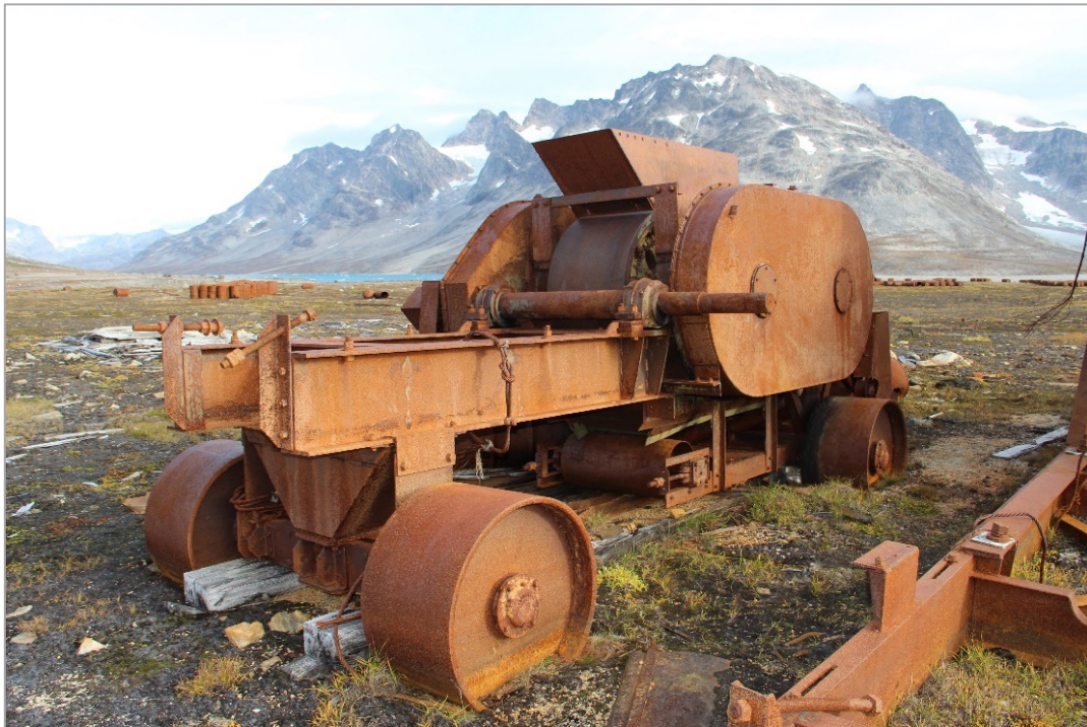
Fig. 54. Rock crusher used to produce gravel for the airstrip at BE-2 (photo: H. Lange 2018).

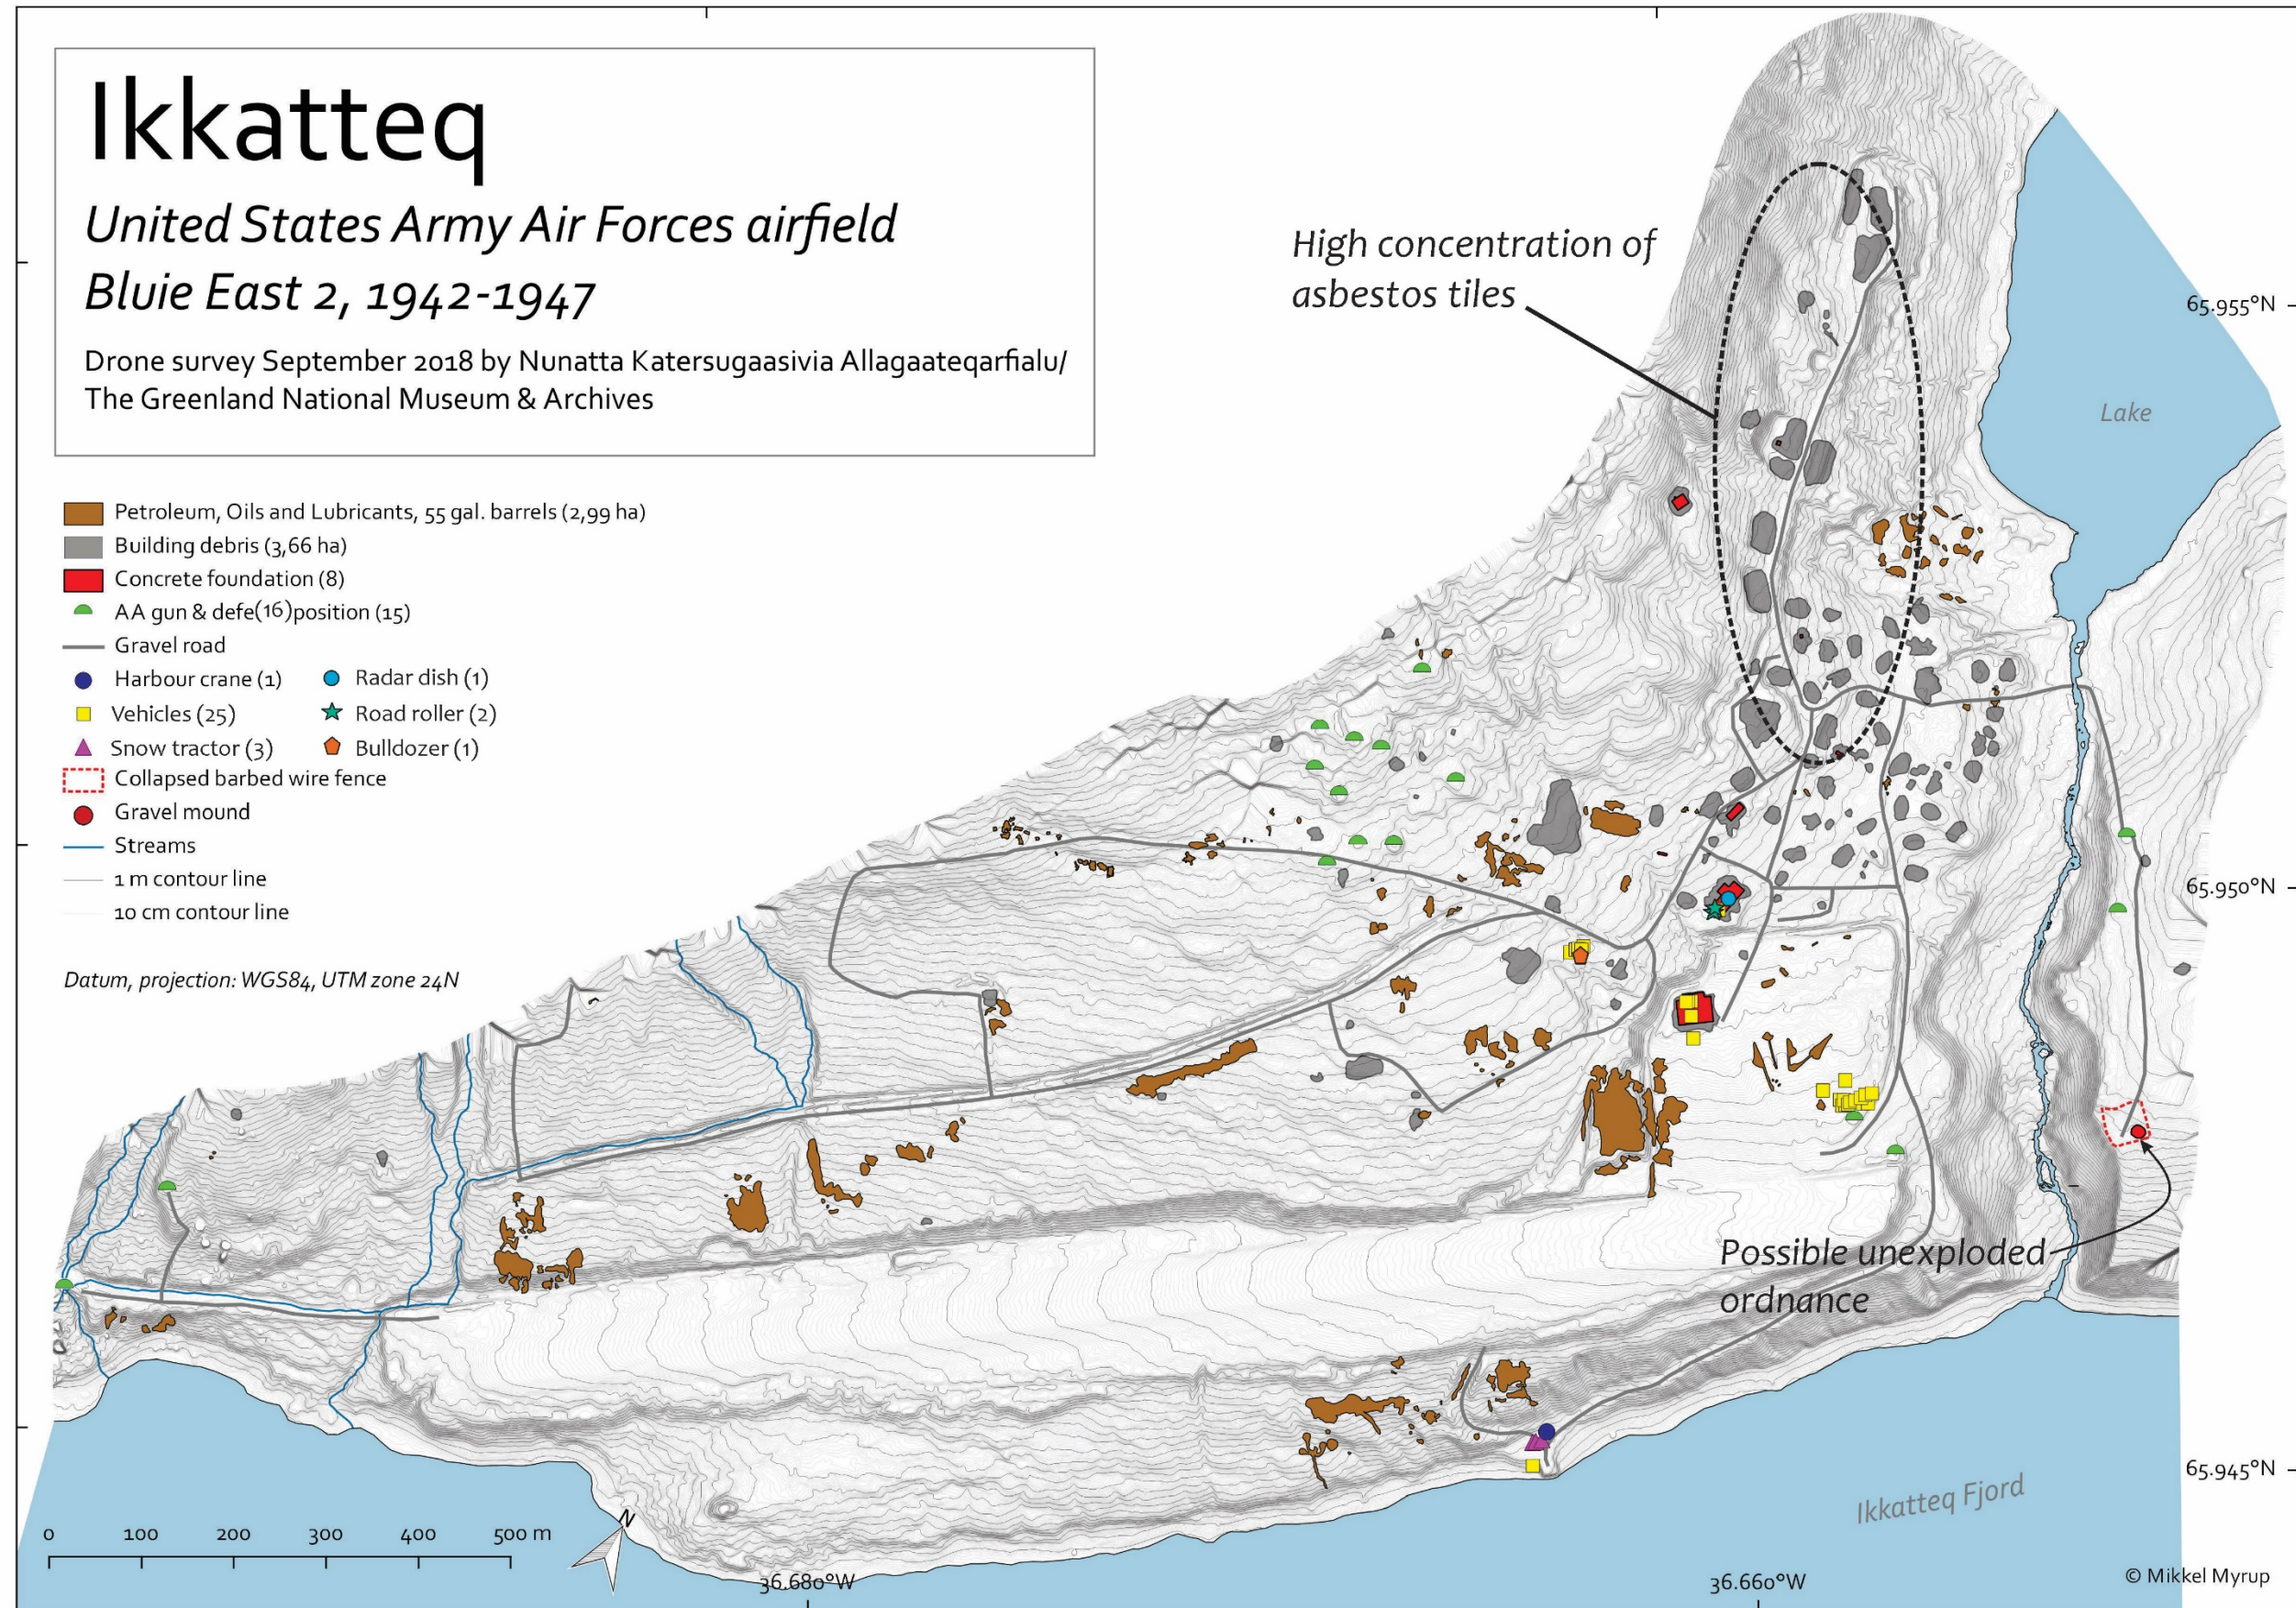
Fig. 56. Map detailing all features and large artifacts observed at BE-2 in September 2018. Map courtesy of M. Myrup, Greenland National Museum and Archives 2018.

- **Environmental risks:** As mentioned above, BE-2 may be heavily contaminated and pose significant risk to human health and well-being. We can definitely confirm the presence of a large concentration of asbestos tiles in the northwestern area of the main camp (Fig. 56) and **advise reasonable protective measures should be taken when entering this area.**

- **Unexploded ordinance:** On the eastern frontier of BE-2 lies the remains of a collapsed barbwire enclosure on the bluff overlooking the fjord. Within this area a conspicuous mound of earth (Fig. 56) was identified that may be related to Bob Baxter's anecdotal story of 700 cases of unexploded dynamite that were left behind after BE-2 was closed in 1947 (see Appendix I). If this is the case, **we advise extreme caution be taken in this area** as aging nitroglycerine--even when buried--can be extremely volatile and pose significant danger if disturbed.

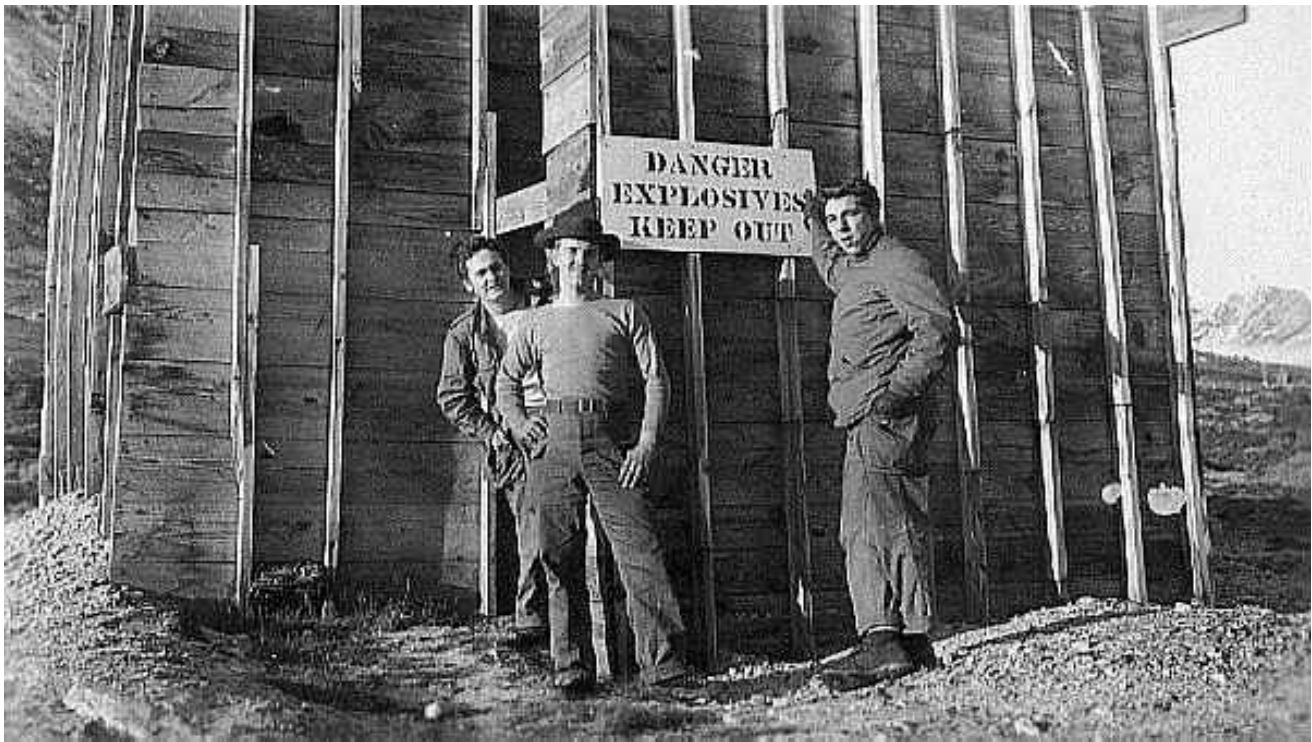
Fig. 57. Bob Baxter (left) posing in front of the explosive depot at BE-2 ca. 1944-1947.
